**AIRCRAFT SERIOUS INCIDENT
INVESTIGATION REPORT**

PEACH AVIATION CO., LTD.

J A 8 1 1 P

**PEACH AVIATION CO., LTD.
AIRBUS A320-214, JA811P
ATTEMPTED LANDING ON A CLOSED RUNWAY
ABOUT 5 NM EAST OF TOKYO INTERNATIONAL AIRPORT
AROUND 480FT AT 00:39 JST, DECEMBER 22, 2016**

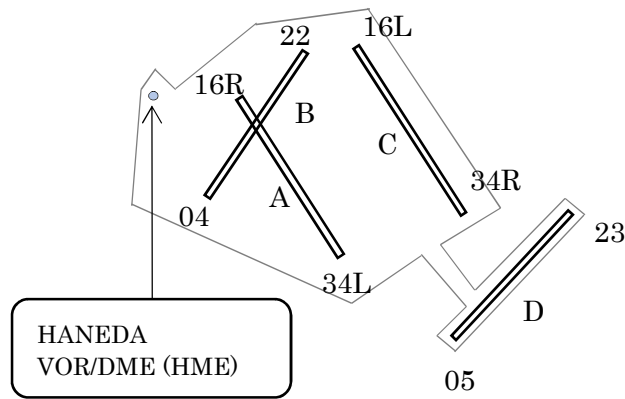
Figure 1 Runway at the Airport

When the serious incident occurred, the runway which the Aircraft was instructed to land on was runway C (runway 16L), which is 3,360 m in length, 60 m in width and 157° in magnetic direction. And the closed runway which the Captain mistakenly tried to approach for was runway D (runway 23) which is 2,500 m in length, 60 m in width and 230° in magnetic direction.

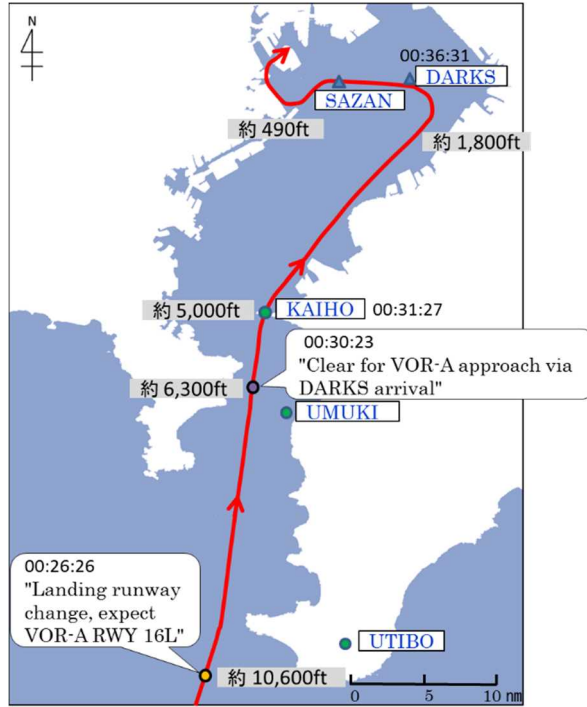
Appended Figure 1 Estimated Flight Route (1)

As shown in Appended Figure 1, the interval time from when the Aircraft was announced the possible approach procedure change to VOR A approach by Tokyo Approach to when passing KAIHO was about five minutes. It is probable that after being announced this notification the FO started following the Captain's order to modify MCDU, however, he got confused and it took quite a long time to realize that VOR A approach was not registered in Database. As described in 2.1.2 (1), it is probable that the Captain tried to give an approach briefing once again because the approach procedure changed from ILS Y approach to VOR A approach, however, he could not have enough time to brief and, in practice, he could barely manage to do on the way to DARKS.

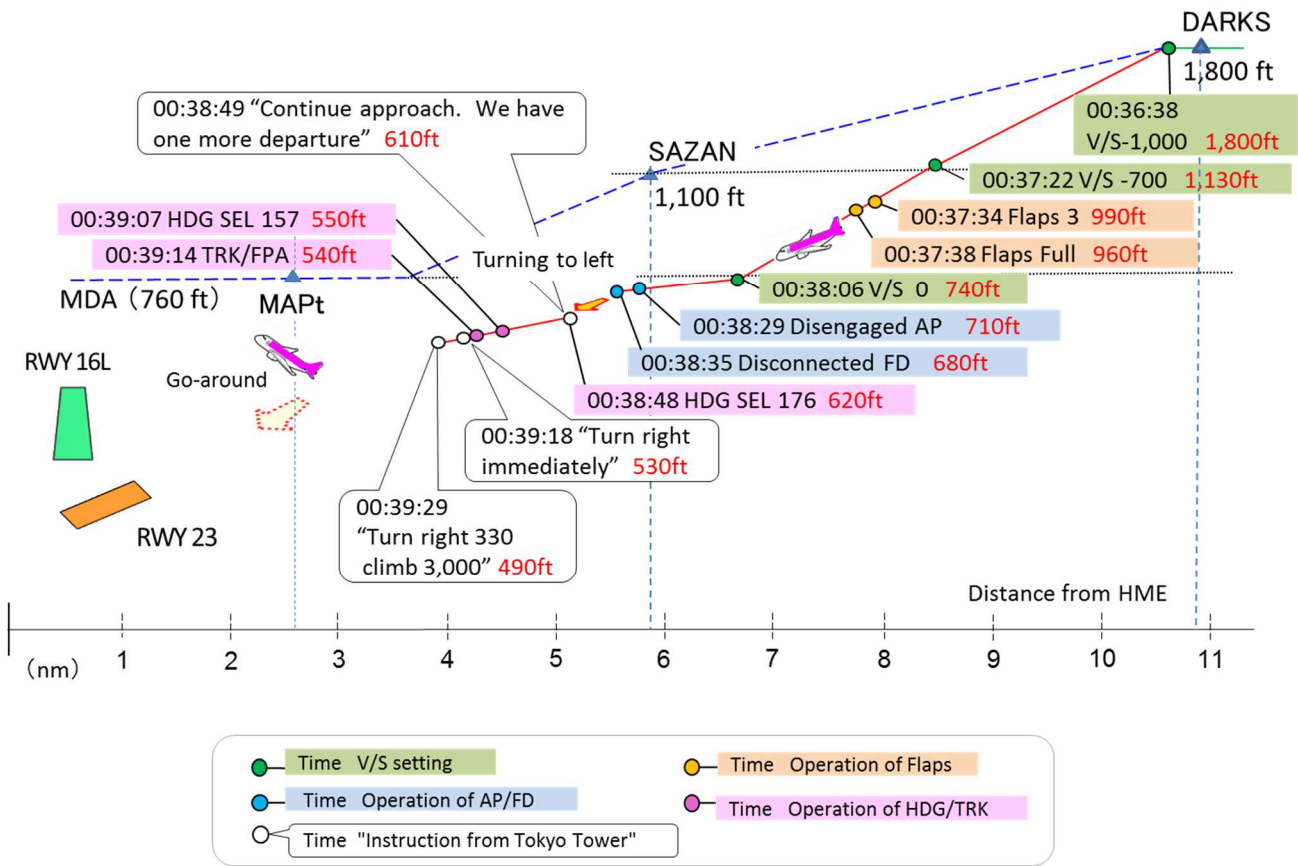
Appended Figure 3 Estimated Flight Route (3)

Appended Figure 3, it descended below 1,100 ft, which was the lower limited altitude of SAZAN. It is probable that it is because the Captain and the FO were not familiar with the procedure in which they should make the approach referring to the approach chart in the state of no FMGC setting and accordingly their crosschecks for the approach profile ended up to become insufficient. In addition, it is somewhat likely that it was a contributing factor for the altitude deviation that the Captain intended to reach Minimum Descend Altitude(MDA) quickly in order to identify the landing runway following the circling approach procedure which was instructed at the recurrent training in the Company.

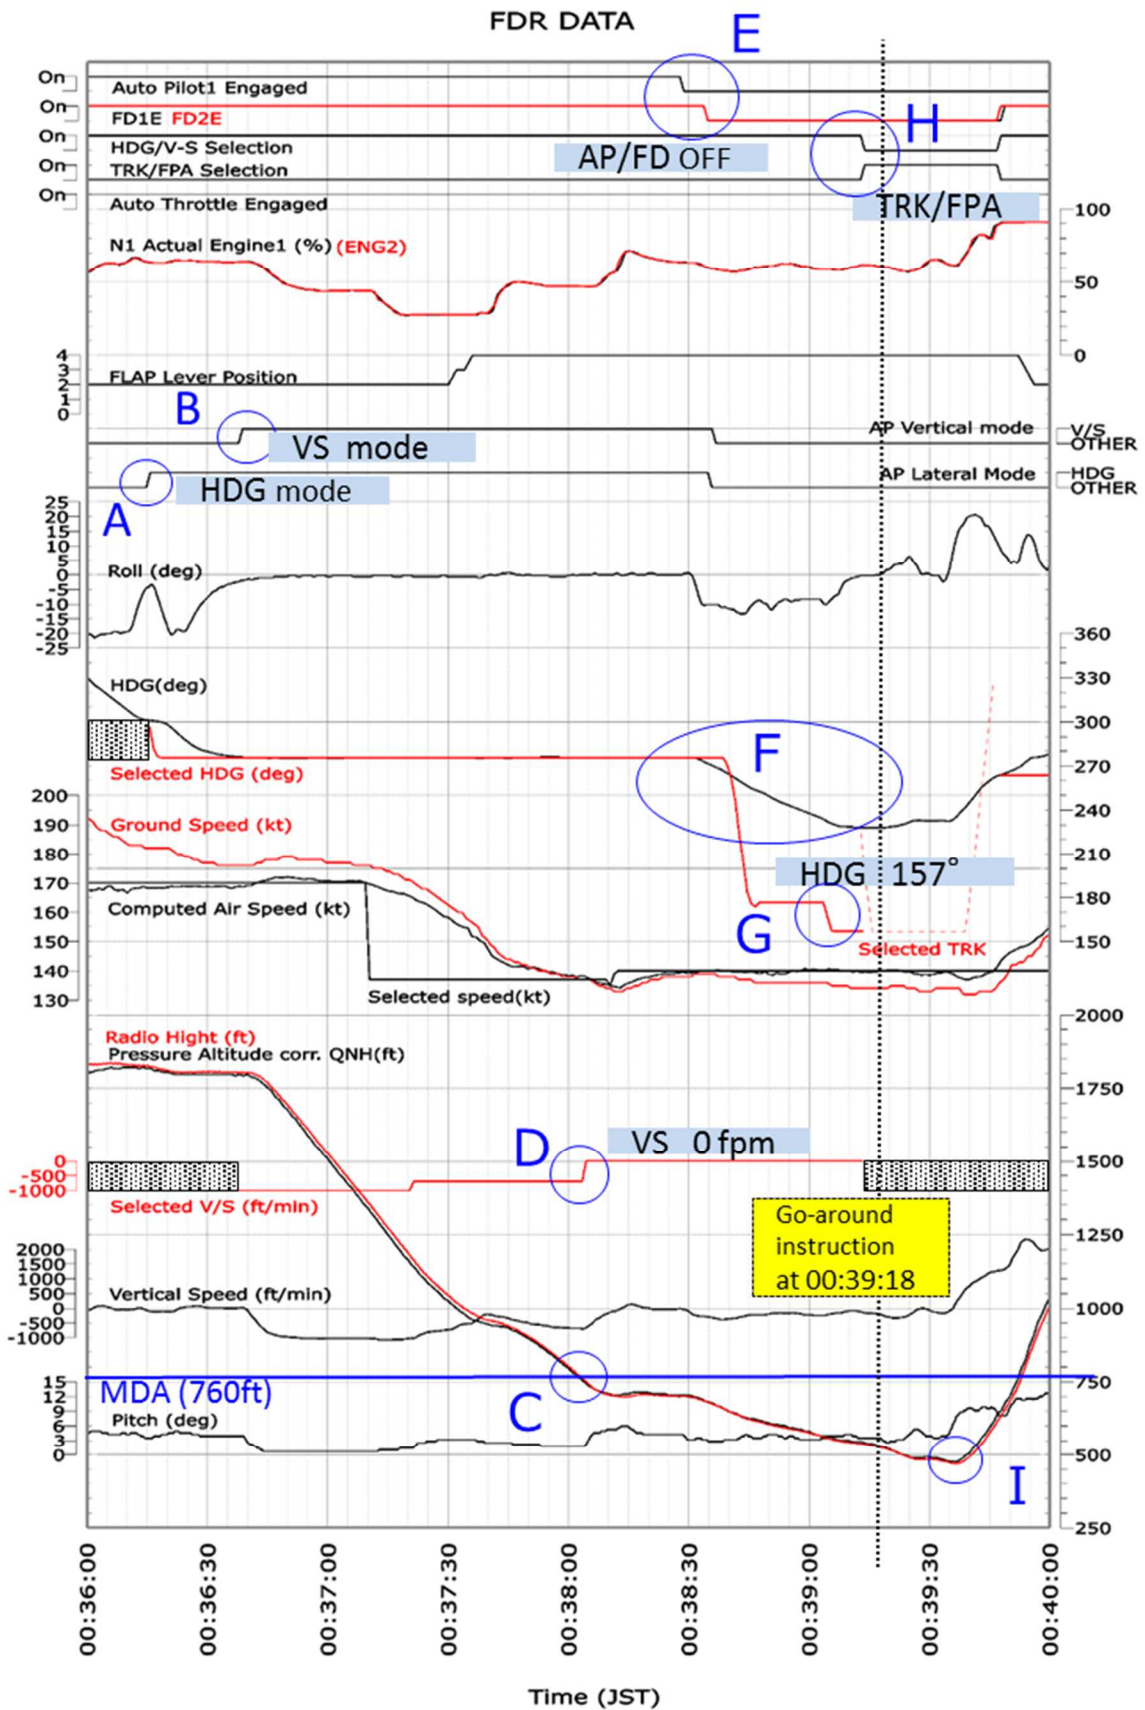
Appended Figure 5 FDR records

As described in 2.1.2 (1) the Captain stated that he verified setting of HME at MCDU, it is probable that he commenced the approach referring to the needle of VOR and indication of DME on ND in the state of no FMGC setting of VOR A approach due to no registration in Database. As shown in Appended Figure 5, the Aircraft had began descending with HDG mode [A]⁶³ and VS mode [B], and those mode had been maintained until when AP/FD was disengaged. Furthermore, as shown in

As shown in Appended Figure 5, when the Aircraft reached MDA of 760 ft [C], the vertical speed, Selected V/S, was changed to 0 fpm [D], it is probable that the Captain was trying to maintain MDA because but the Aircraft descended below MDA and continued gradual descending even after AP/FD was disengaged [E].

As described in 2.1.2 (1), the Captain stated that when he saw runway 23, which was closed, brightly lighted in left front of him he instinctively let the Aircraft turn to the direction. As shown in Appended Figure 5 [E], [F], after disengaging AP and changing to manual control the Aircraft turned left and descended. It is probable that he was mistakenly tried to approach to runway 23 at that time. Afterward, it is probable that the Captain instructed the FO to set runway track of 157° [G] and TRK/FPA [H] but he noticed that "HDG (TRK) bug" and "Track Index" were not appeared on PFD and that the current HDG shown the direction of 230°, and then he felt odd and realized that the runway right in front of him might not probably be runway 16L but runway 23 which was being closed.

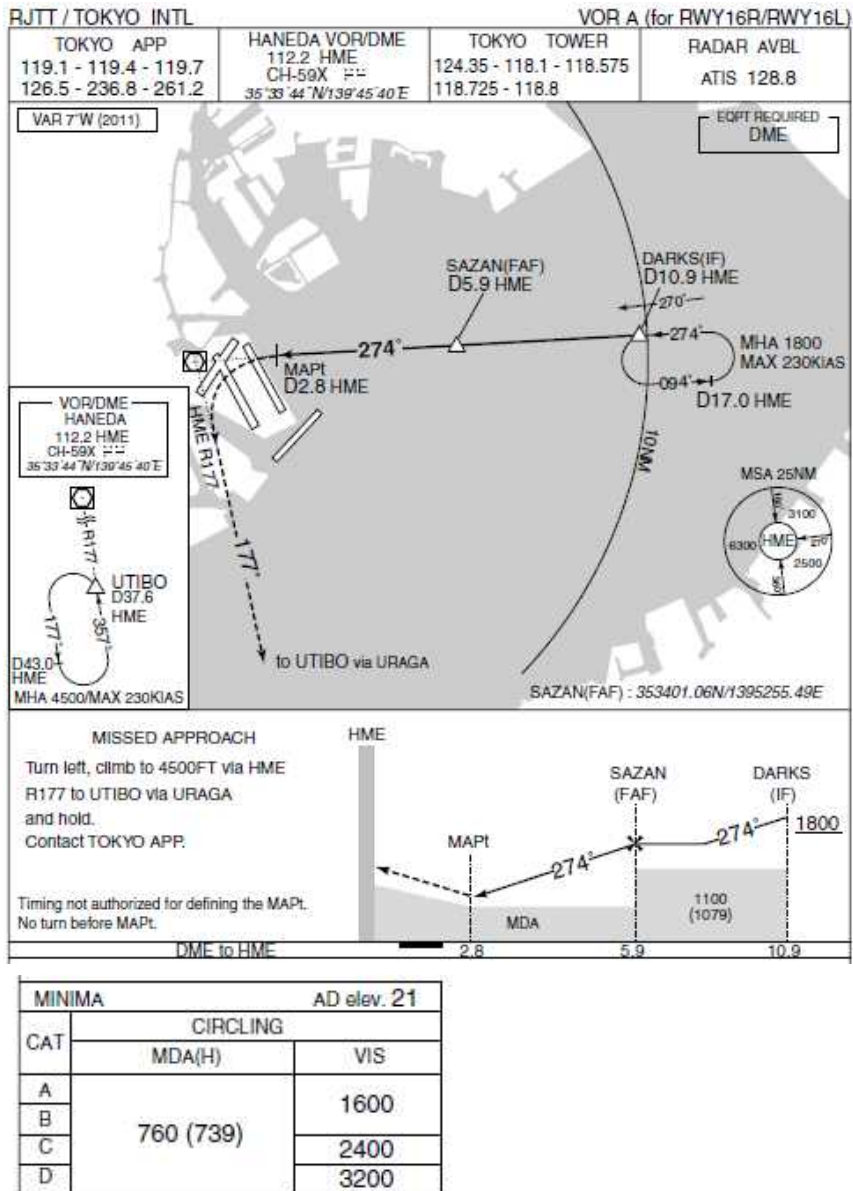
Appended Figure 7 VOR A approach at HND

VOR A approach procedure at the Airport is shown in Appended Figure 7, which is connected from DARKS arrival in Appended Figure 6. Under normal conditions, after a pilot shall fly over DARKS at or above 1,800 ft he/she shall fly along 274° course for HME to fly over SAZAN at or above 1,100 ft. Then after identifying runway 16L visually, he/she shall turn right to enter circling approach: for downwind of runway 16L. As later described in 2.8.4, regarding conducting a circling approach "The preferential route for noise abatement³⁷" were officially published, in which a pilot was requested to fly along or inside of the route in order to abate noise.
