**AIRCRAFT SERIOUS INCIDENT
INVESTIGATION REPORT**

JAPAN AIR COMMUTER

J A 8 4 8 C

**JAPAN AIR COMMUTER CO., LTD.
BOMBARDIER DHC-8-402, JA848C
ON RUNWAY A AT OSAKA INTERNATIONAL AIRPORT, JAPAN
AT 16:27 JST, AUGUST 12, 2008**

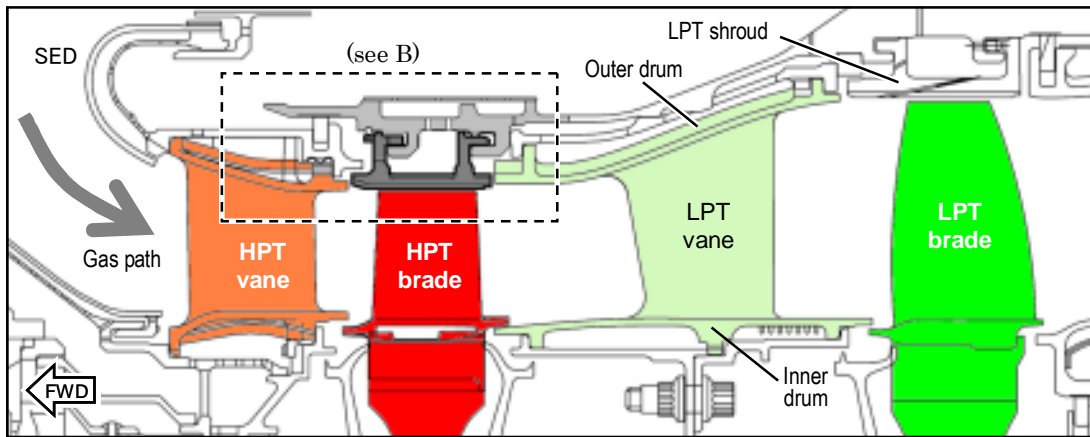
Figure 5 HPT and LPT

The thermal cracking and heat erosion/oxidation spread to the adjoining HPT shroud segments, which caused growing deterioration of the shroud. As the deterioration advanced further, the HPT blade clearance increased, which in turn caused the combustion gas pressure to drop, leading to slower NH (high-pressure compressor speed) and increased ITT. To compensate for the eventual drop in output, the FADEC increased the Wf (fuel flow), and consequently, both the increased ITT and Wf accelerated the oxidation process, further advancing the deterioration of the HPT shroud. (See Figure 5 and Photos 24, 25, 26.)

As described in 2.11.1 (11) and (12), the HPT vane located upstream of the HPT shroud had no major damage, and the SED located further upstream from the HPT vane had, despite the damage in 11 locations on it, smaller damage than with the other elements in the location between the 12 o'clock and 4 o'clock positions, the location that roughly corresponds to the locations of damage in the HPT shroud and the elements that follow it. It is therefore considered unlikely that the damage on the SED contributed to the deterioration of the HPT shroud that is located downstream from it. (See Figure 5 and Photo 27.)

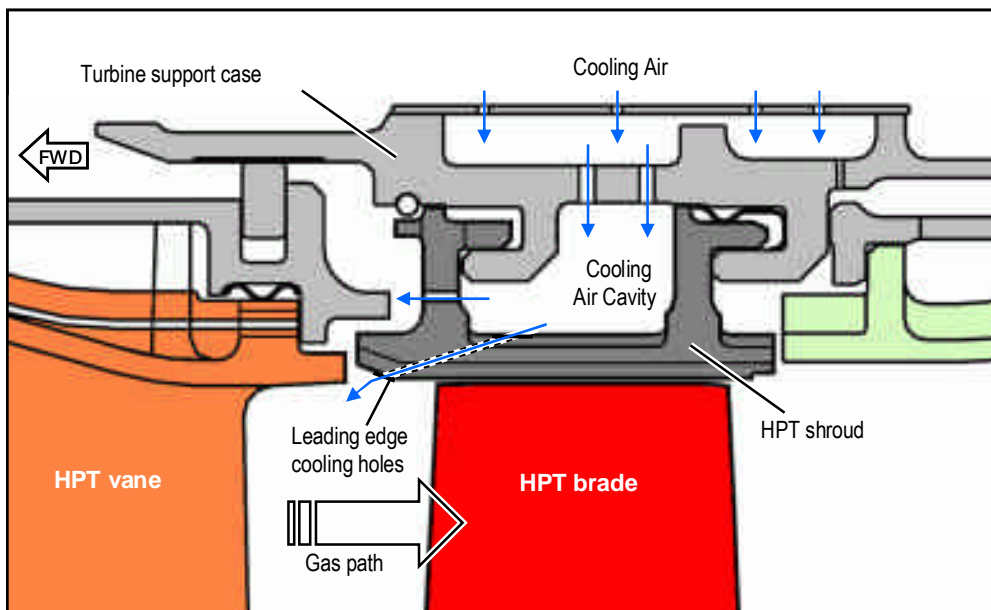
Figure 6 HPT Shroud Segment

- (10) The HPT shroud had four consecutive segments (#20, #1, #2 and #3) completely burnt away. Two segments (#4 and #5) next to one end of these consecutive segments had their surfaces completely burnt away and the surfaces of two other segments (#19 and #6) were partially lost. (See Figure 6 and Photos 24, 25, 26.)

The locations of major damage were between the 11 o'clock and 4 o'clock positions (especially between the 12 o'clock and 2 o'clock positions) for the HPT shroud, between the 10 o'clock and 4 o'clock positions (especially between the 12 o'clock and 3 o'clock positions) for the LPT vane, and between the 1 o'clock and 2 o'clock positions for the inter-turbine vane. As these locations almost agree with each other, it is considered highly probable that the material produced in the deterioration process in the upstream section was carried along the gas path and affected the downstream stage elements. (See Figures 6, 7 and Photos 14, 19, 21, 24, 25.)

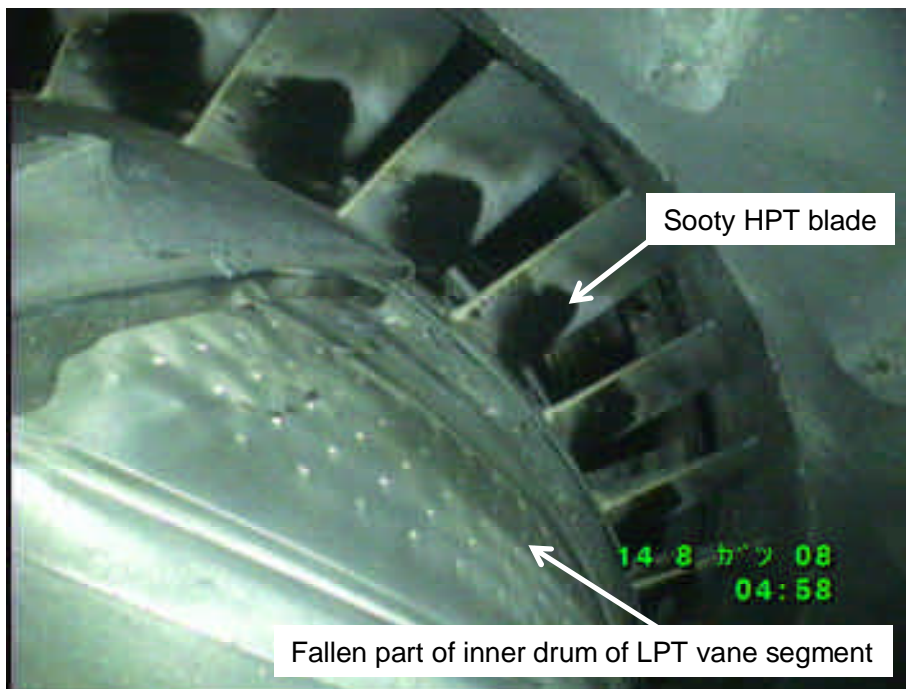
Photo 6 Fractured LPT vane airfoils (BSI view)

the #2 LPT vane segment were lost; since the supports had been lost, the segment's inner drum then fell off. (See Figures 4, 5, 7 and Photos 5, 6, 7, 14, 19, 20.)

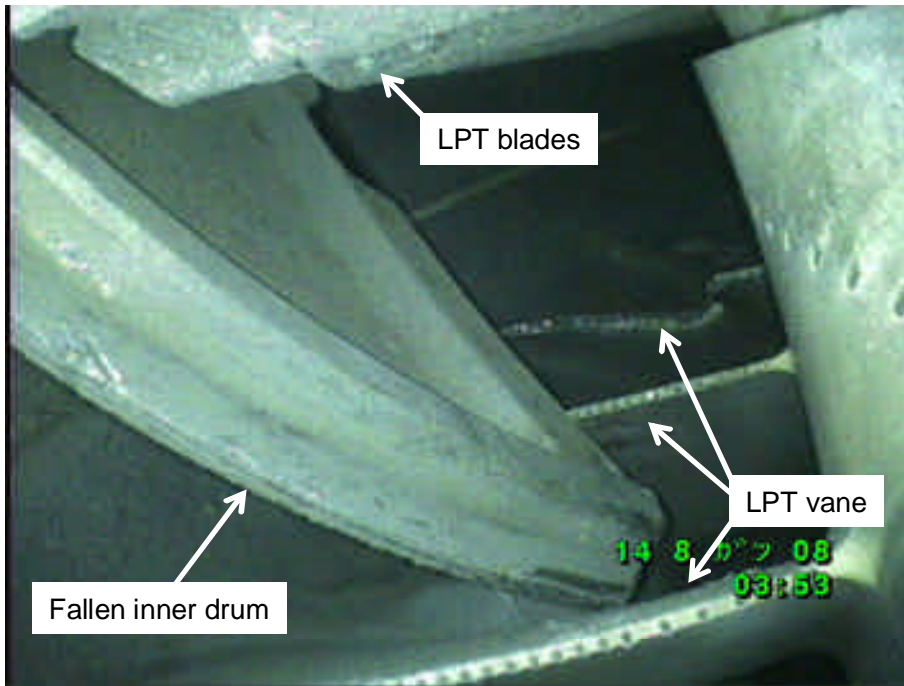
Photo 9 Fallen inner drum of LPT vane segment – the end trapped in LPT vane (BSI view)

Being rhomboidal in shape, the LPT vane segment's inner drum that had fallen off became lodged between the LPT vane and the inter-turbine vane with one sharp-angled edge trapped in the former and the opposing edge in the latter. Against this fallen and trapped inner drum, the LPT blades that were rotating between the LPT vane and the inter-turbine vane struck and the blades on its entire circumference broke off to almost the same length. (See Figure 4 and Photos 8, 9, 10, 13, 15, 16, 18, 20.)

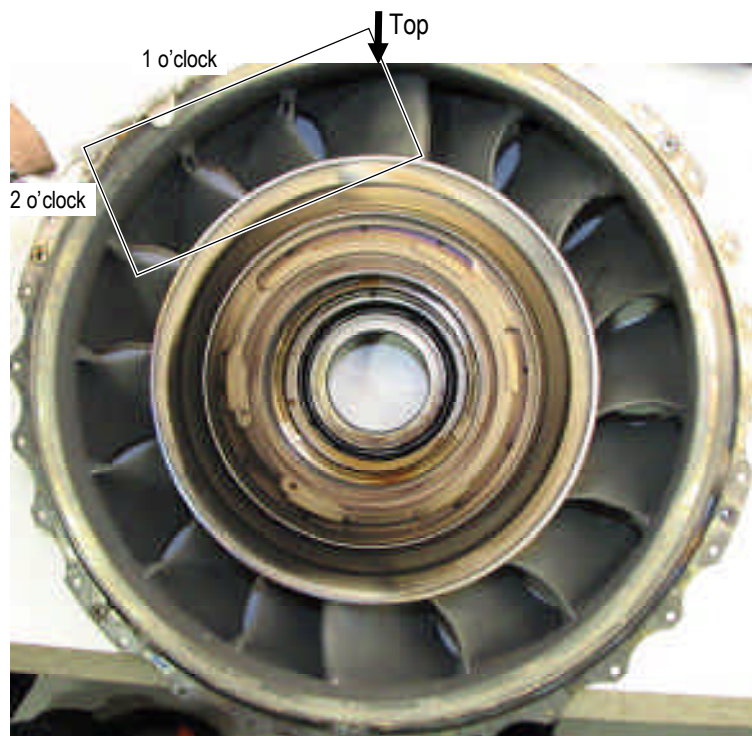
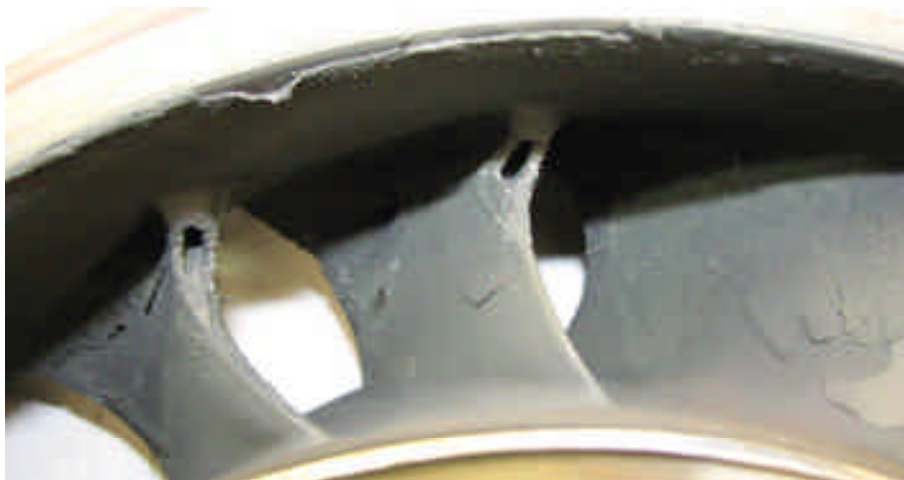
Photo 14 Inter-turbine vane – leading edge side

Heat erosion of inter-turbine vane airfoils

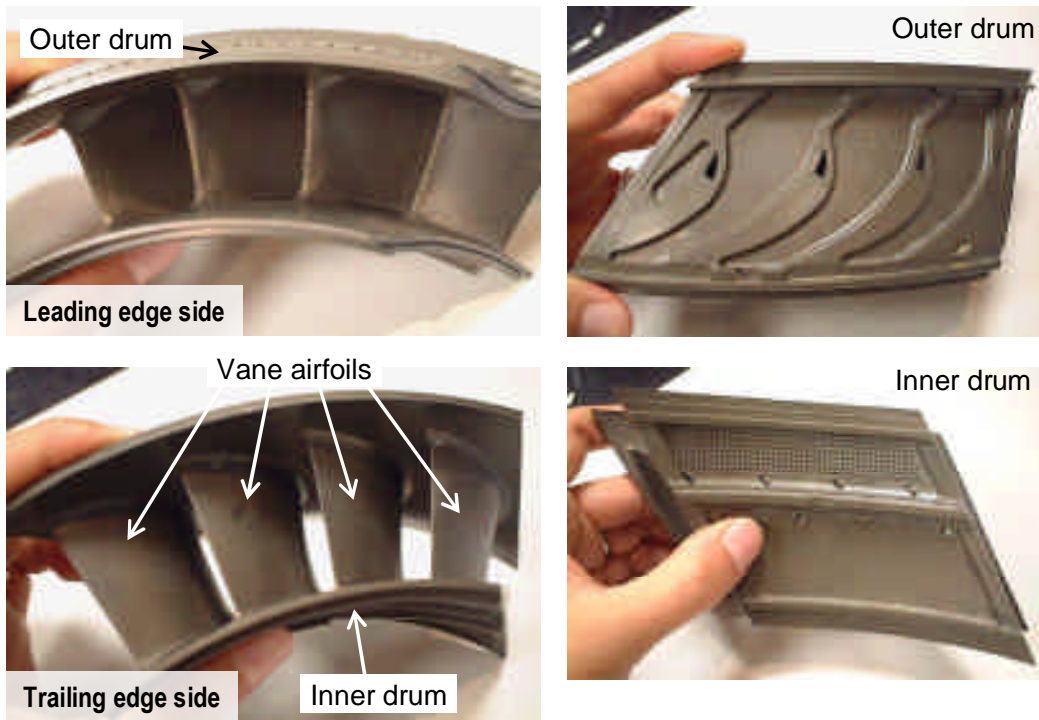
Photo 20 LPT vane segment – new segment

- (8) The LPT vane assembly showed severe heat distress in the area approximately between the 10 o'clock and 4 o'clock positions, while the vanes located between the 12 o'clock and 2 o'clock positions were completely burnt away. All four vane airfoils on the #2 LPT vane segment were missing and the inner drum had detached and fallen off. Three vane airfoils on the #1 LPT vane segment were missing but one vane airfoil remained on the segment with half of it lost due to heat erosion. The missing vane airfoil side of the #1 segment's inner drum was lifted towards the gas path. Two vane airfoils on the #3 LPT vane segment were missing due to heat erosion. (See Figure 7 and Photos 18, 19, 20.)

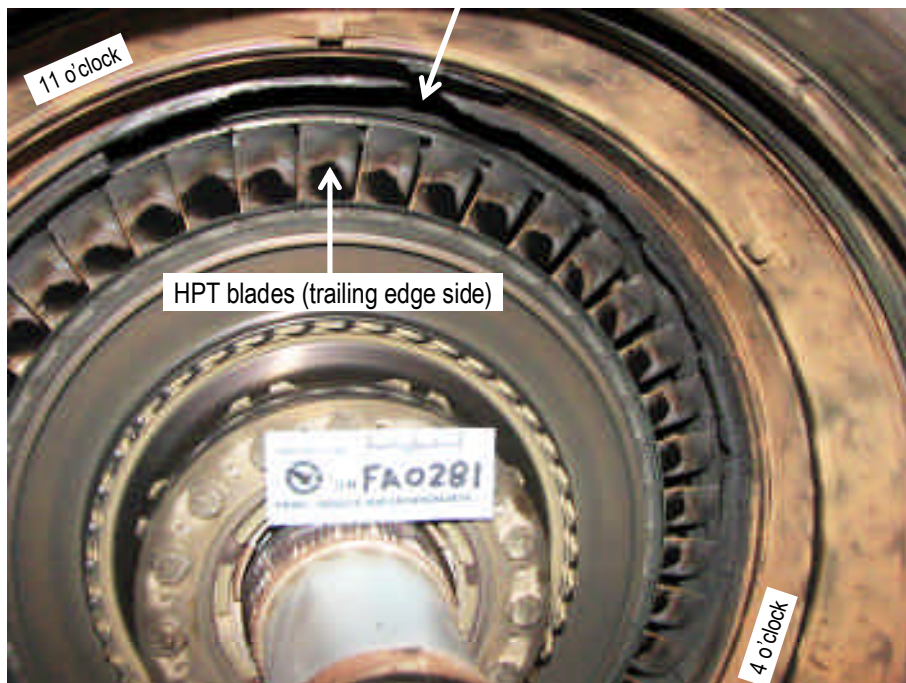
Photo 21 Damage to HPT shroud

- (9) The HPT disc assembly had no visible damage on the blades when viewed from the trailing edge side. Due to damage to the HPT shroud segments, the HPT blade tip clearance was found to be excessive in the section located approximately between the 11 o'clock and 4 o'clock positions. (See Photo 21.) Removal of the HPT disc assembly revealed heat erosion on the leading edge of the blades, and the cooling cores at the tips of six of the blades were exposed. All of the HPT blades tips were heat eroded, oxidized and rubbed resulting in the exposure of their internal core passages to combustion gas at several locations. (See Photos 22, 23.)
