AA2006-1

**AIRCRAFT ACCIDENT
INVESTIGATION REPORT**

**JAPAN AIRLINES FLIGHT 356
BOEING 747-400D, JA8903
OVER THE SEA 8 NM S.E. OF HAMAMATSU CITY, JAPAN
OCTOBER 21, 2002**

**Aircraft and Railway Accidents Investigation Commission
Ministry of Land, Infrastructure and Transport**

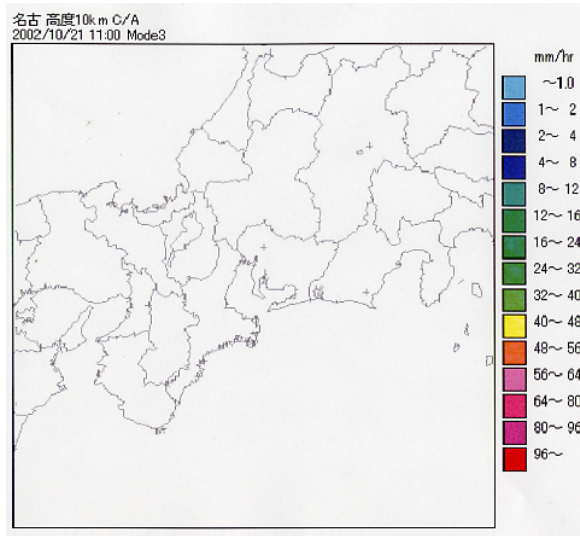
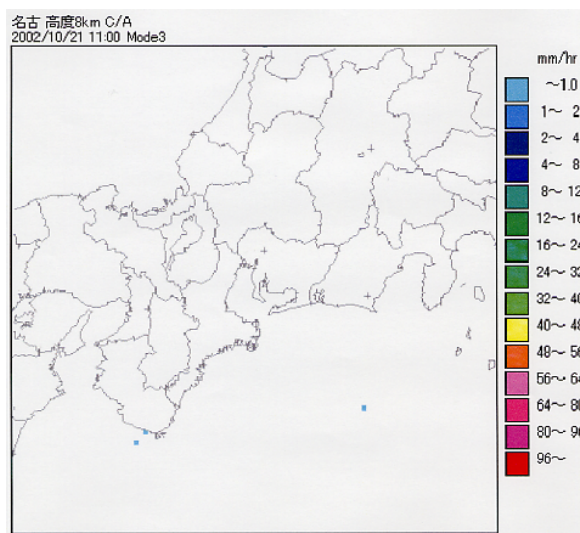
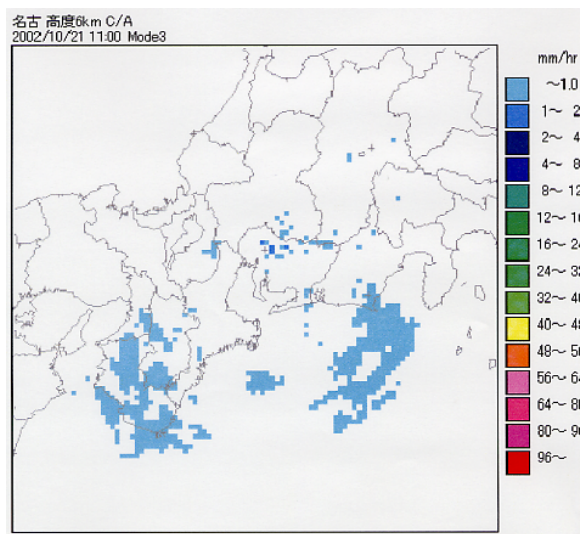
Figure 9 Nagoya RADAR CAPPI Chart
(1100JST, 21 Oct. 2002, Altitude 10km, 8km, 6km)

However, as described in 2.11.1(1), since the aircraft was flying at around 39,000ft at the time the accident occurred, based on the CAPPI chart issued by Meteorological Agency's Nagoya Radar (Figure 9) it is estimated that it was flying more than 20,000ft above the tops of the convective clouds.

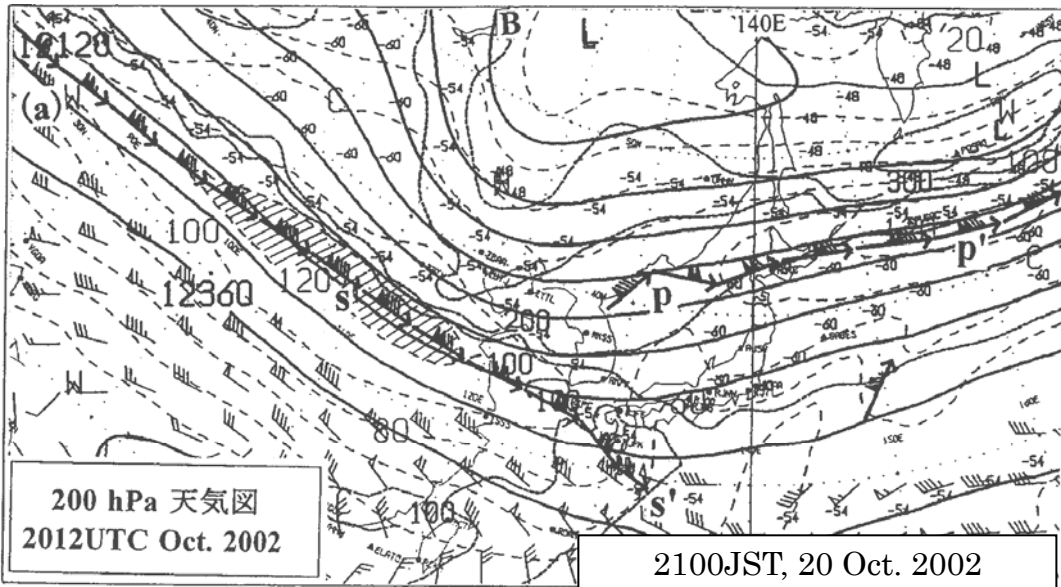
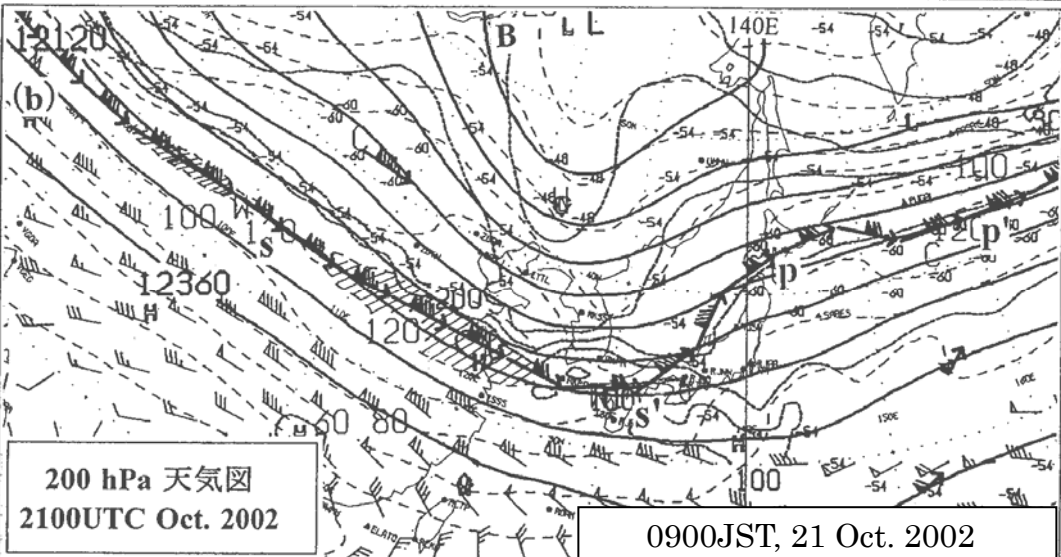
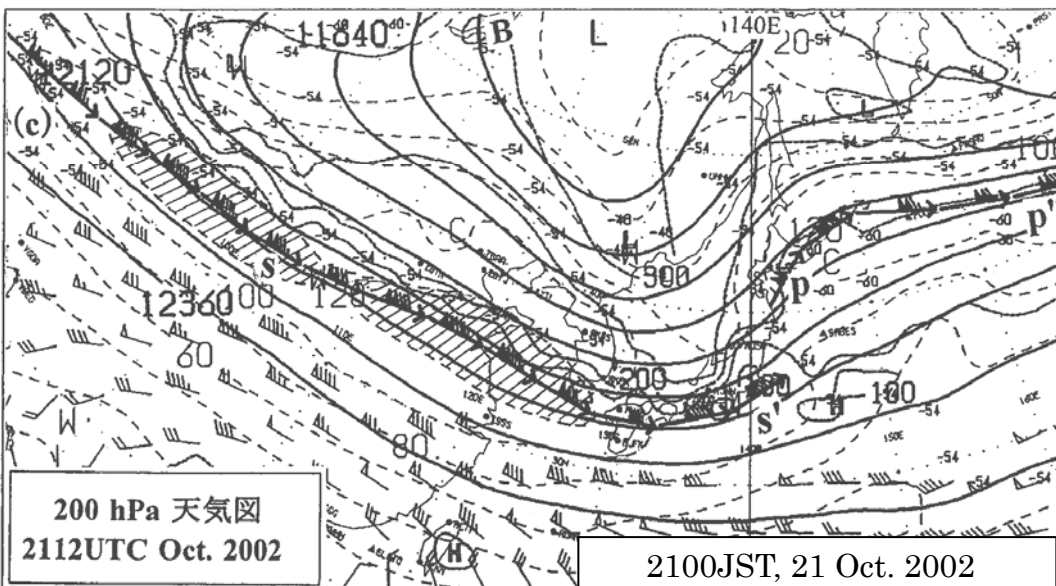
Figure 10 Asian 200hPa Chart
 (2100JST, 20 Oct., 0900JST and 2100JST, 21 Oct. 2002)

According to the 200hPa weather chart for Asia in figure 10, there was strong wind zone (shaded) of 120kt or greater accompanying a subtropical jet stream (shown as $s \sim s'$ in the chart), and a polar jet stream (shown as $p \sim p'$ in the chart) at the latitude of Hokkaido. The potential temperatures of these jet streams differed; the potential temperature of the former was around 355–360K, and the potential temperature of the latter was 330K.

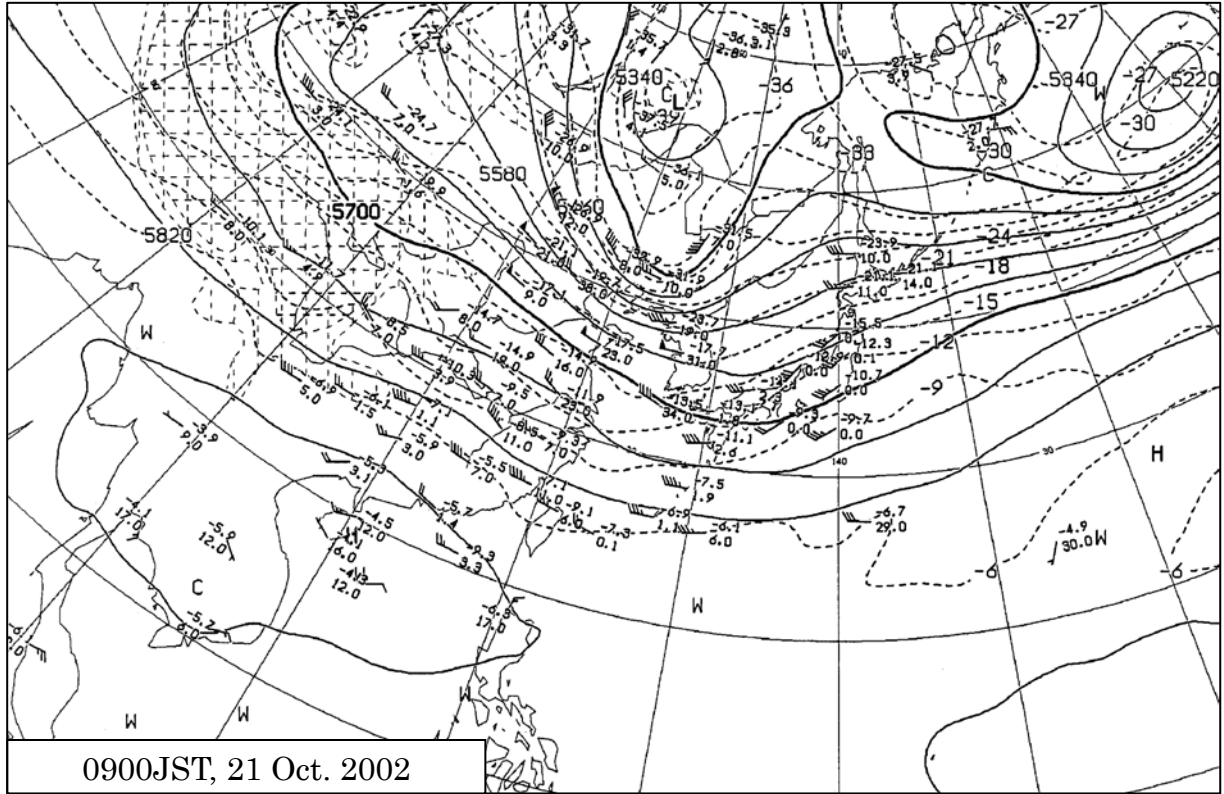
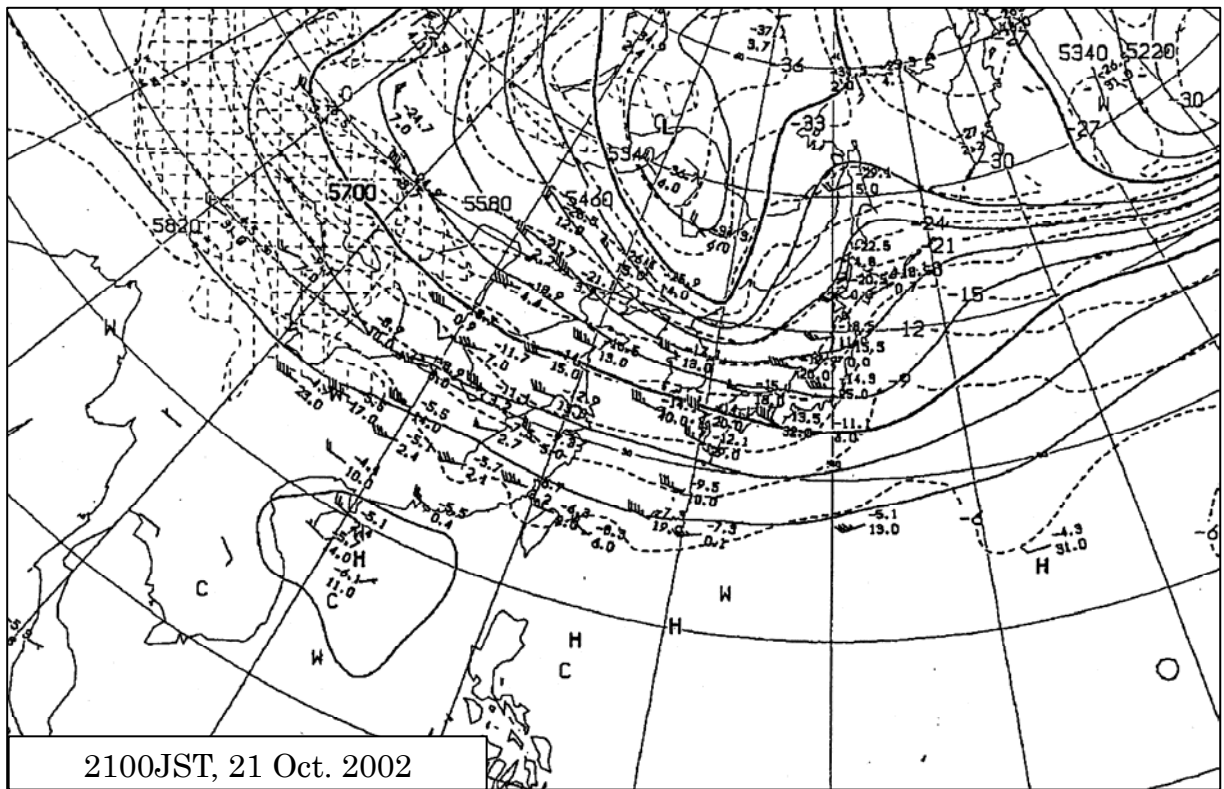
Figure 11 Asian 500hPa Chart
(0900JST and 2100JST, 21 Oct. 2002)

According to the 500hPa weather chart for Asia in figure 11, a trough (valley of atmospheric pressure) was passing below the subtropical jet stream.

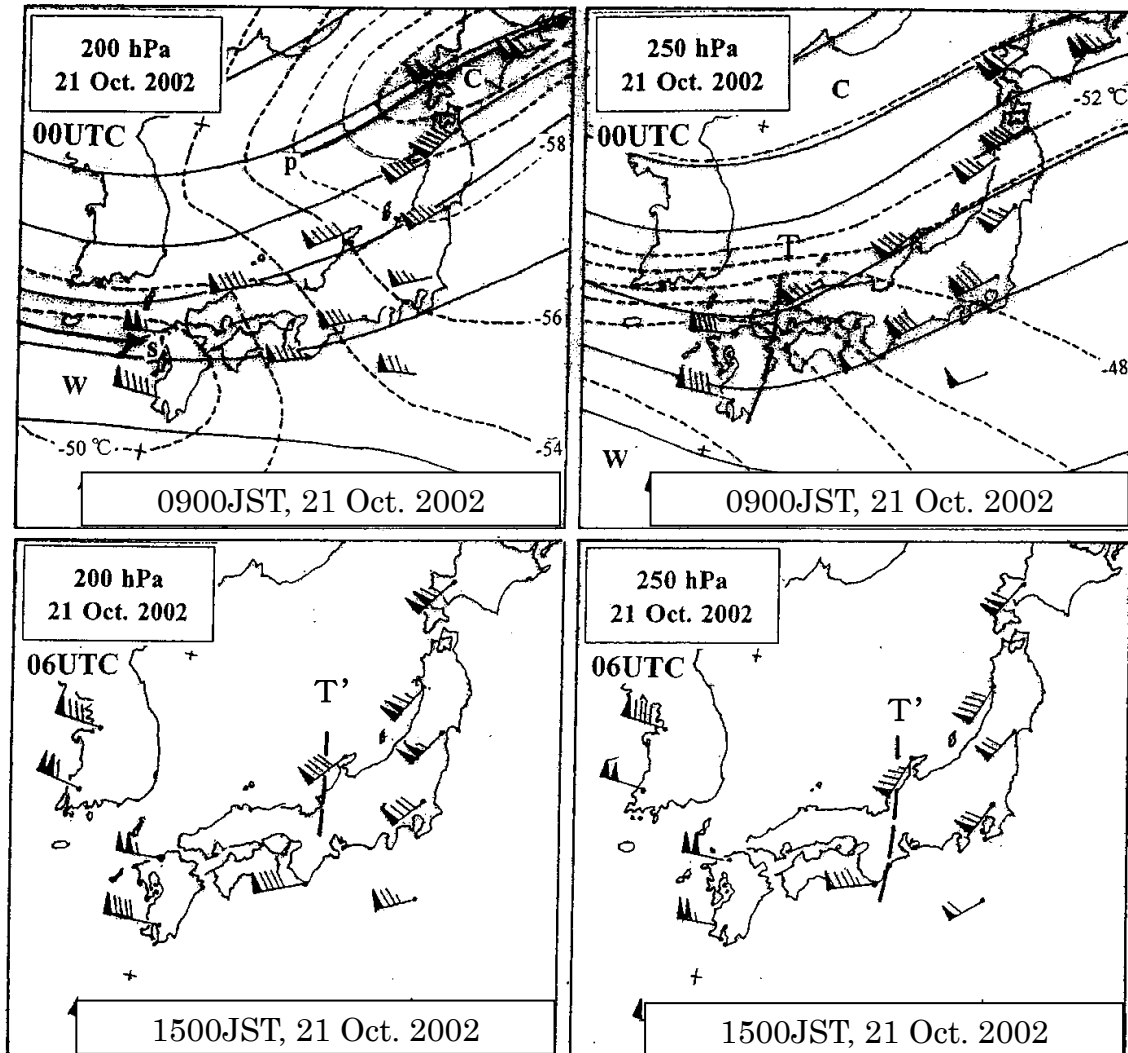
Figure 12 200hPa and 250hPa Chart
 (0900JST and 1500JST, 21 Oct. 2002)

As shown in figure 12, the trough, indicated by a T in the 250hPa weather chart, was over the east coast of the island of Kyushu at 09:00 on October 21, but was not in the 200hPa weather chart for Asia. The trough in the 250hPa weather chart proceeded east and was at the position T' at 15:00 on October 21, and the trough in the 200hPa weather chart was the virtually same position as the trough in the 250hPa weather chart for 15:00 on October 21; that is, at 21:09

As described in (3) above, there was a trough below the jet stream, and while that had not reached an altitude of 250hPa at 09:00, it developed upwards while proceeding east, and had reached up to 200hPa at 15:00. There was updraft in front of the trough, which can be confirmed in meteorological satellite cloud image (water vapor image) in figure 7. Due to this updraft, the low-speed prevailing lower layer wind with a southerly component was transported upward, and the upper limit for the wind of 240° at point S (250hPa) in figure 14 at 09:00 became a direction of 246–248° up to the altitude of point Q (200hPa) at the time of the accident, but with a speed reduced by around 8kt compared with the value at 09:00.
