**AIRCRAFT SERIOUS INCIDENT
INVESTIGATION REPORT**

**AERO ASAHI CORPORATION
JA9678**

DROPPING OF OBJECT
DURING EXTERNAL CARGO SLING OPERATION
TOTSUGAWA VILLAGE, YOSHINO-GUN
NARA PREFECTURE, JAPAN
AT AROUND 10:23, AUGUST 5, 2016

AERO ASAHI CORPORATION
AÉROSPATIALE AS332L1 (ROTORCRAFT),
JA9678

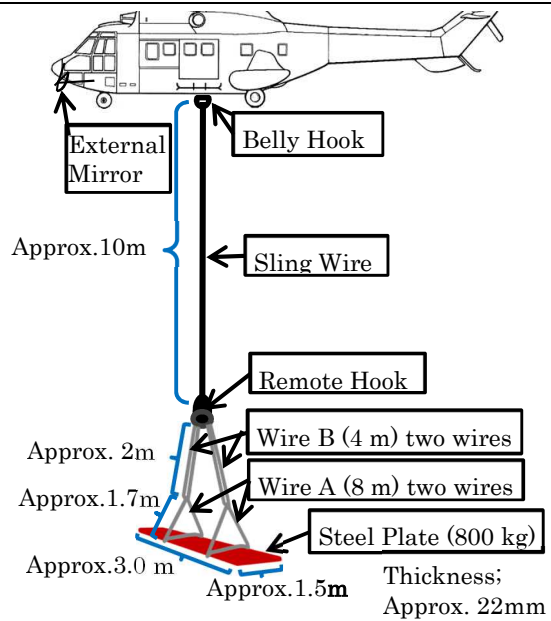
Figure 1 Image of Slings

checking the steel plate status through external mirror. Because the steel plate was slung in the direction of longer side at the right angled to the traveling direction (hereinafter referred to as “the right angled”), and it was stable as slightly tilting

backward due to the wind pressure, the captain increased the speed up to 80 kt which is the upper limit speed for the sling transportation. After turning to right as crossing over the small ridge, since the steel plate was rotated up to approximately 45° without showing any signs of load collapse, then returned to the original sideways slinging position and became stable, so the captain continued the flight with the same speed. Later on, as transiting almost to a level flight, when the captain turned his gaze from the external mirror of the downward to the ridge in front, he felt strong impacts as “bang” so he returned his gaze to the external mirror and confirmed as seeing the steel plate dropping. At the time of dropping, the flight height was approximately 2,900 ft, there were no air turbulence and the rotorcraft was maintaining the stable flight.

The on-board worker was monitoring the slung cargo condition through the opened sliding door at the left side of cabin, and he was witnessing the dropping of the steel plate occurred at the moment that the separation between two wires of lashing the plate became narrow.

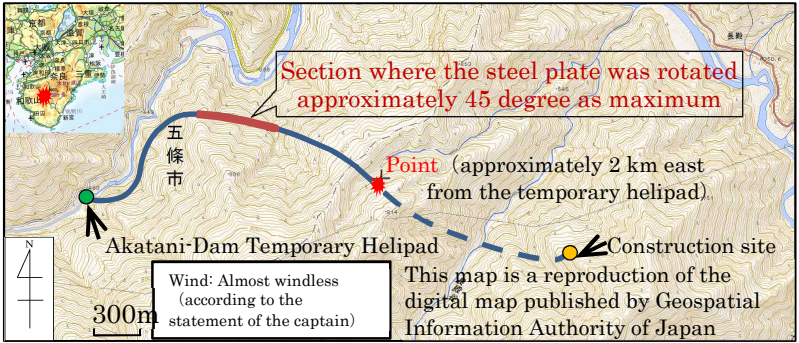
| | <p>This serious incident occurred in the mountain of Nagatono, Totsukawa Town, Yoshino-gun, Nara Prefecture (N34°07'44", E135°44'17") and at around 10:23 on August 5, 2016.</p> <p>Figure 2 Estimated Flight Route and Point where the steel plate dropped</p> |
