# AIRCRAFT ACCIDENT INVESTIGATION REPORT

Northwest Airlines  
Boeing 747-400, N663US  
New Tokyo International Airport  
September 19, 1991

Aircraft Accident Investigation Commission  
Ministry of Transport

September 24, 1993

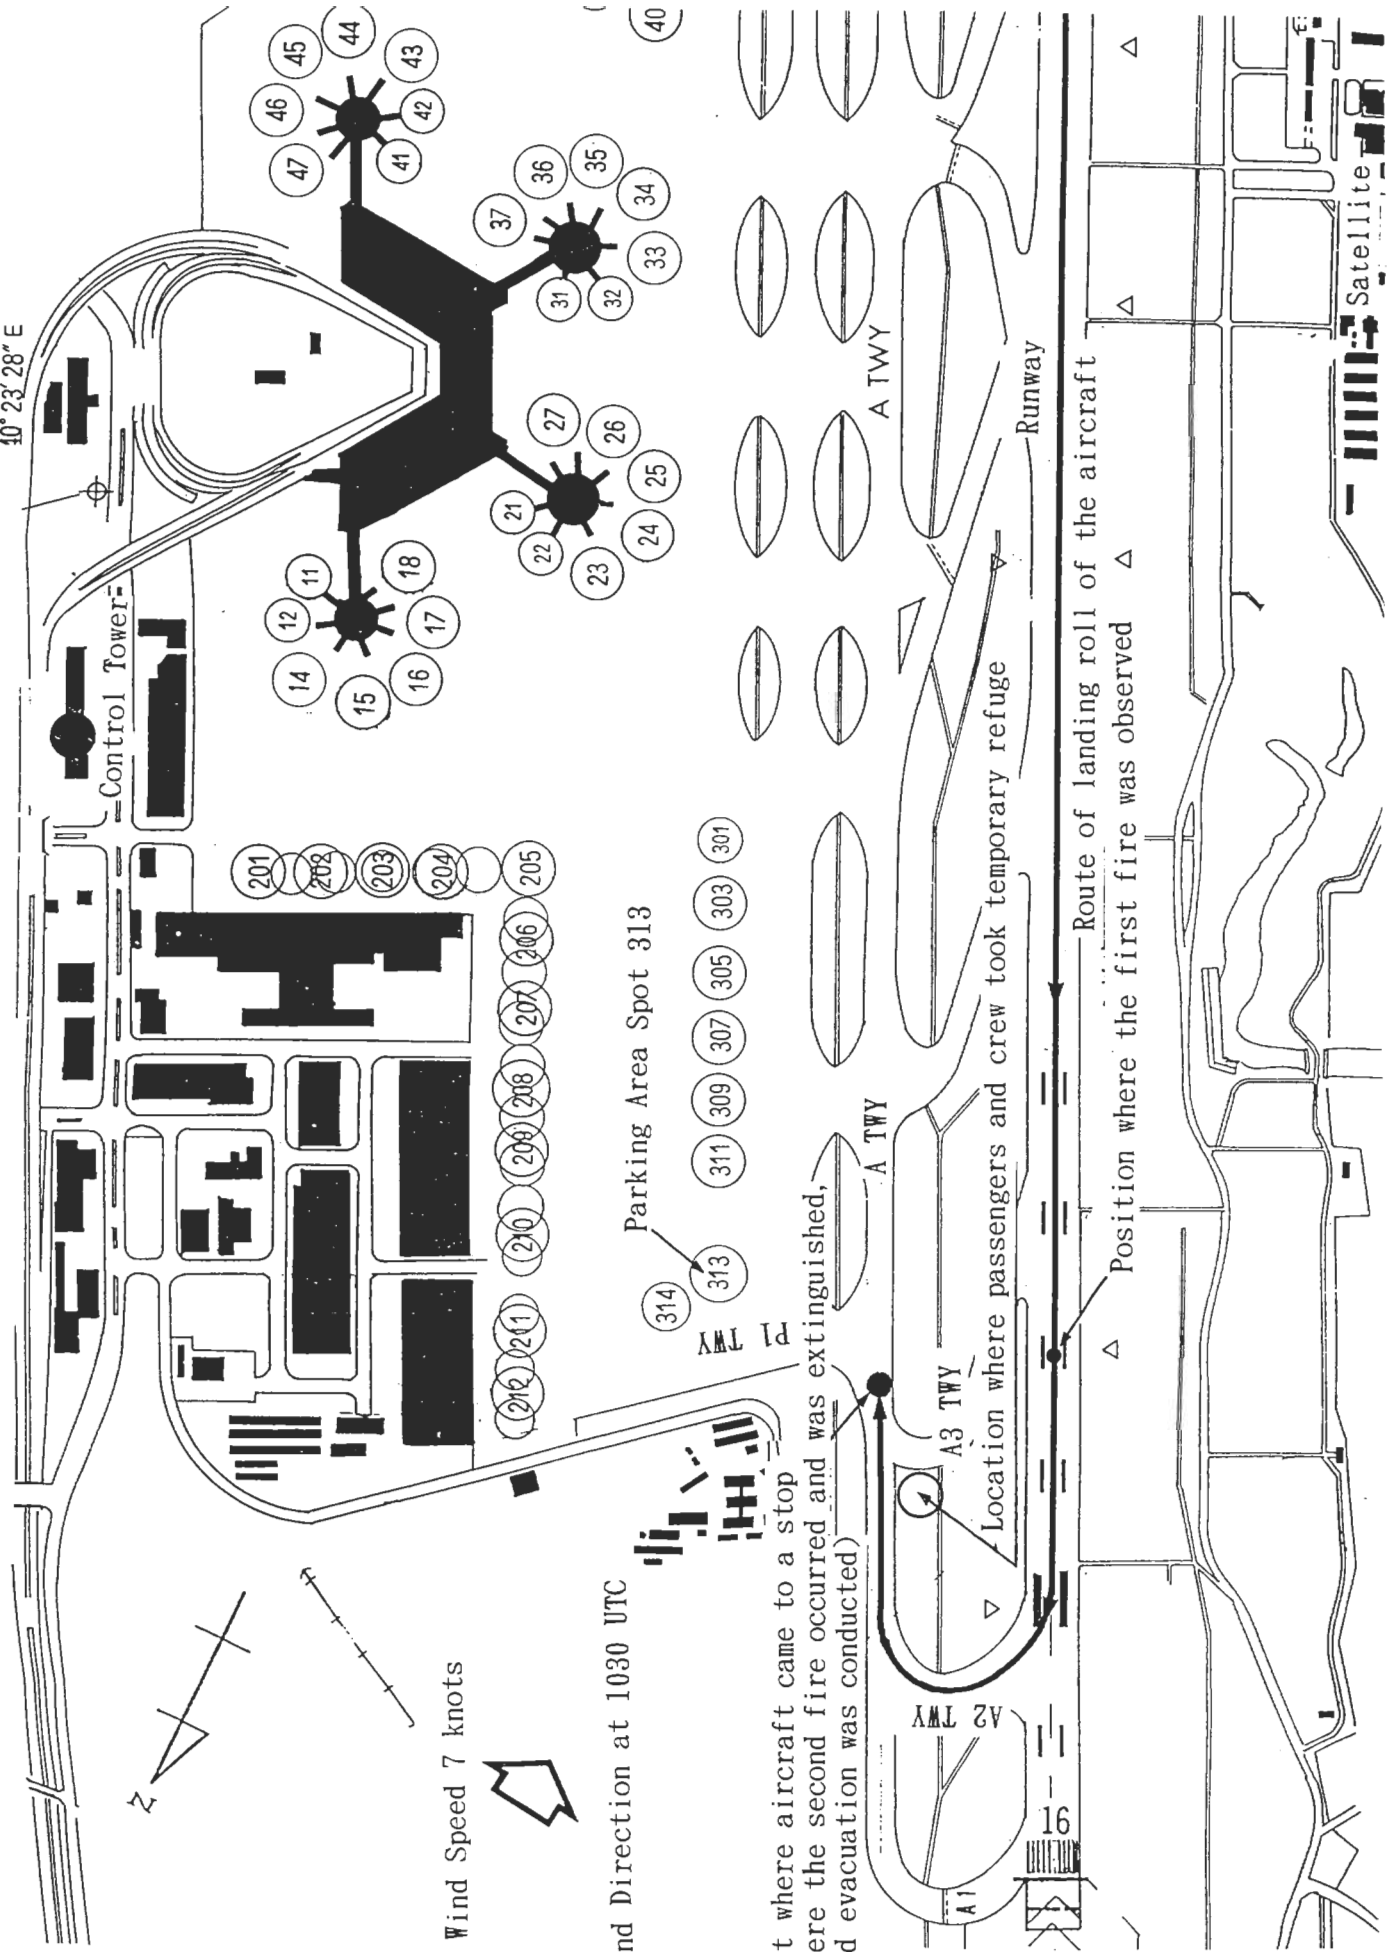
Attached Fig. 2 Taxiing Route of Accident Aircraft at Narita Airport

Route of landing roll of the aircraft  
Position where the first fire was observed

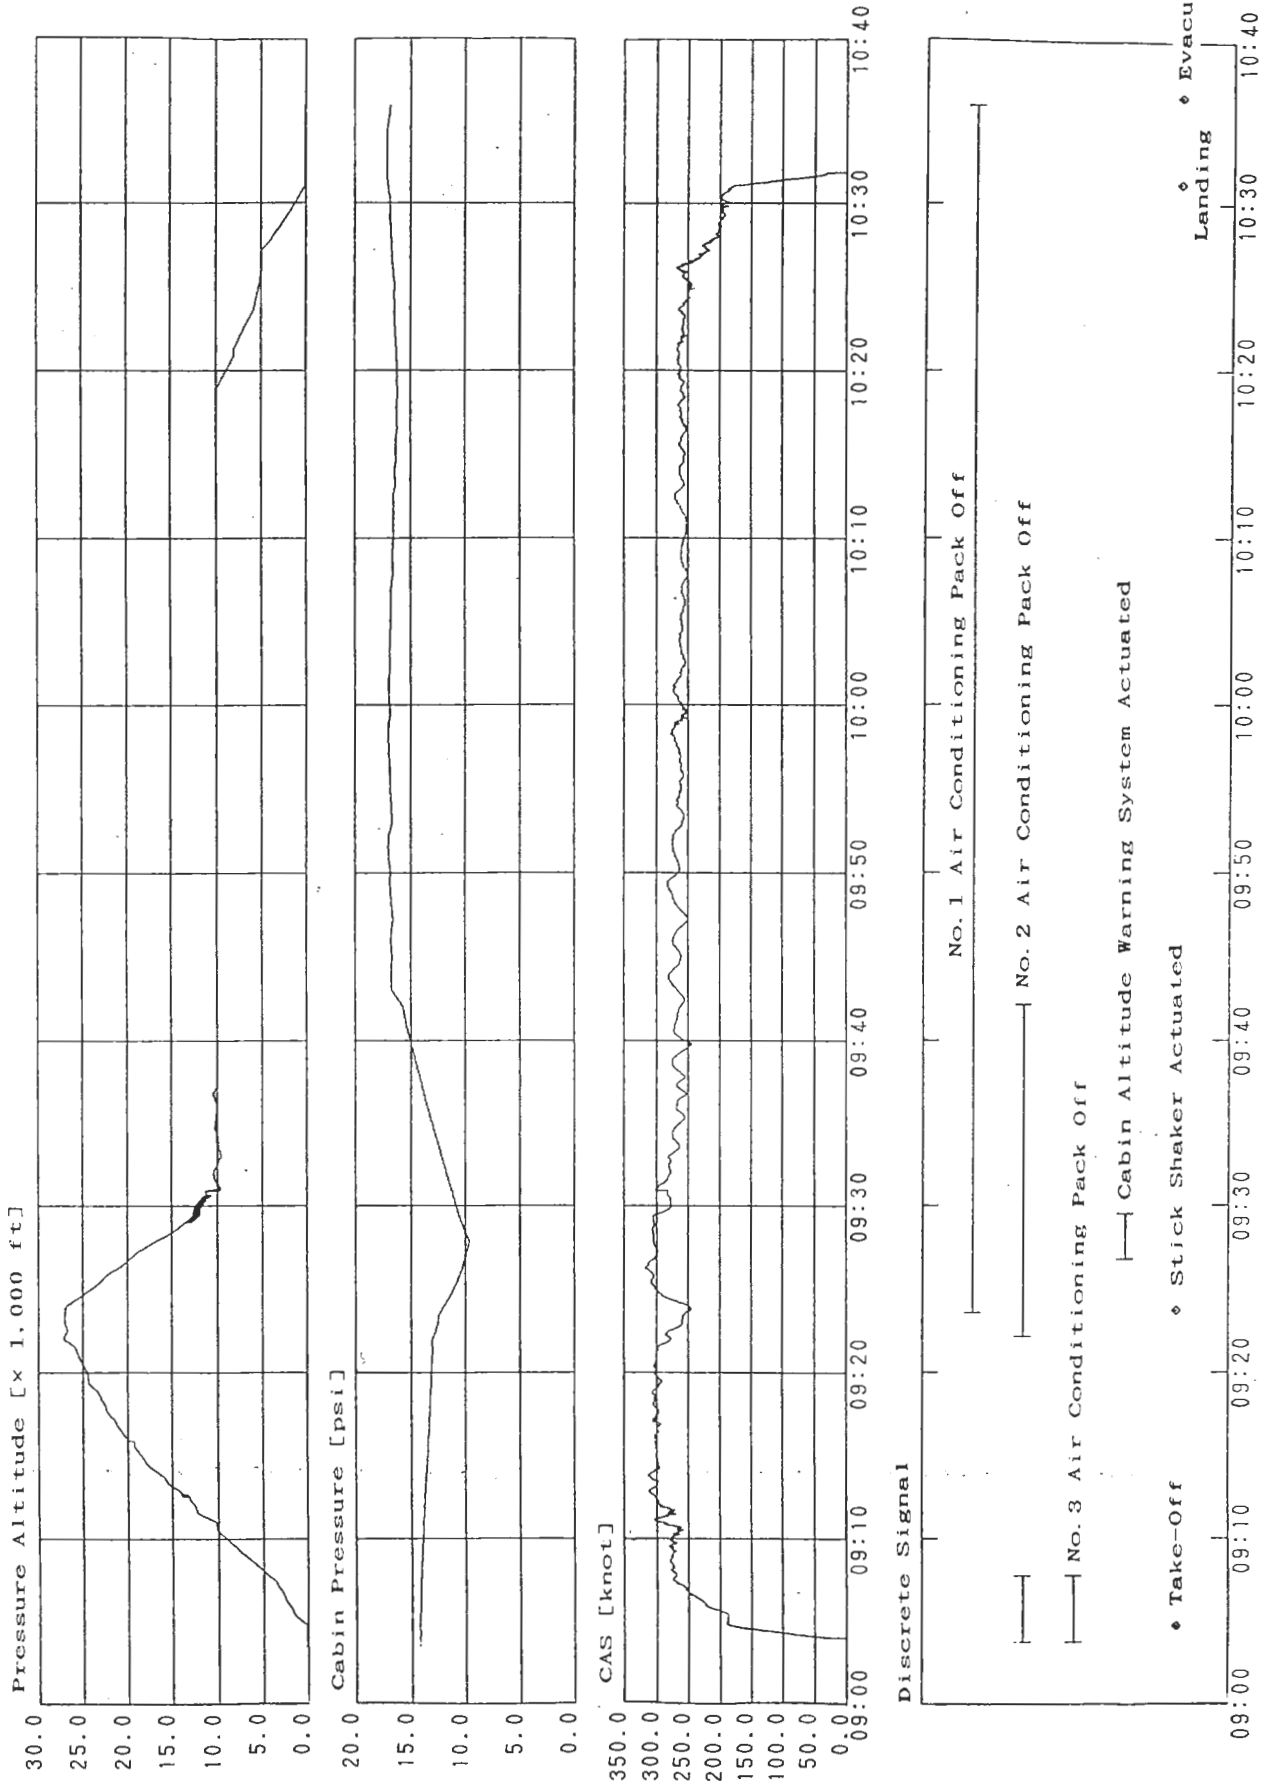
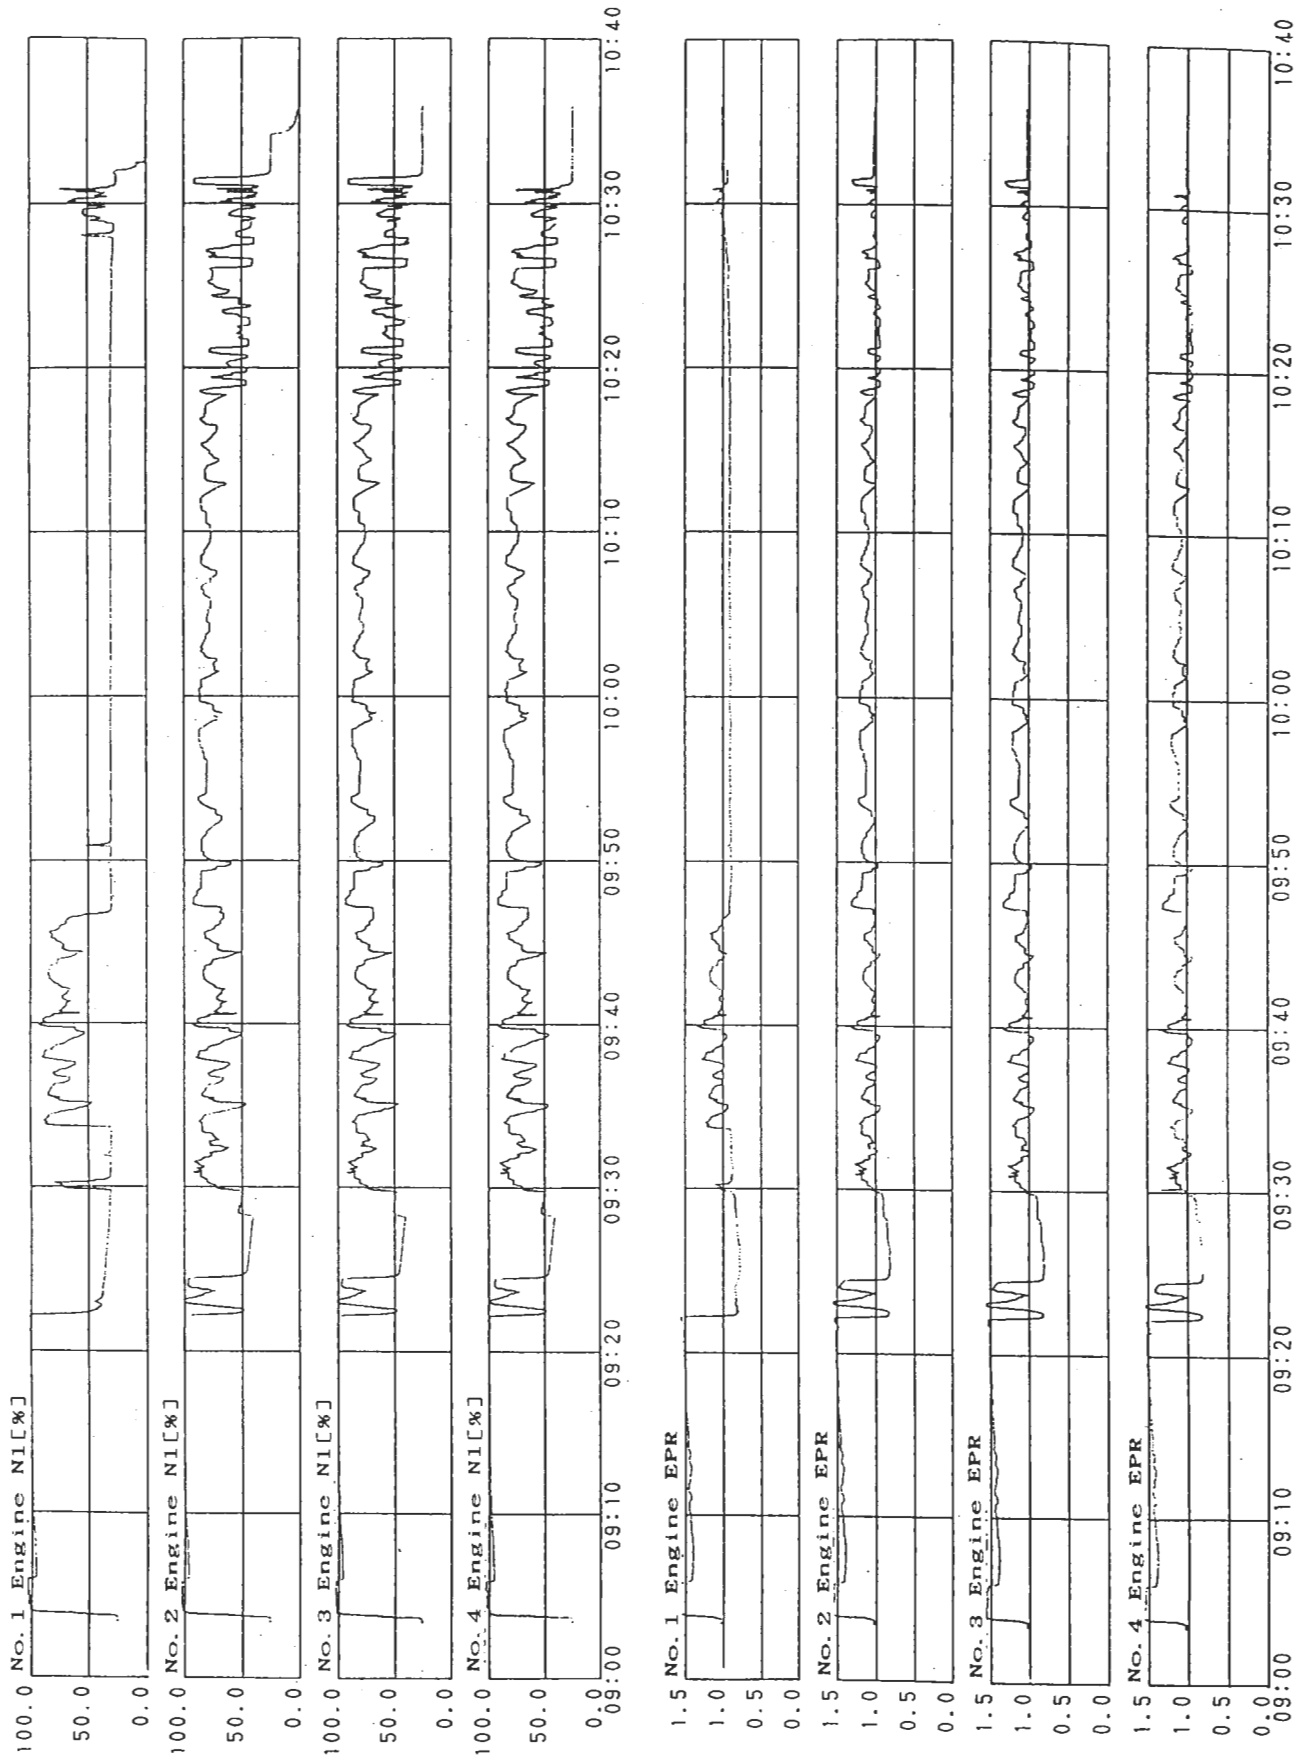
Attached Fig. 8 DFDR Records

Main records in DFDR were as follows: (see Attached Figs. 8 and 9)

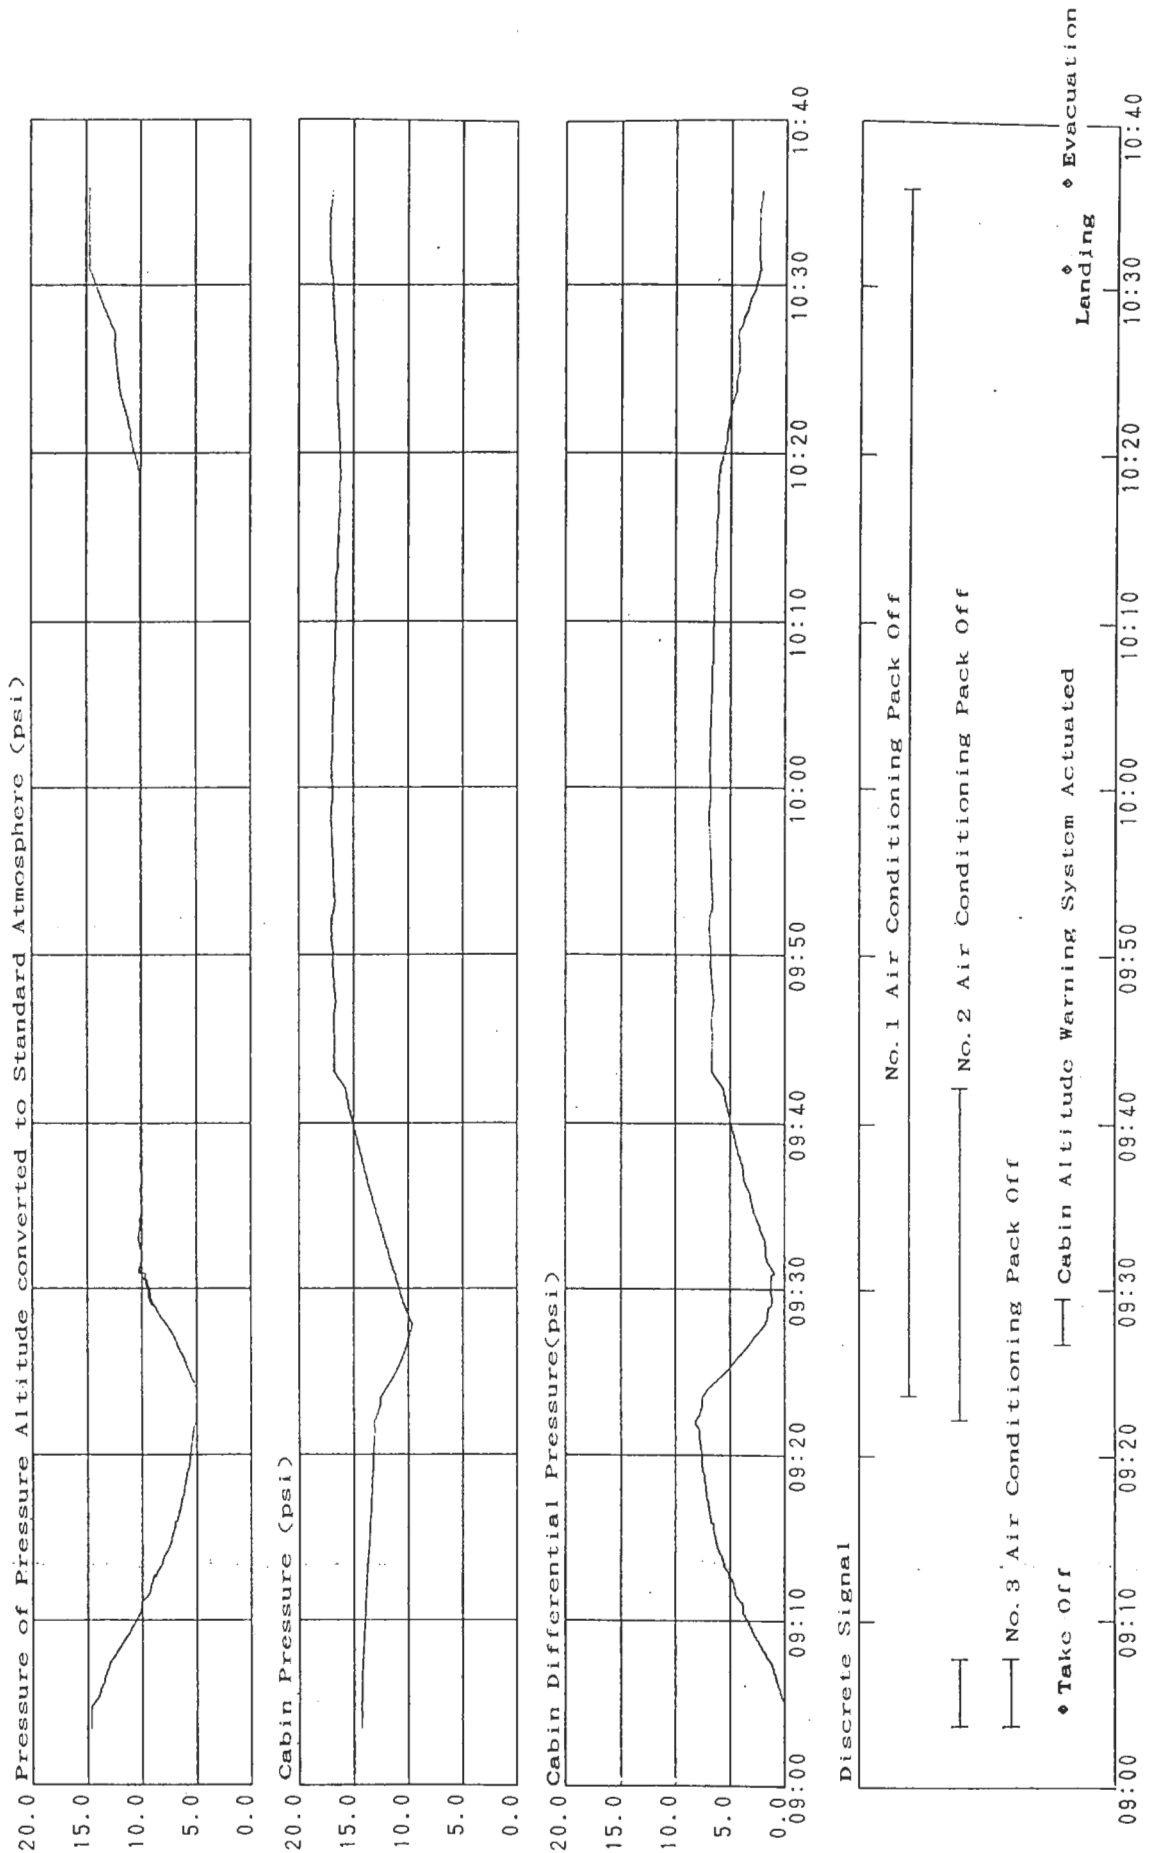
Attached Fig. 9 Status of Cabin Pressurization

from the taxiway where the emergency evacuation was conducted. About 1301 UTC fire occurred near No.2 engine when a mechanic of the company connected external power in order to unload passenger baggage left in the cabin, but the fire was immediately put off. (see Attached Figs. 2, 8 and 9)
