**MARINE ACCIDENT
INVESTIGATION REPORT**

Vessel type and name: Vehicles Carrier PYXIS

Accident type: Fire

Date and time: About 0948 hrs (JST), October 14, 2008

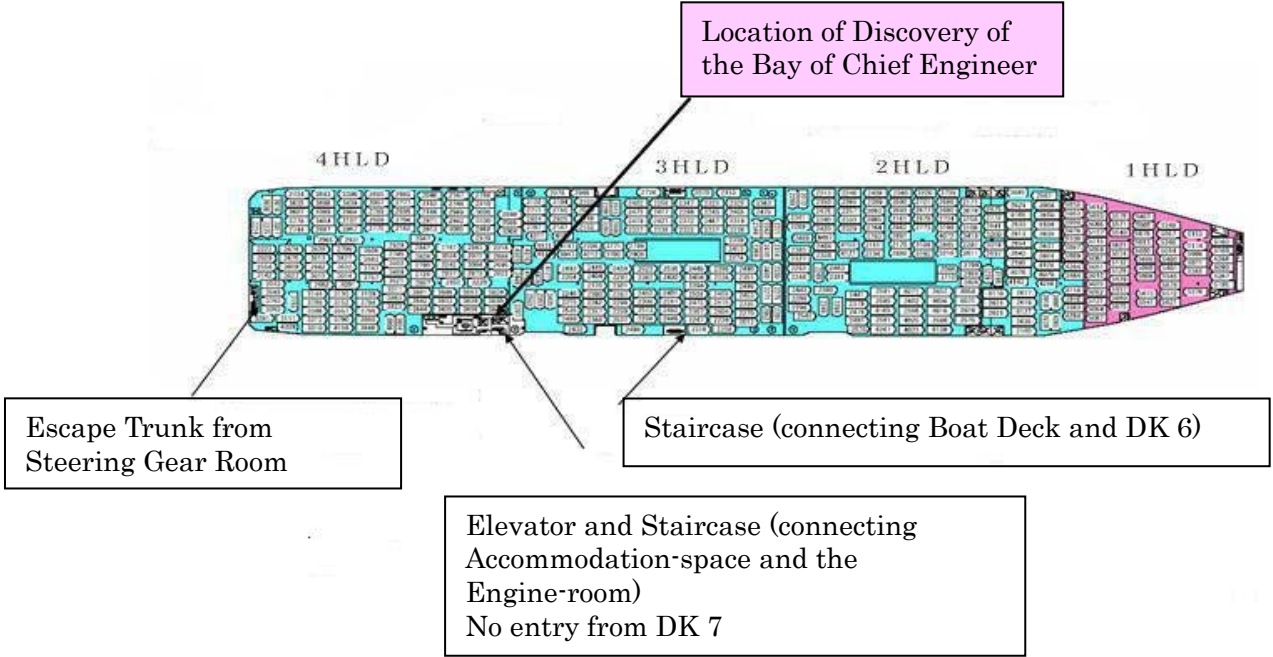
Figure 7: Map of Location of Discovery of the Bay of Chief Engineer (DK 7)

According to the statements from the master and the first engineer, the transceiver to be carried by chief engineer was left in engine control room; it was found in the engine control room. (See Figure 7: Map of Location of Discovery of the Bay of Chief Engineer (DK 7), Figure 8: Detailed Map of Location of Discovery of Chief Engineer (around the DK 7 car ladder))

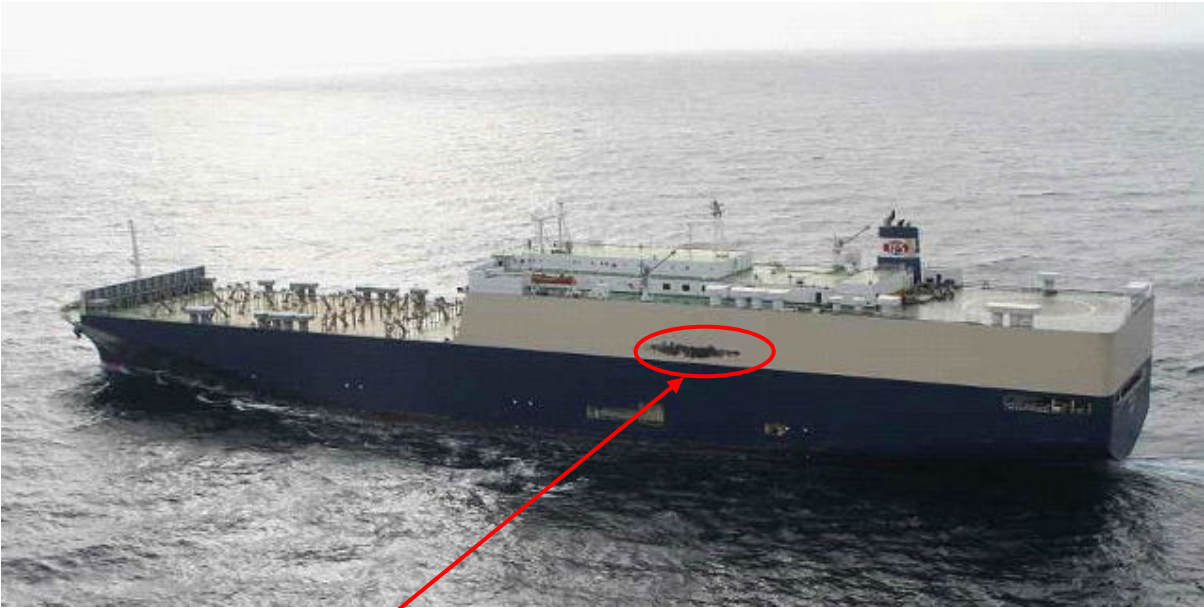
Photo 1: Bird's-eye View of the Ship (after the accident)

(See Figure 1: Map of Accident Location, Figure 2: General Arrangement Plan, Figure 3: Layout of Smoke Accumulators and CO₂ Release Nozzles of Smoke Sampling Type Fire Detection System on DK 11, Photo 1: Bird's-eye View of the Ship (after the accident))

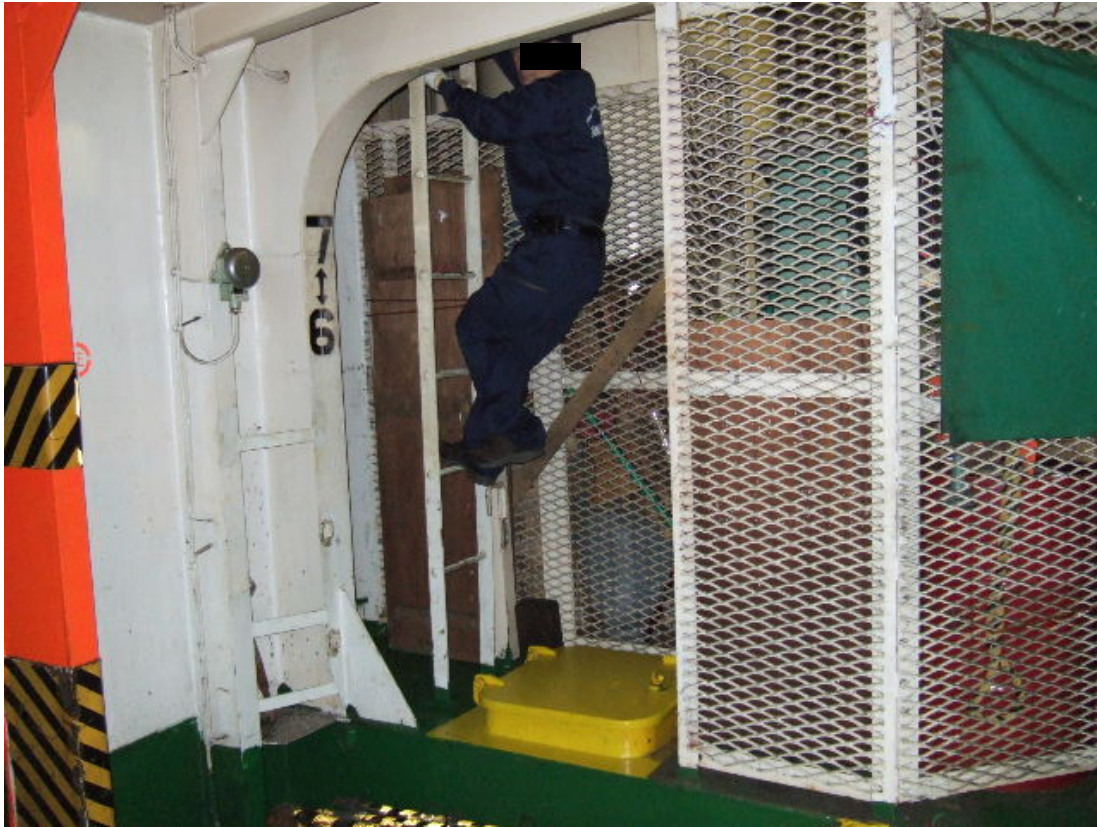
Photo 5: Vertical Ladder Connecting DK 6 and DK 7

(See Figure 2: General Arrangement Plan, Figure 4: Details around DK 6 Car Ladder, Photo 5: Vertical Ladder Connecting DK 6 and DK 7, Photo 15: Clasps.)

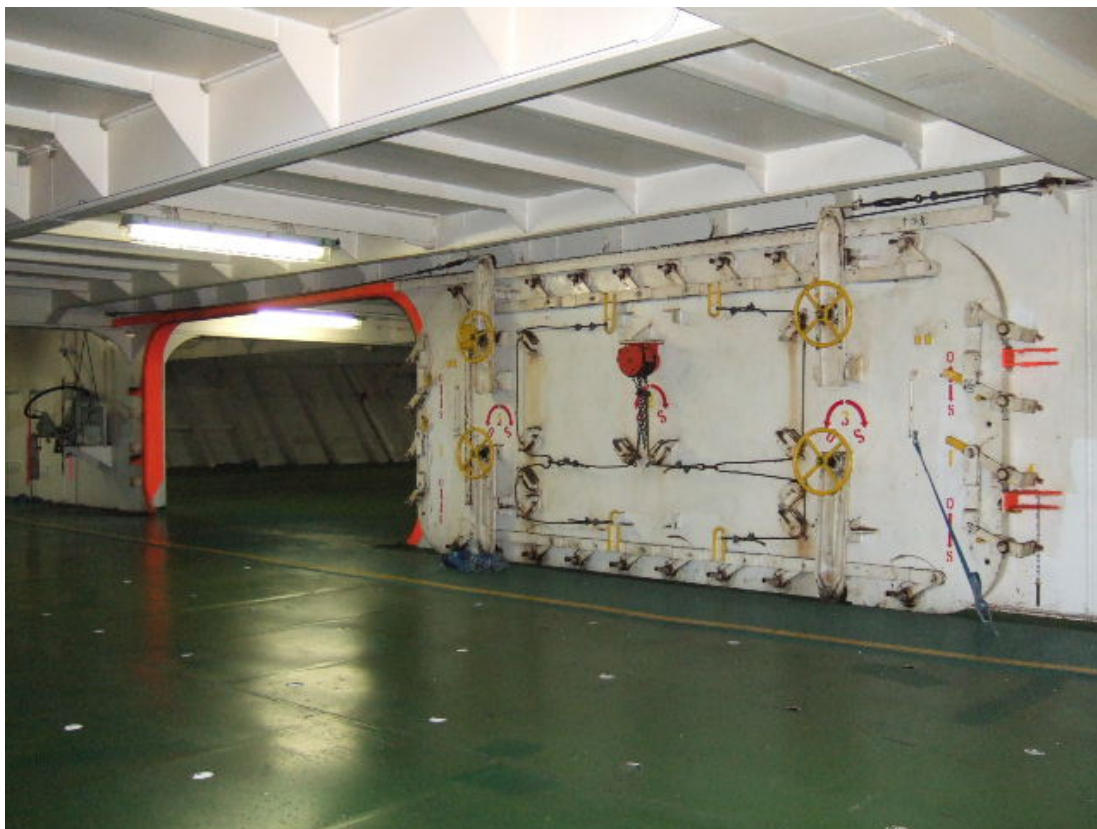
Photo 6: Sliding Bulkhead Door

A watertight partition was installed between Zone B and Zone C. In addition, the doors listed below worked to provide protection from smoke and flames.

(See Photo 6: Sliding Bulkhead door.)

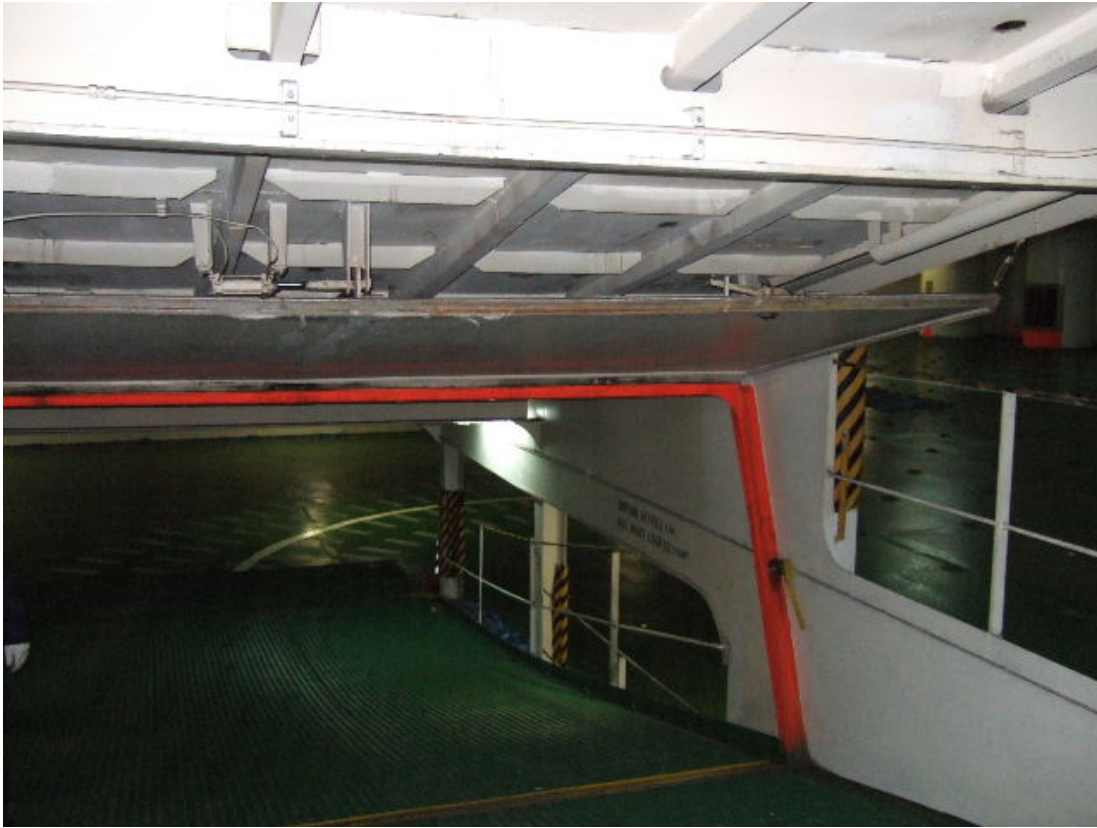
Photo 7: Tilting Gastight Door

(See Photo 7: Tilting Gastight Door)

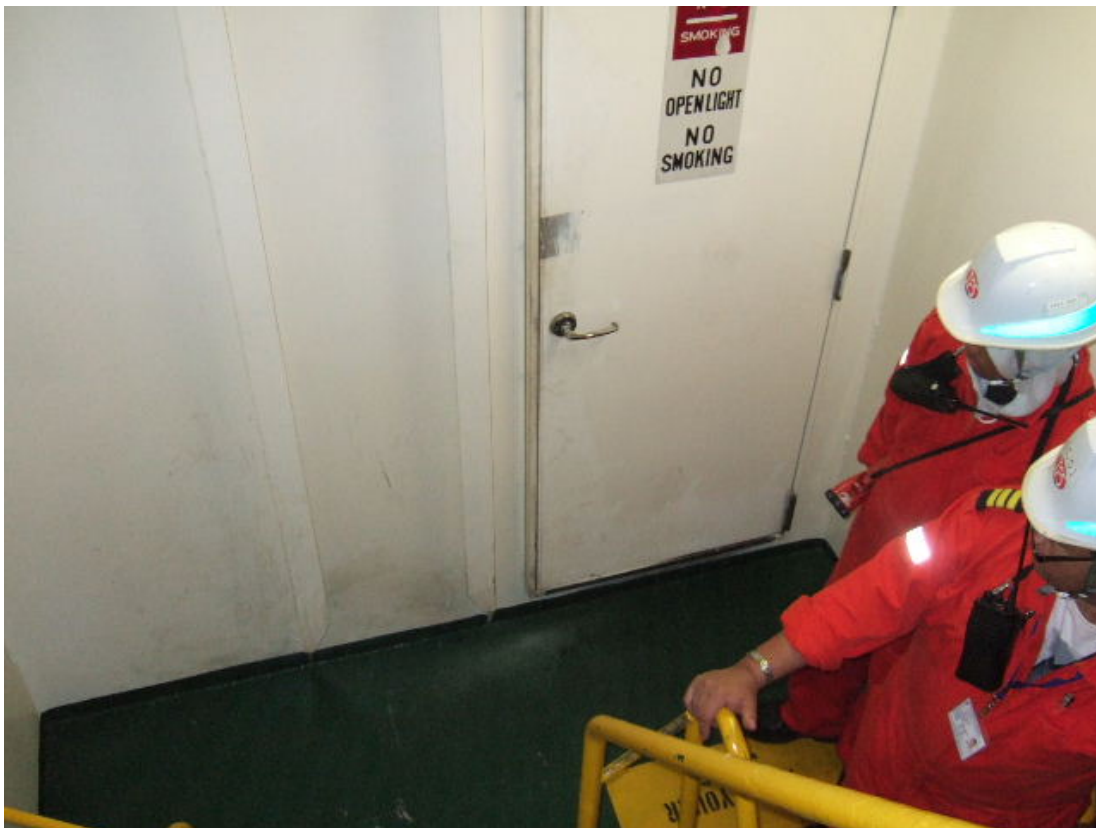
Photo 8: Fire Door from Staircase to Car deck

The Ship passed the ship inspection on fire protection construction in April 2008 and received a Cargo Ship Safety Construction Certificate.
(See Photo 8: Fire Door from Staircase to Car deck)

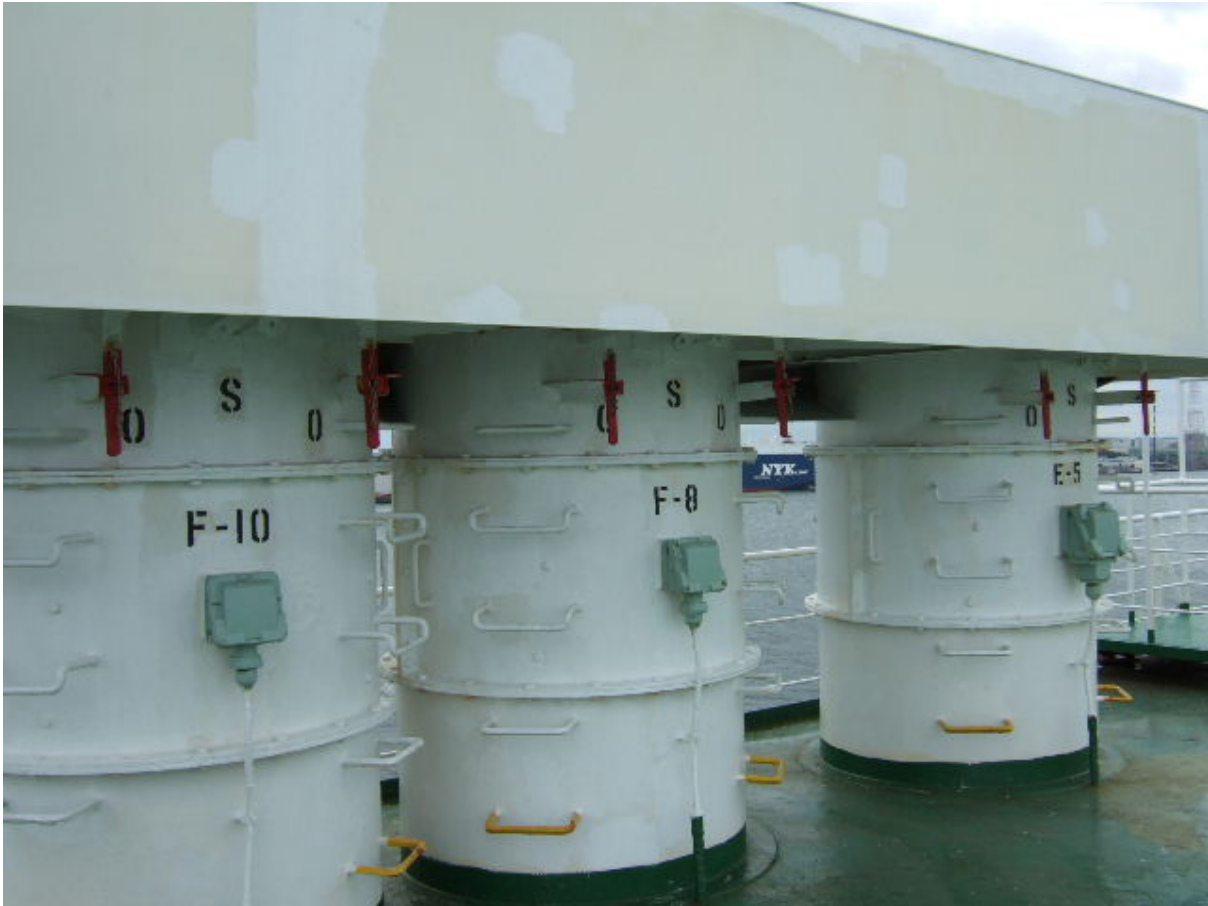
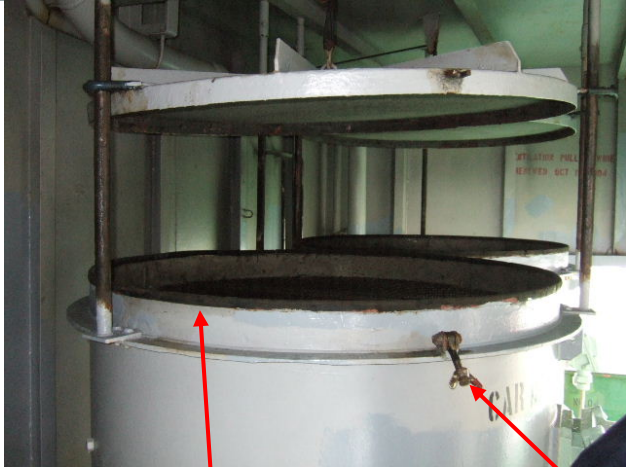
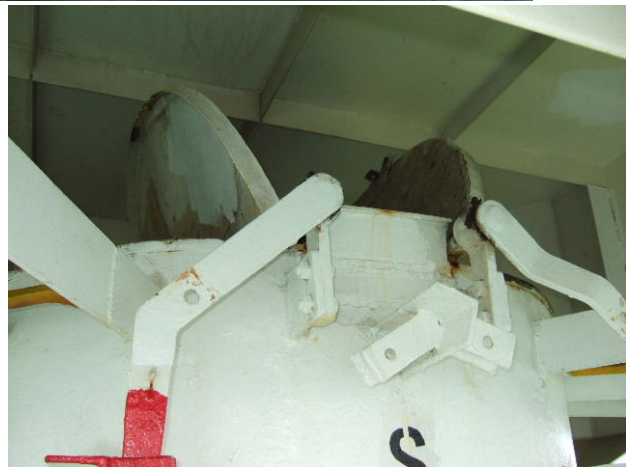
Photo 9: Ventilator (Dampers and Ventilation Holes)

The ventilation holes in the zone of fire retarding positions were connected to the exhaust holes and intake holes in the same zone by the steel ventilation trunks embedded in the hull, and the ventilation holes were able to be shut by closing the up-down or tilting dampers installed on the boat deck or container deck, so as to separate the corresponding zone from the outside air.
(See Photo 9: Ventilator (Damper and Ventilation Holes))

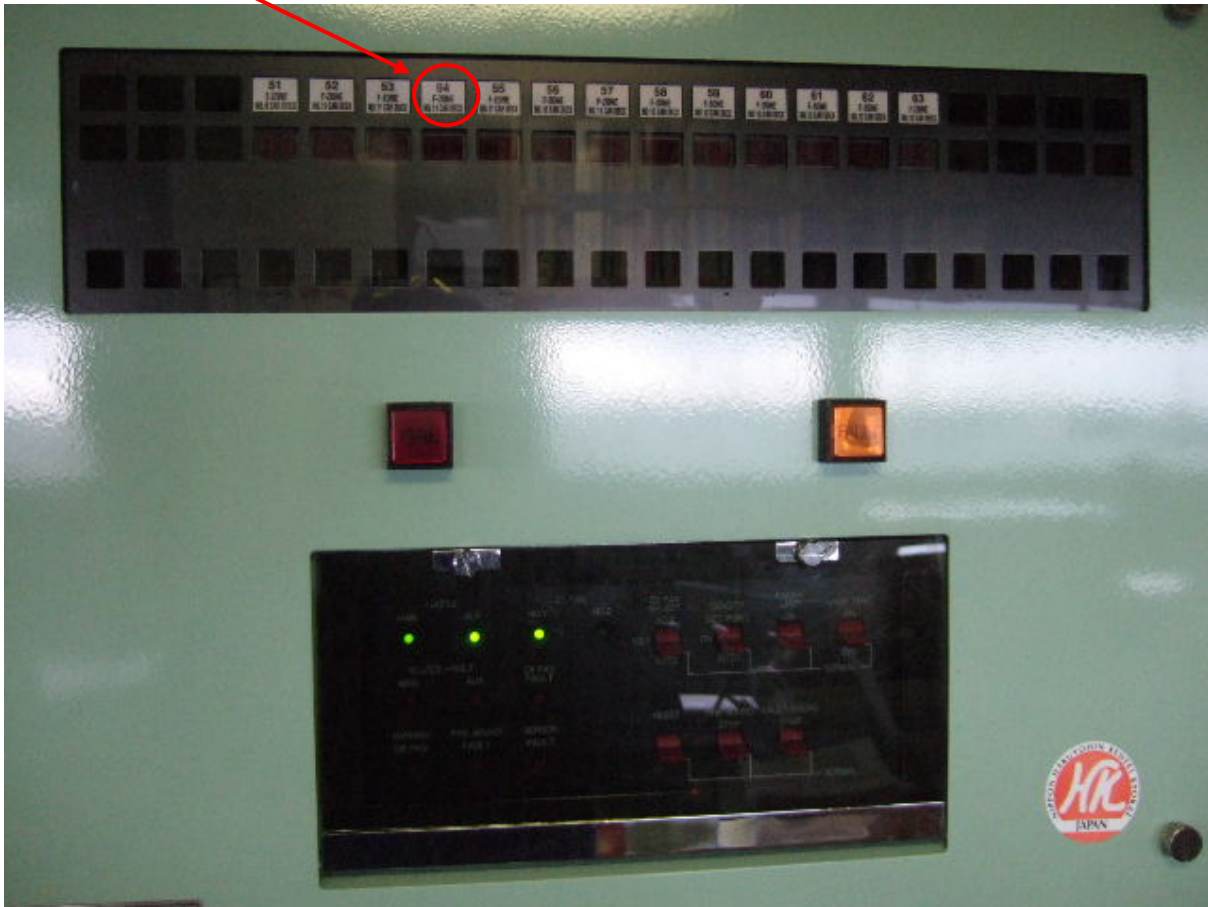
Photo 10: Smoke Detector Control Panel

(See Figure 5: Simplified Diagram of Construction of Smoke Sampling Type Fire Detection System, Photo 10: Smoke Detector Control Panel)

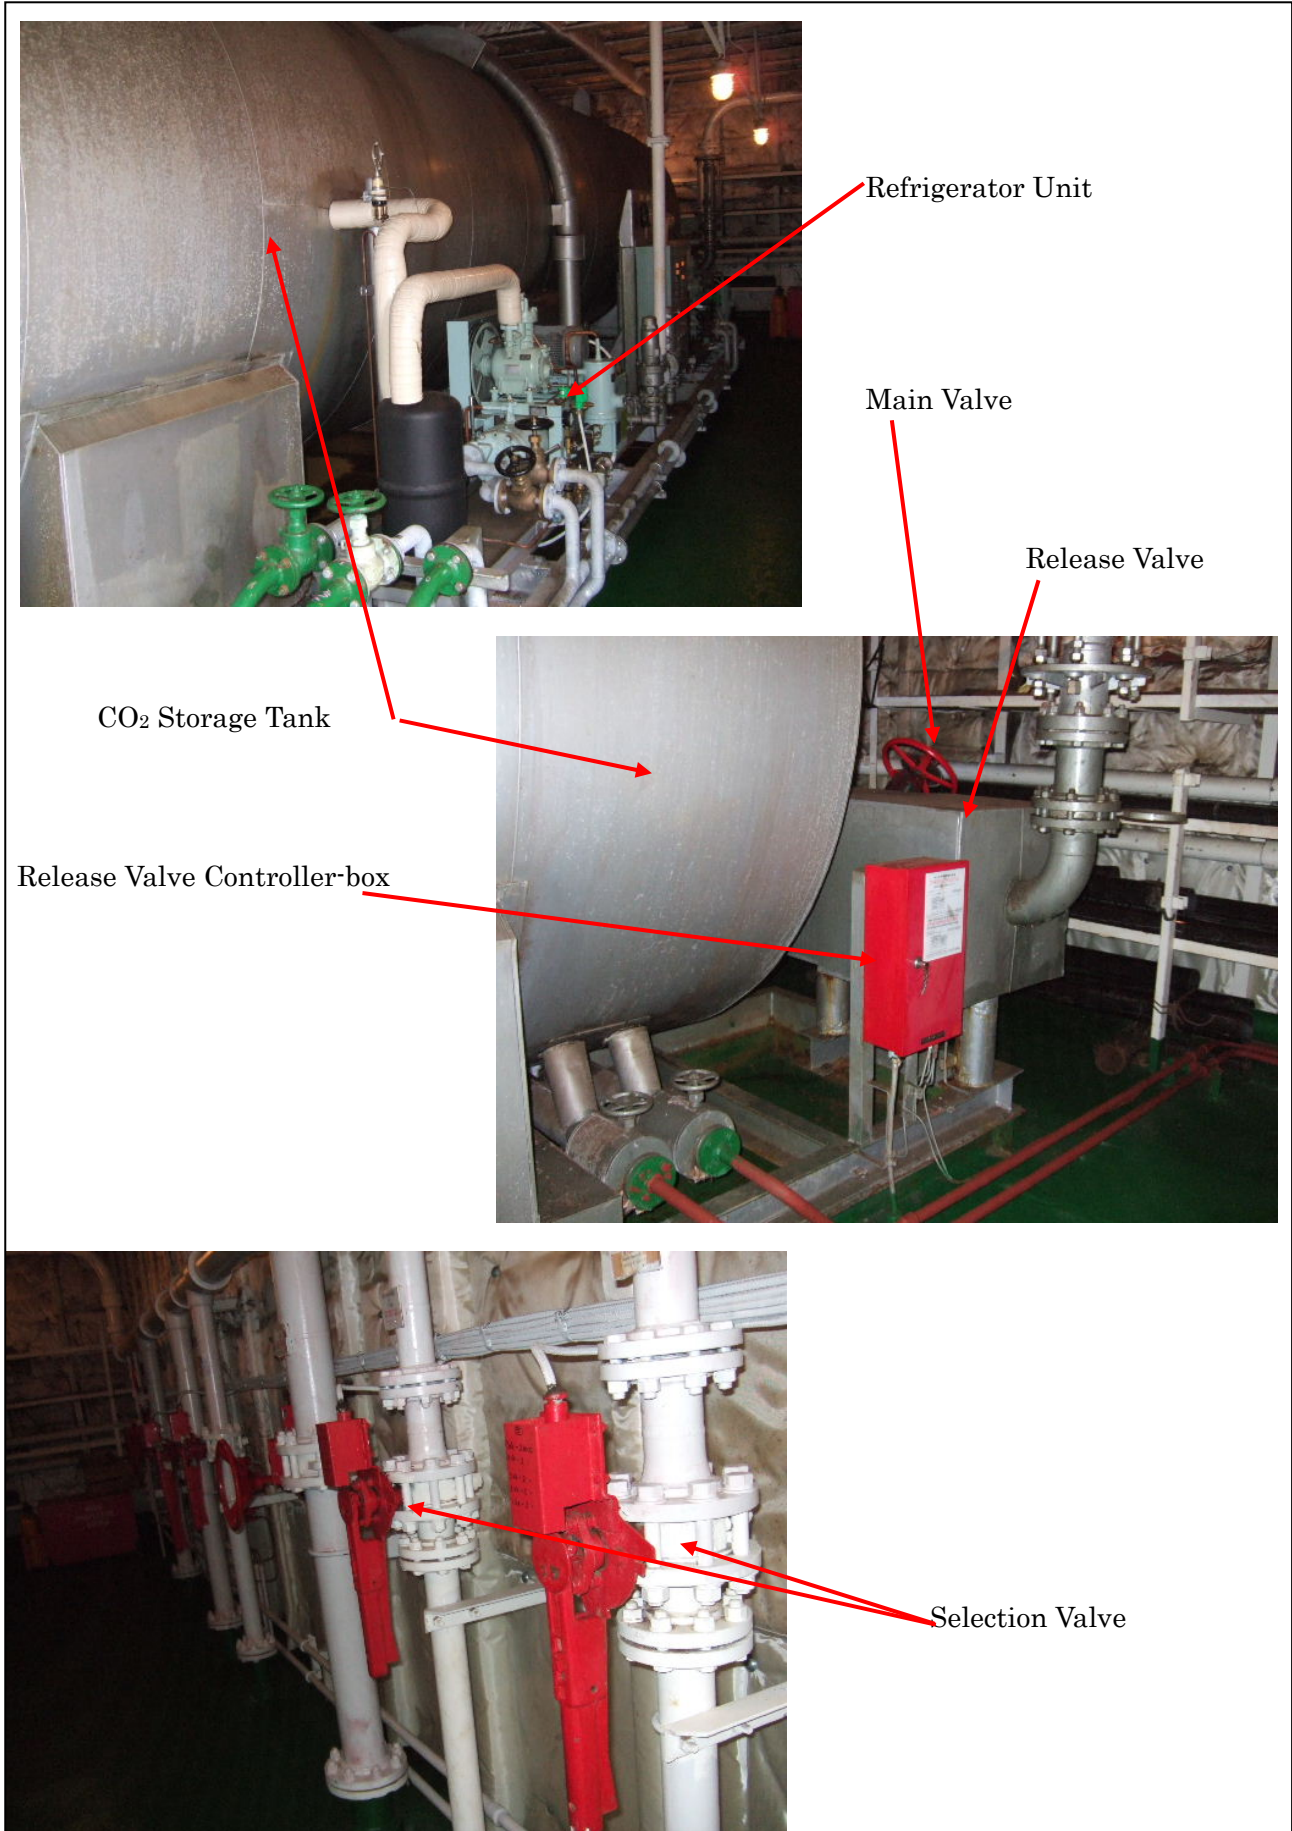
Photo 11: Fixed CO₂ Fire Extinguisher System

(See Figure 6: Block Diagram and Construction Map of Fixed CO₂ Fire Extinguisher System, Photo 11: Fixed CO₂ Fire Extinguisher System)

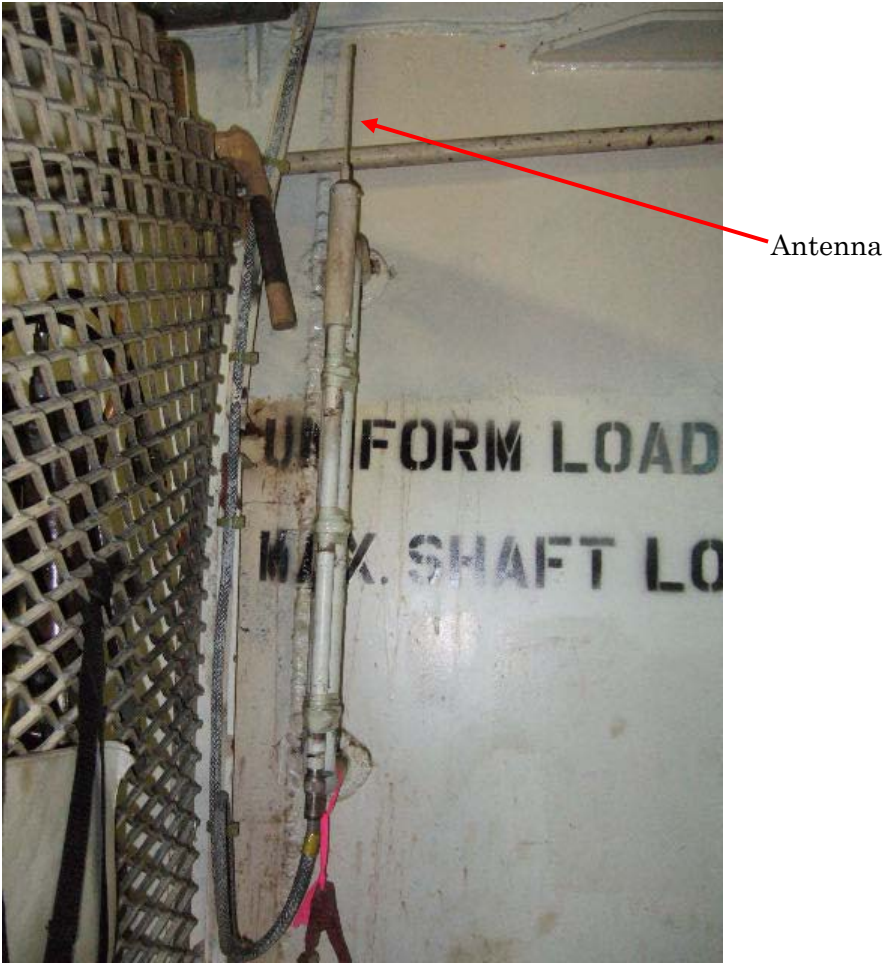
Photo 12: Transceiver Antenna installed in Cargo Hold

(See Photo 12: Transceiver Antenna installed in Cargo Hold)

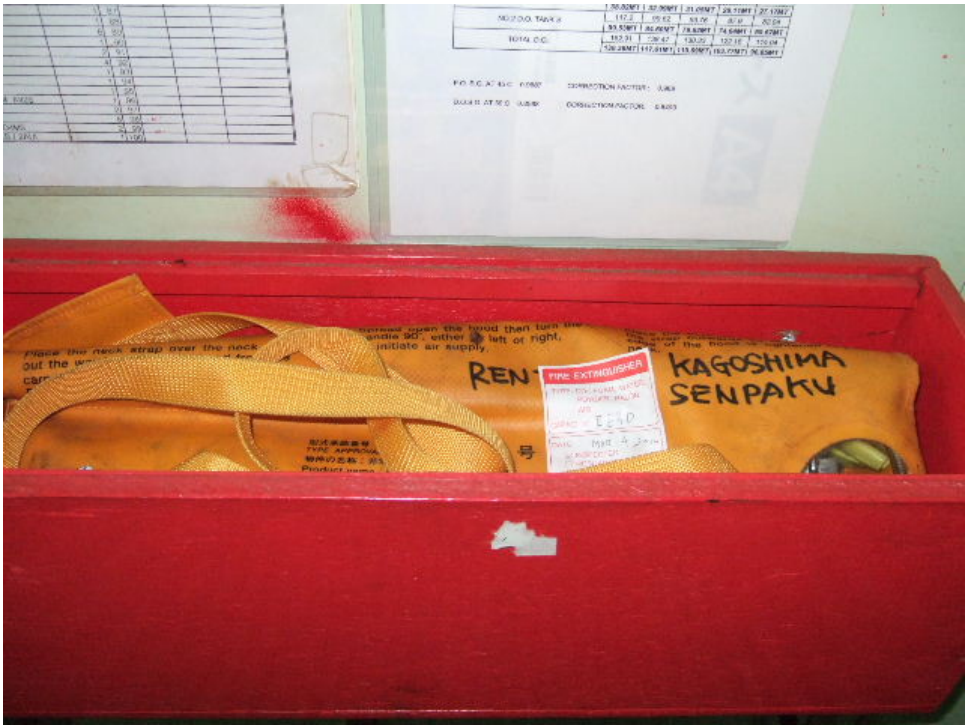
Photo 13: EEBD (Engine Control Room)

All ships should be equipped with EEBDs in such a way that EEBDs are installed at easily noticeable locations and can be used and accessed promptly in whatever type of fire situation. An EEBD—a supplier of air or oxygen—should be used only in a situation of escape from a compartment in danger. An EEBD should not be used for firefighting or entering oxygen deficient spaces or tanks. An EEBD is required to supply air or oxygen continuously for at least 10 minutes. The numbers and locations of EEBD installation should be clearly shown on fire control plans.

(See Photo 13: EEBD (Engine Control Room))

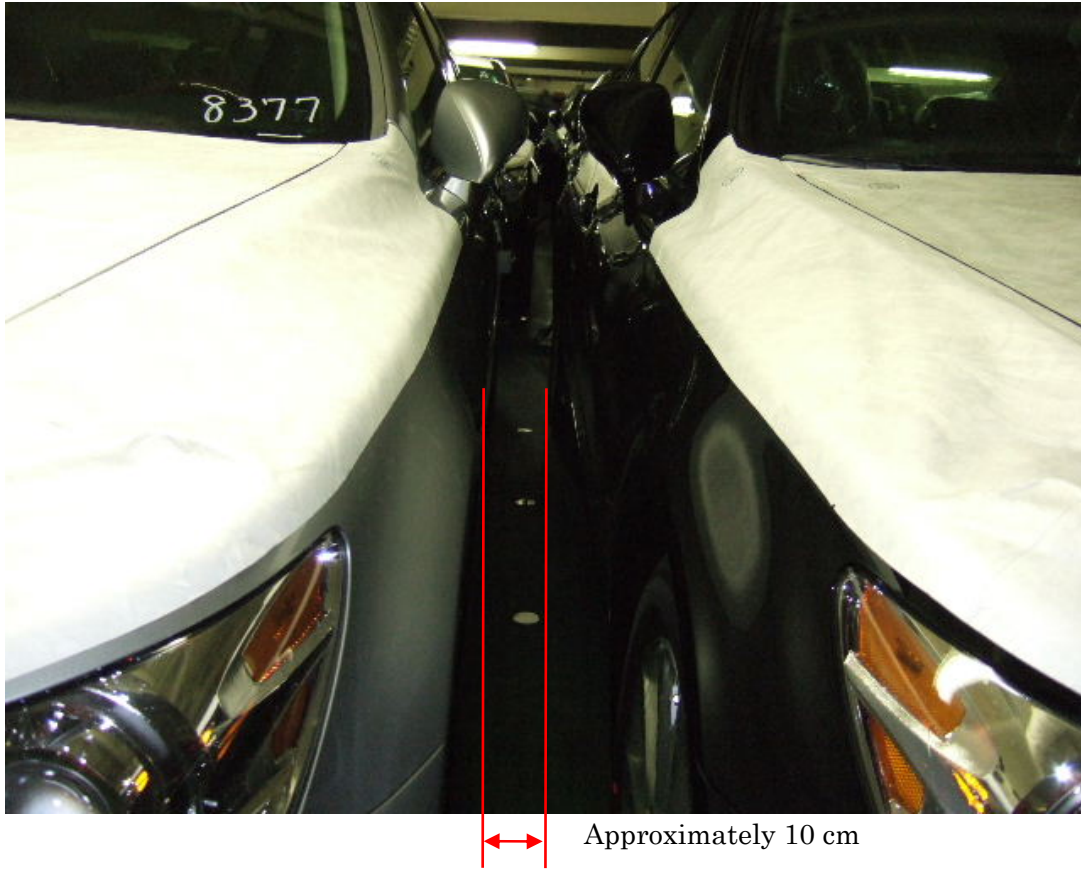
Photo 14: Car Stowage

ground workman. The ground workman guided the driver to adjust the position in such a way that the door-to-door distance between cars was about 10 cm, the bumper-to-bumper distance was about 30 cm, and the distance between a car and the wall, which was used for walking space, was about 60 cm. The ground workman then used clasps to clamp the car to the car deck.
(See Photo 14: Car Stowage)

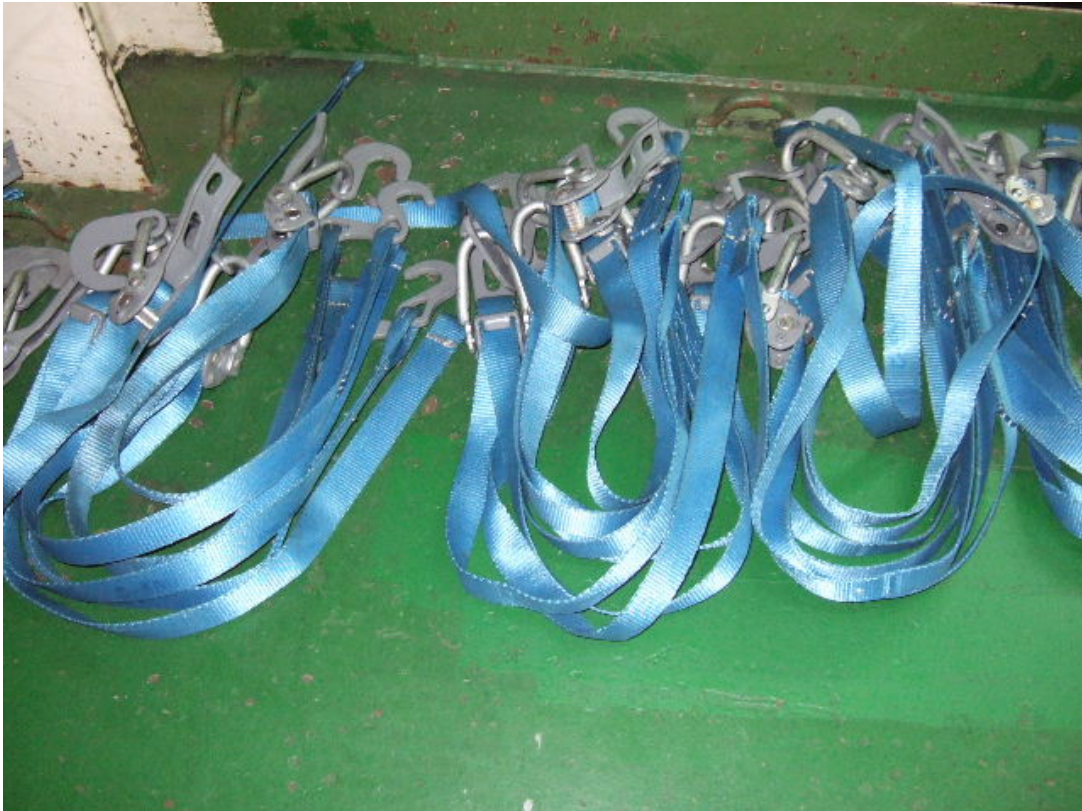
Photo 15: Clasps

¹¹ A "clasp" refers to belt-shaped lashing equipment used to tie cars to the hull.
