MA2011-6

**MARINE ACCIDENT
INVESTIGATION REPORT**

Vessel type and name: Cargo ship RICKMERS JAKARTA

Type of accident: Accident with workers injuries and a fatality

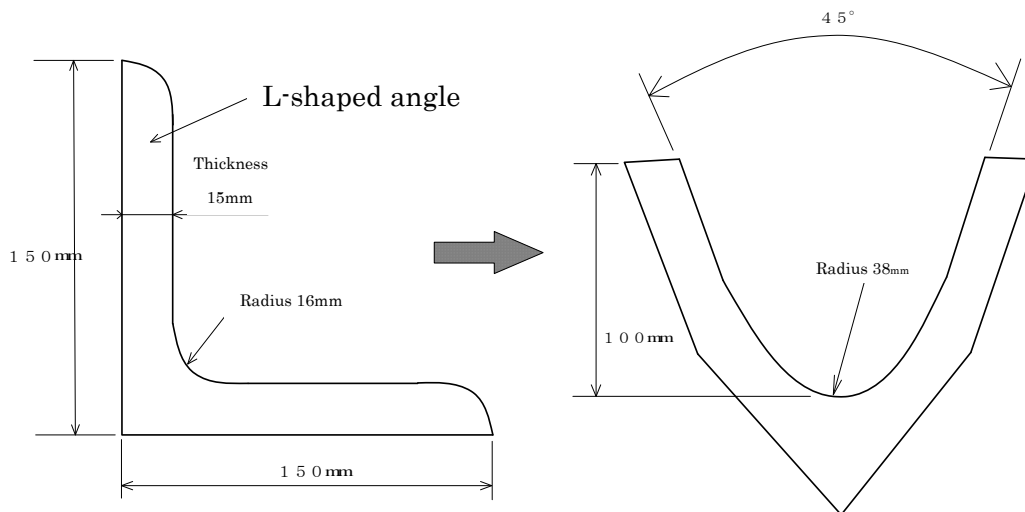
Manufacture of the Rim

The rim was manufactured from L-shaped angle steel material (DIN¹² S355J2G3¹³, width of 150 mm and thickness of 15 mm, cross-section inner radius of 16 mm) through bending and shaping using a cold forming technique¹⁴ to form it into a rim with a minimum groove radius of 38 mm (at the bottom of the wire guide surface) and a groove angle of 45°.

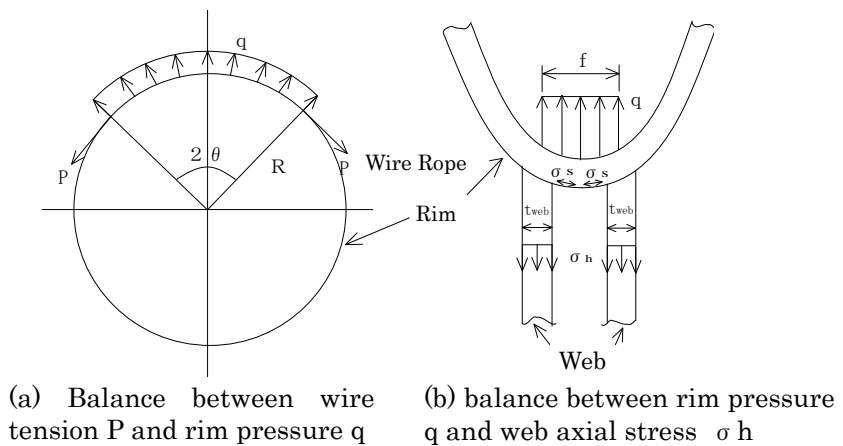
Balance among the wire rope, rim, and web

As θ approaches zero, $2 \sin\theta$ can be approximated by 2θ . Substituting this into the equation above, we obtain the following approximate formula representing the relation between normal surface stress of Main Sheave C (σ_s) and wire rope tension P.

$$\begin{aligned} \sigma_s &= (1/4 \sim 1/3) \cdot \sigma_h \\ &= (1/4 \sim 1/3) \cdot P / (2R \cdot t_{web}) \end{aligned}$$

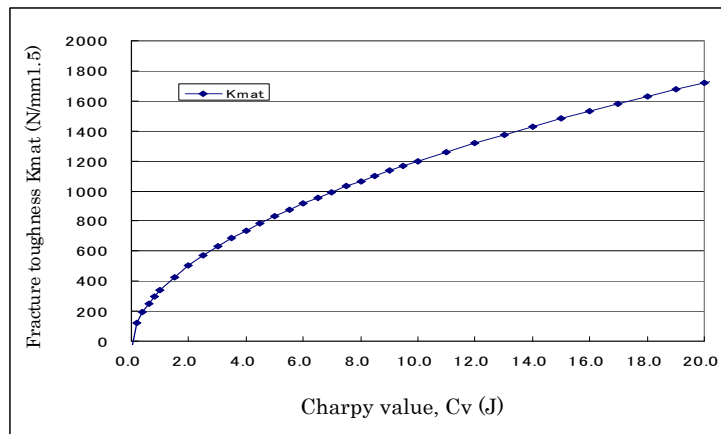
Charpy value vs. Fracture toughness

If $C_v = 6$ J is used in the graph, we obtain $K_{mat} = 916\text{N/mm}^{1.5}$. Substituting $P = 150$, $a = 8$ mm, residual stress = 15.0kgf/mm^2 (147N/mm^2) into the equation gives $K = 930.7\text{N/mm}^{1.5} > K_{mat} = 916\text{N/mm}^{1.5}$, satisfying the required condition of brittle fracture. Therefore, we concluded that a brittle fracture could have occurred.
