**MARINE ACCIDENT
INVESTIGATION REPORT**

Vessel type and Name: Cargo ship MARUKA

Vessel type and Name: Fishing vessel KAIRYO MARU No.18

Accident type: Collision

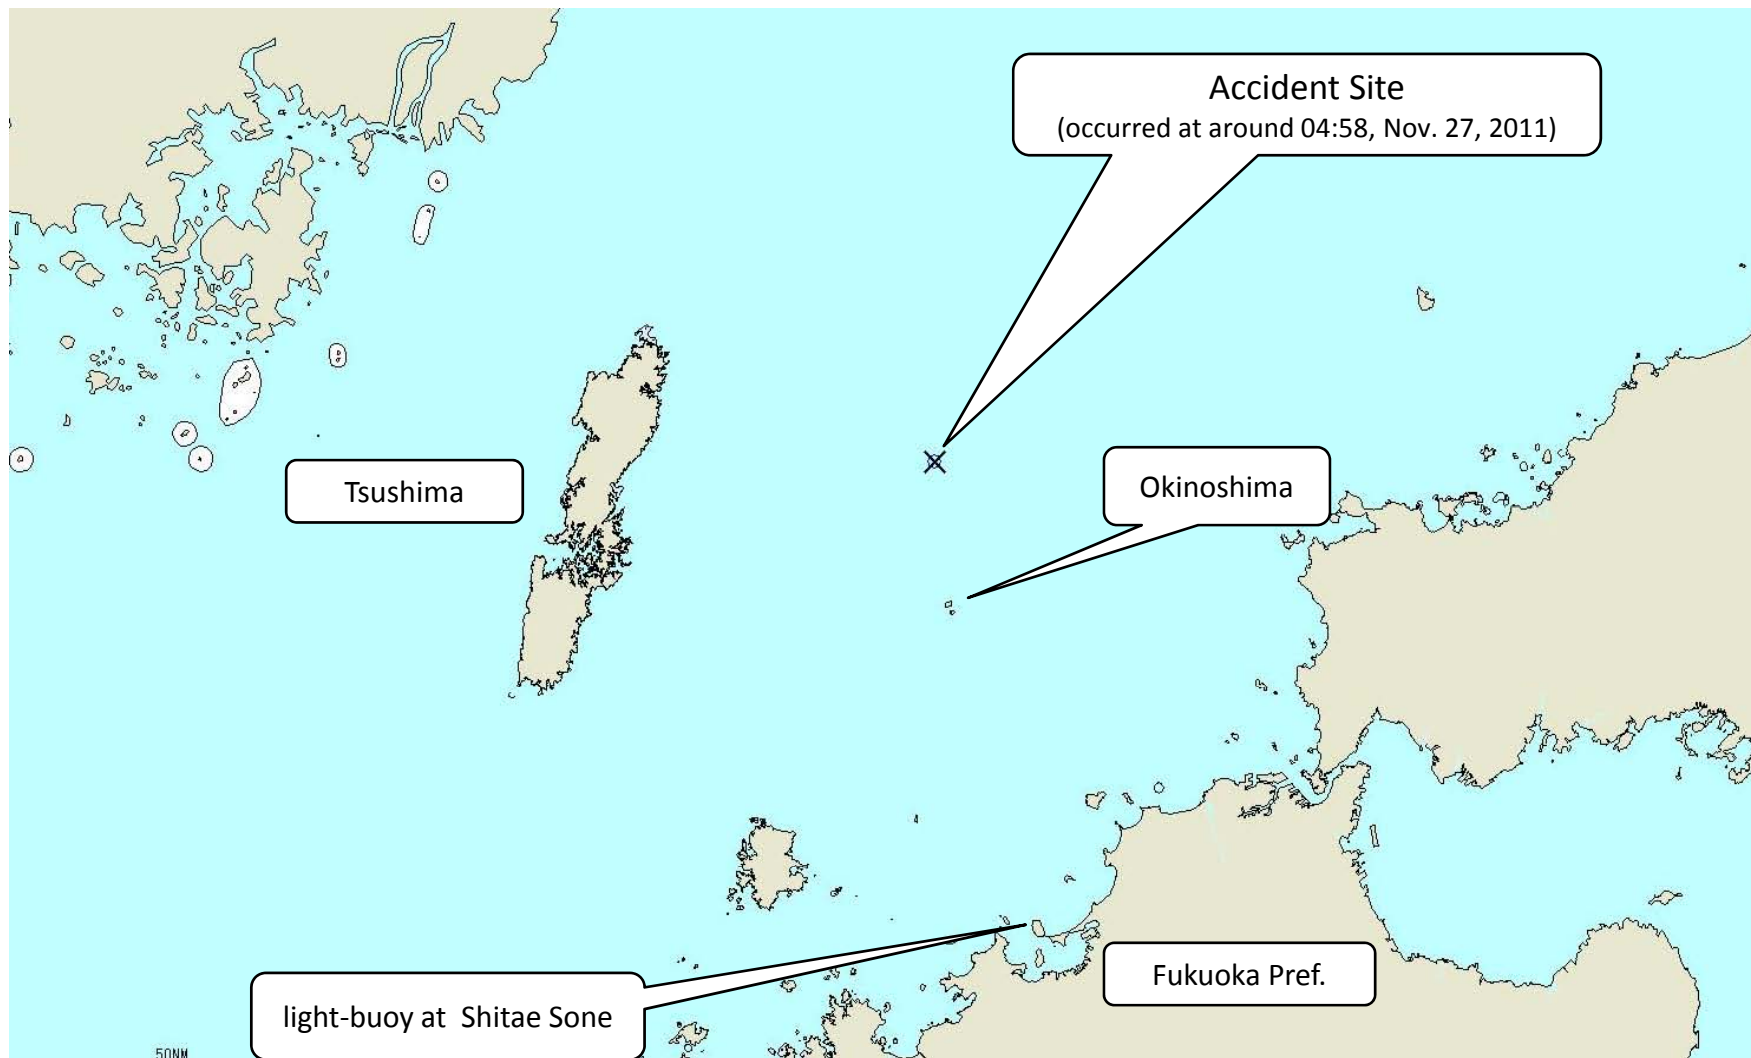
Figure 1: Location of Occurrence of the Accident

Location: Off the northern coast of Okinoshima, Munakata City, Fukuoka Prefecture,
Japan
Around 354° true bearing, 14.6 nautical miles from the Okinoshima
Lighthouse
(Approximately 34° 29.2' N, 130° 04.6' E)

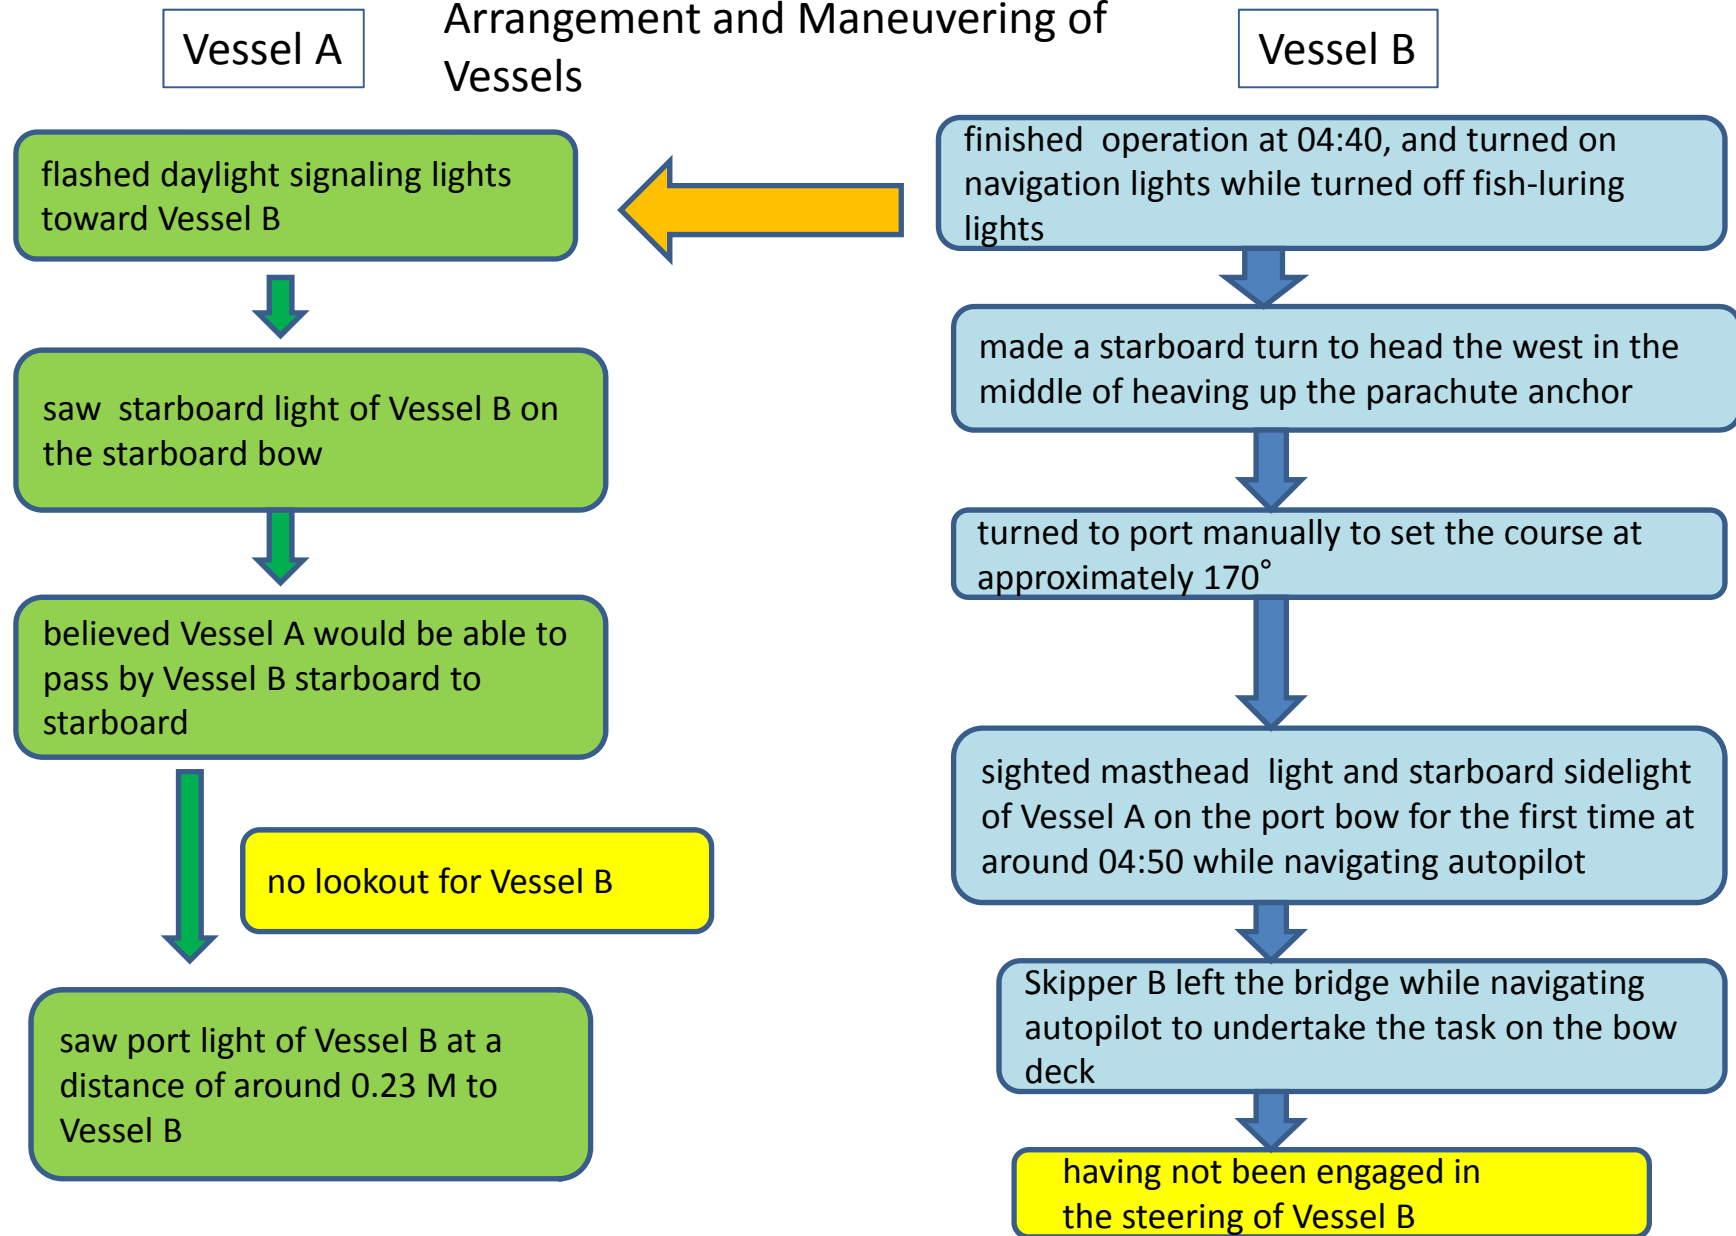
Figure 8: Analysis of Watch-Keeping Arrangement and Maneuvering of Vessels

- (1) Those on the bridge watch should keep a proper lookout at all times.
- (2) When vessels on the point of starting to navigate come in sight while underway pay attention to the subsequent movements.

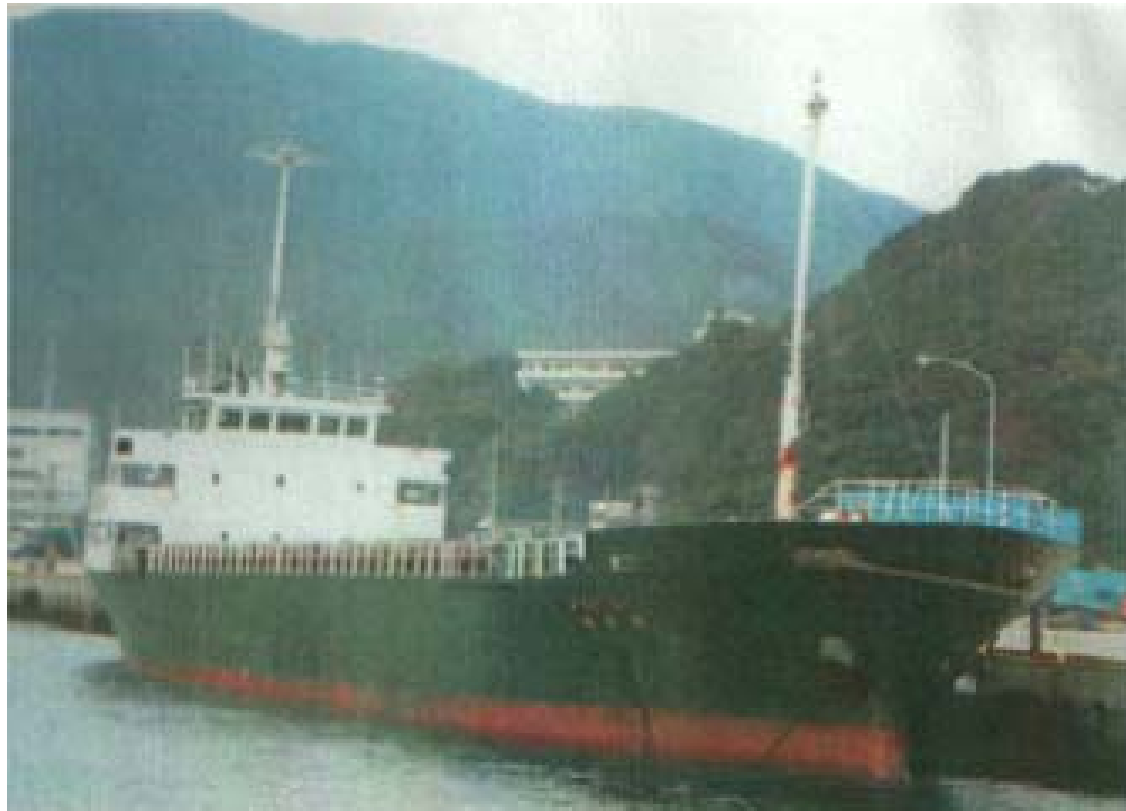
Photo 2: Vessel A

According to 2.3, it is probable that Vessel A sustained a fracture at the starboard section of the bulbous bow and a crack at the center of it, while Vessel B was cut in two parts at the center of the hull, and sank leaving only the bow section over the sea.
