MA2013-11

**MARINE ACCIDENT
INVESTIGATION REPORT**

Vessel type and name: Container ship TIAN FU (TIANJIN)

Accident type: Collision

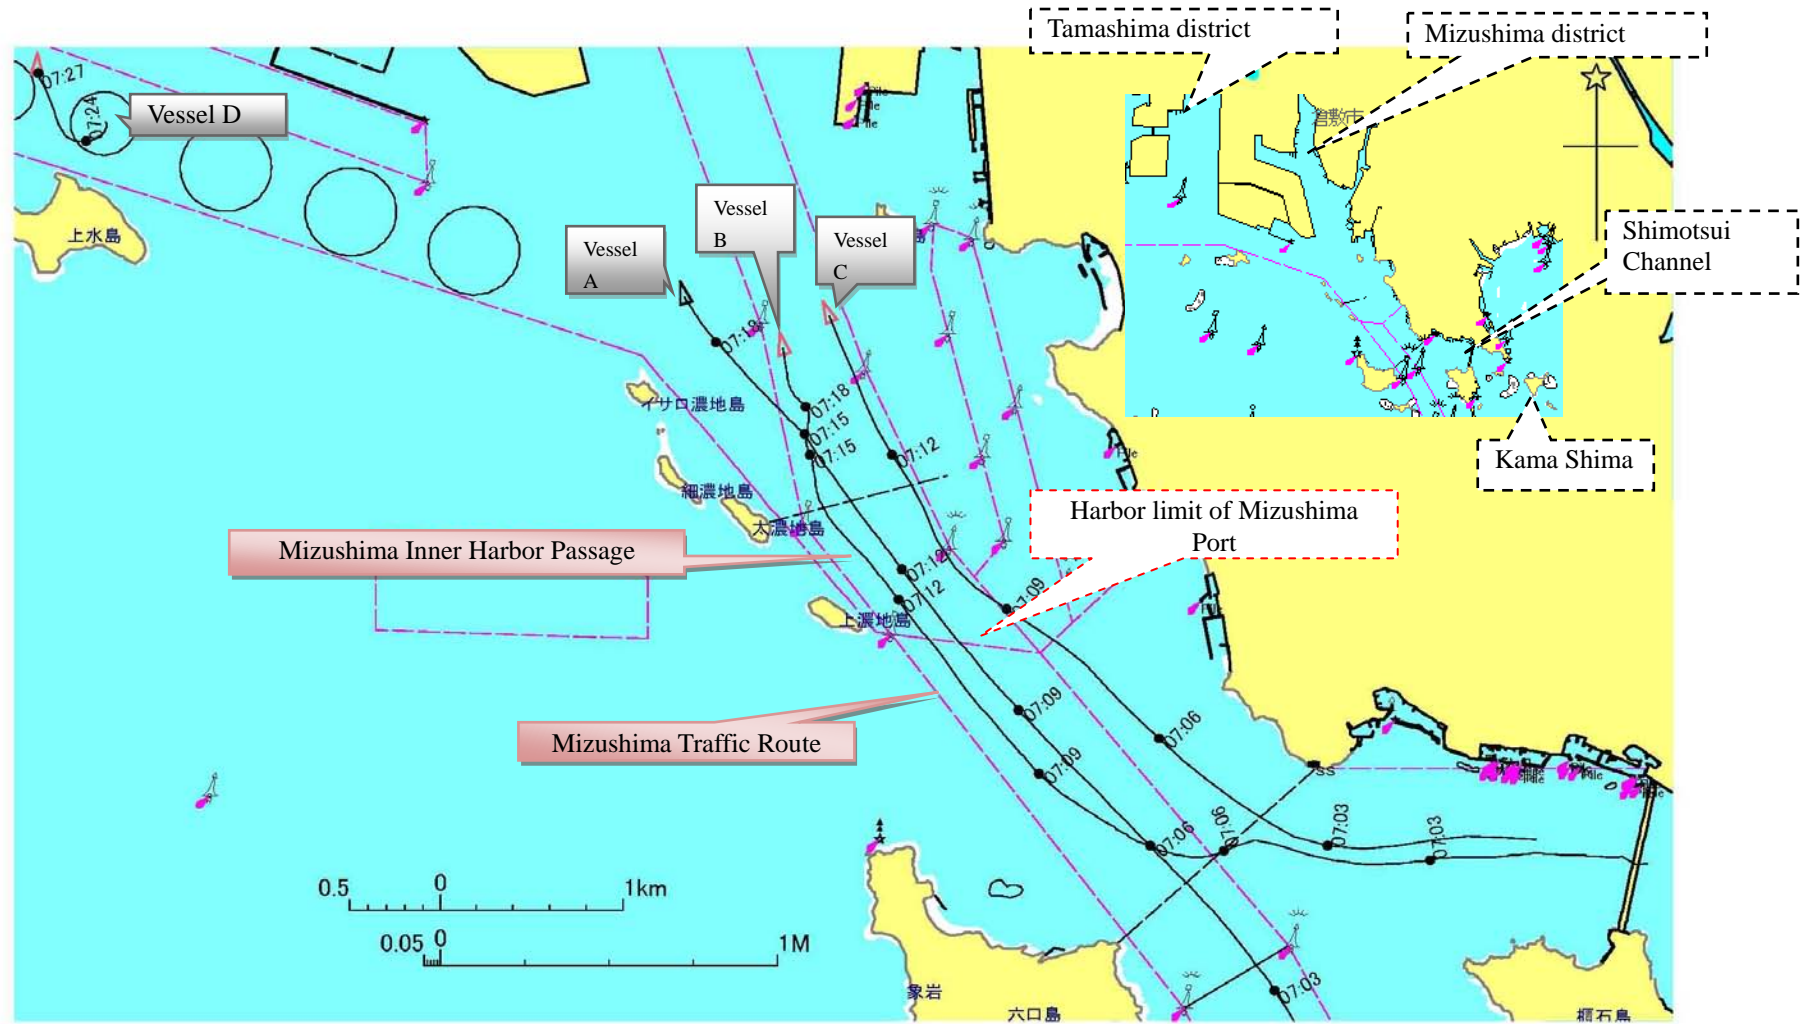
Figure 1: Estimated vessel tracks (Overall figure)

It is probable that, in the Mizushima Inner Harbor Passage, while Vessel A was proceeding northwest toward Tamashima district in Mizushima Port and Vessel B was proceeding northwest toward Mizushima district in Mizushima Port, Vessel B ended up proceeding parallel to Vessel A, which was ahead, on her port side, which caused the two vessels to collide.
