**MARINE ACCIDENT
INVESTIGATION REPORT**

Vessel type and Name: Ro-Ro Passenger Ferry ARIAKE

Accident type: Listing

Date and time: Around 05:06, November 13, 2009 (local time, UTC+ 9 hours)

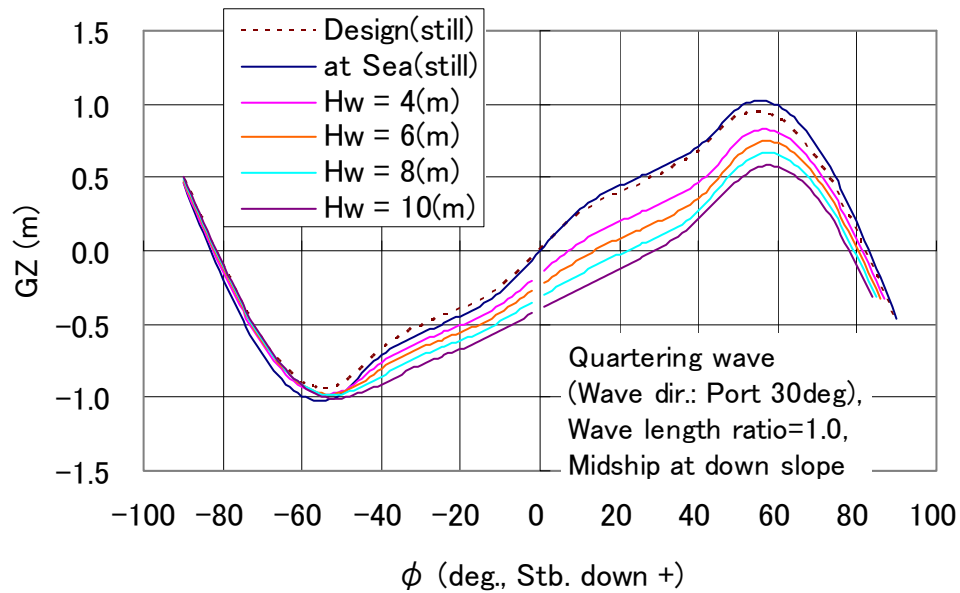
Figure 19: Stability Curves in High Waves
at the Time of the Accident

(quartering seas with waves 30° left oblique, ratio of the hull length to the wavelength: 1.0, the midship: on a down slope of the wave)

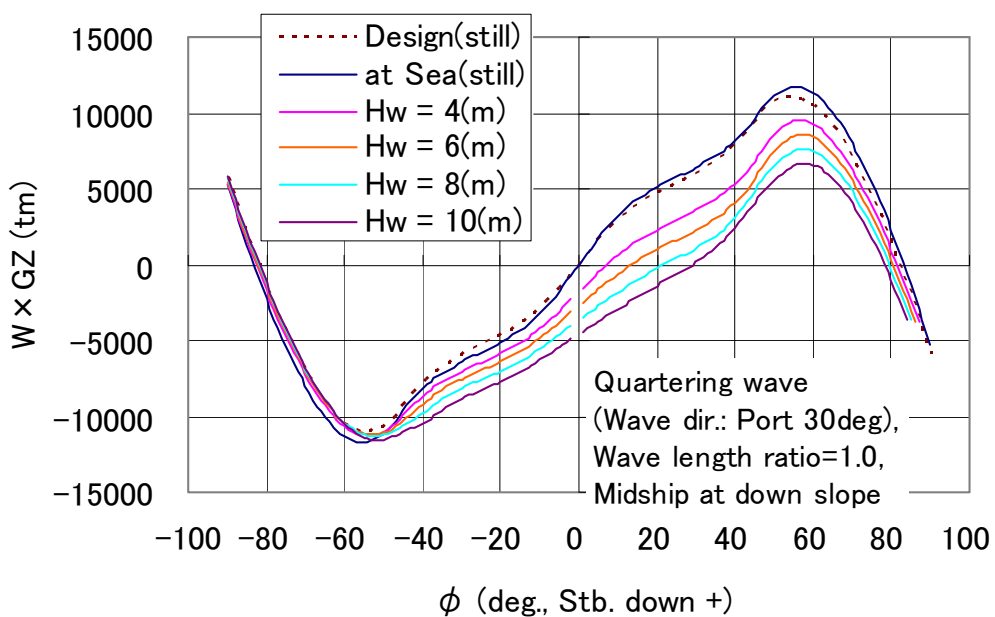
Figure 20: Relation Between Angle of List and Listing Moment

When collapse of cargoes is expected, the angle of list corresponding to the listing moment can be estimated by applying the product of the weight of the collapse of cargoes and the amount of the travel to the vertical axis (listing moment) in Figure 20.

(quartering seas with waves 30° left oblique, ratio of the hull length to the wavelength: 1.0, the midship: on a down slope of the wave)

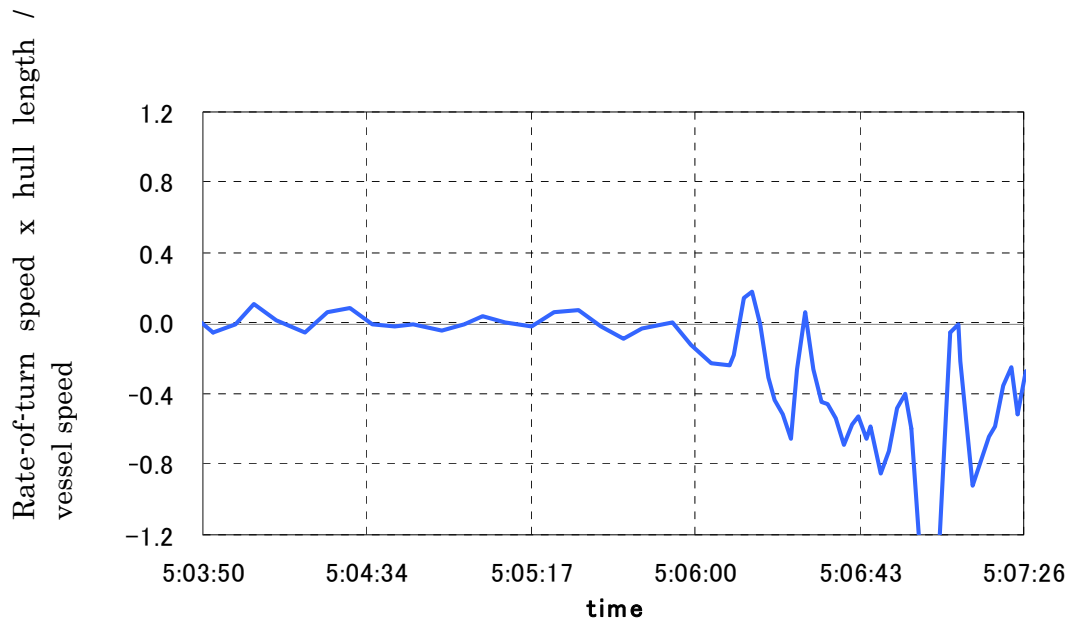
Figure 21: Dimensionless Rate-of-Turn Speed
Obtained From AIS Records

When the dimensionless value from the heading, speed and length of the Vessel is sought, it is found that the Vessel was swung largely from side to side after 05:06, and afterward the rate-of-turn speed became larger on the port side (minus), which shows that the Vessel started turning to the left. Accordingly, it is estimated that the accident occurred after 05:06. (See Figure 21)

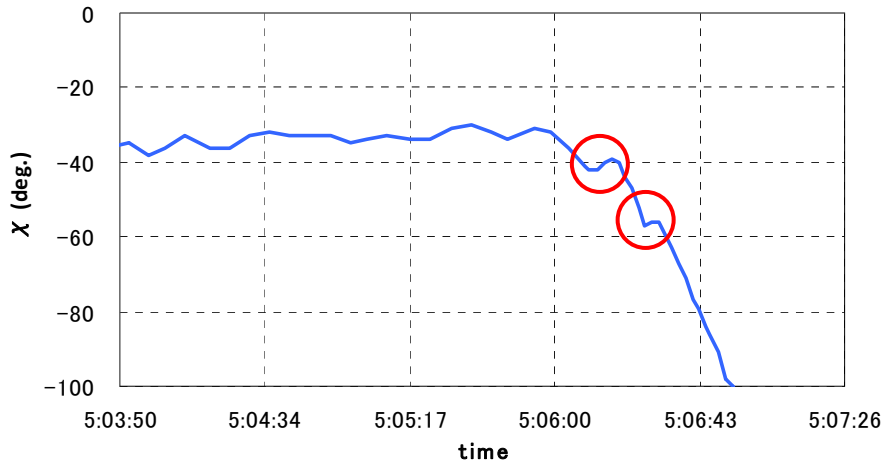
Figure 23: Angle of Encounter With Waves Obtained From AIS Records and Estimated Values by Weather Association

It is estimated that the angle of encounter with the second wave on a down slope at that time was about 55°. (See Figure 22, 23)

χ indicates an angle of encounter with a wave, while $-$ (minus) indicates waves coming on the port side.

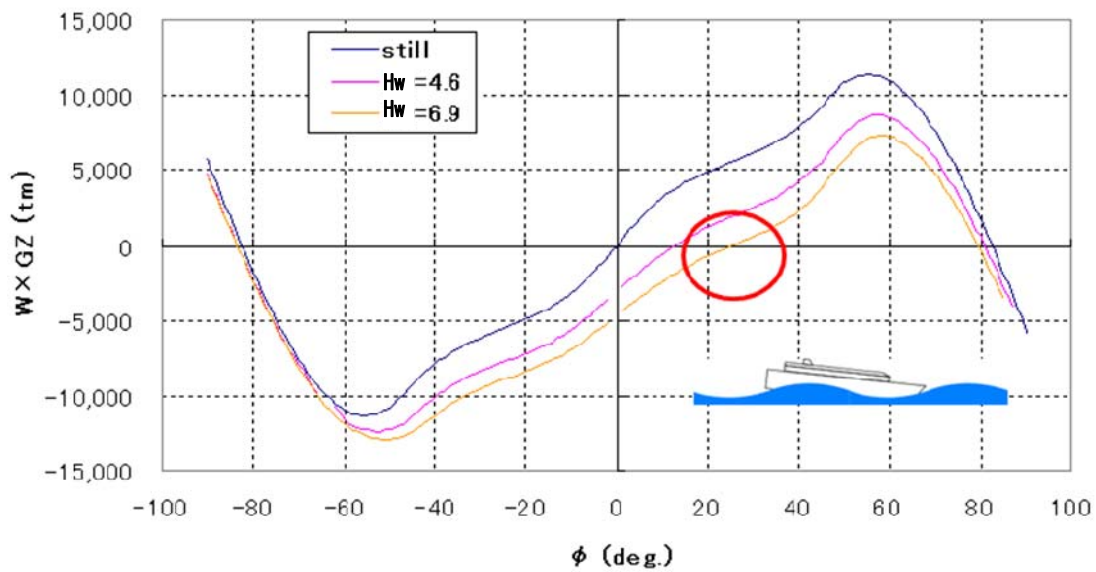
Figure 24: Heeling Moment and Angle of Heel in the First Wave

Accordingly, assuming that some of the containers and chassis started collapsing after the Vessel was hit by the First Wave, there is a possibility that when being hit by the second wave, the Vessel heeled about 40° while accelerated by the outward heel generated during turning to the left. (See Figure 24, 25)
