**MARINE ACCIDENT
INVESTIGATION REPORT**

Vessel type and name: Cargo ship GUANG DA

Accident type: Fatality during mooring operation

Date and time: At around 07:08 on January 11, 2012 (local time, UTC+9 hours)

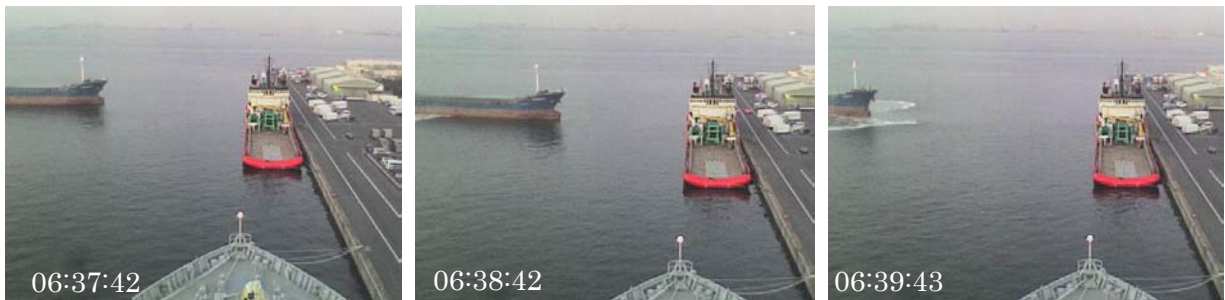
Figure 2.1-3 Images of the Berth (between 06:37:42 and 06:39:43)

- (1) From around 06:37 to 06:40, the Vessel approached the Berth and then went astern away from the Berth. (See Figure 2.1-3.)

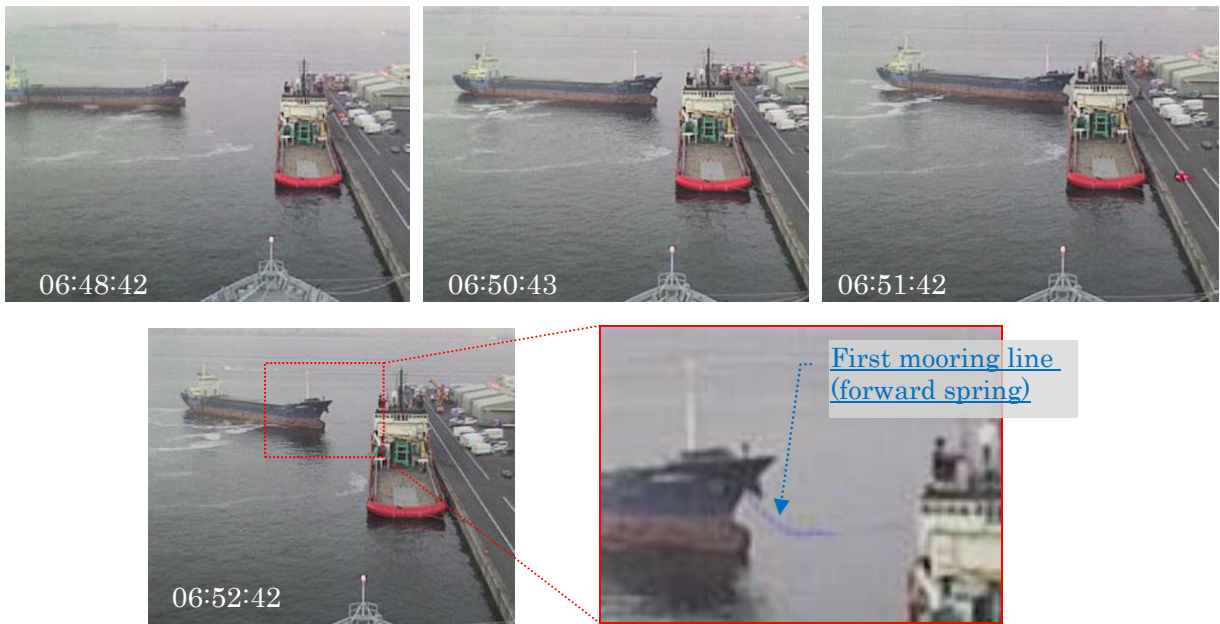
Figure 2.1-4 Images of the Berth (between 06:48:42 and 06:52:42)

(2) From around 06:48 to 06:52, the Vessel approached the Berth again and, after the first mooring line was sent out to the Berth, went astern away from the Berth. (See Figure 2.1-4.)

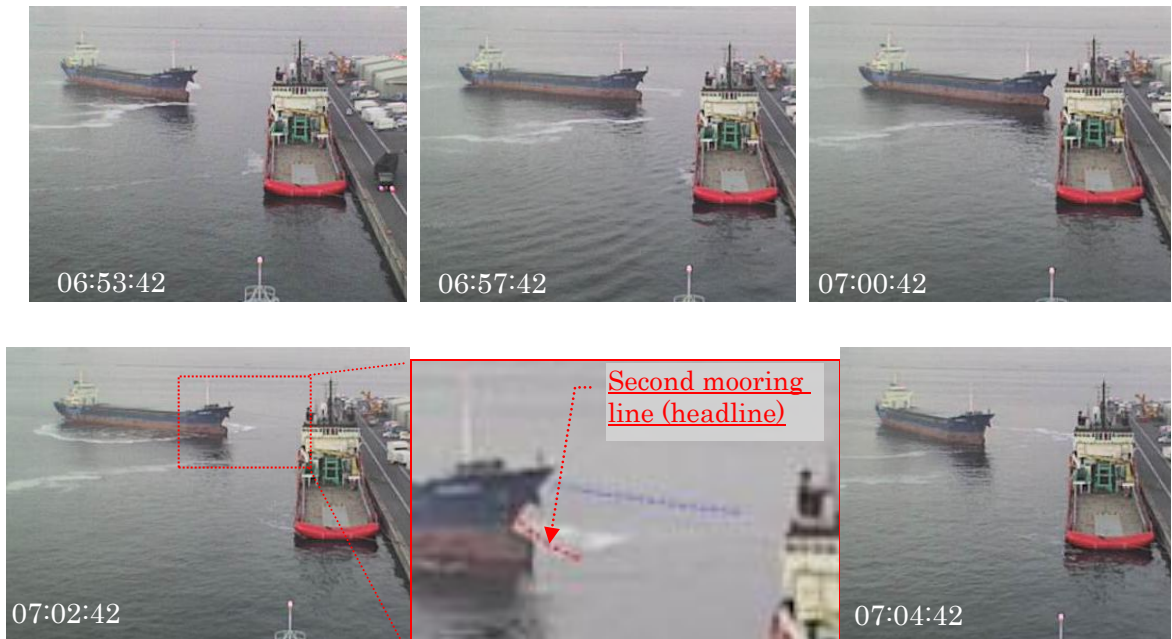
Figure 2.1-5 Images of the Berth (between 06:53:42 and 07:04:42)

(3) From around 06:53 to 06:59, the Vessel kept a distance of 30 meters to 40 meters from the Berth. At around 07:00, the Vessel approached the Berth and the second mooring line was sent out. Then, the Vessel went astern away from the Berth. (See Figure 2.1-5.)

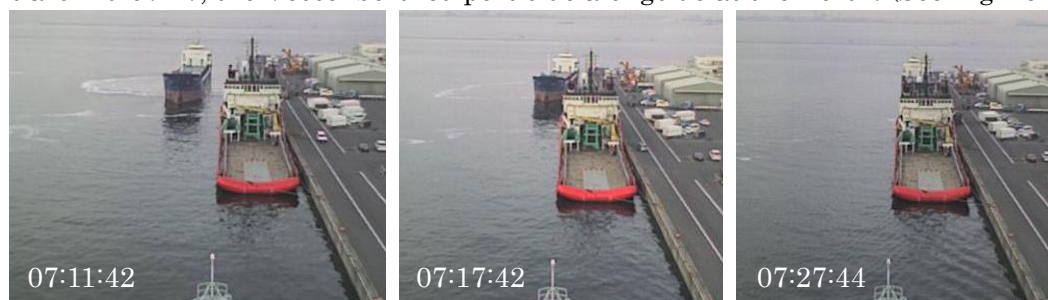
Figure 2.1-7 Images of the Berth (between 07:11:42 and 07:27:44)

(5) At around 07:27, the Vessel berthed port side alongside at the Berth. (See Figure 2.1-7.)

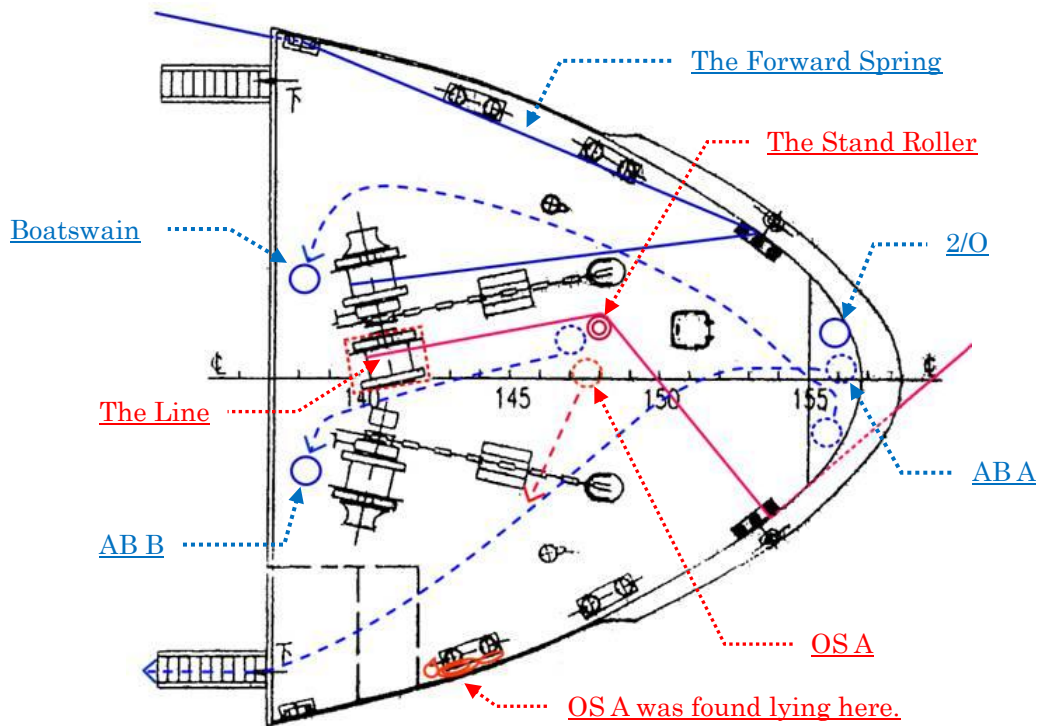
Figure 2.1-8 Crew positions at the forward station when the accident occurred

The crew assigned at the forward station found OS A lying along the starboard bulwark plating on the forecastle deck.

OS A was found lying along the starboard bulwark plating on the forecastle deck, with his head on the stern side and facing the port side. He was breathing with his eyes open. He was not bleeding. He looked pale and did not respond to any calls.

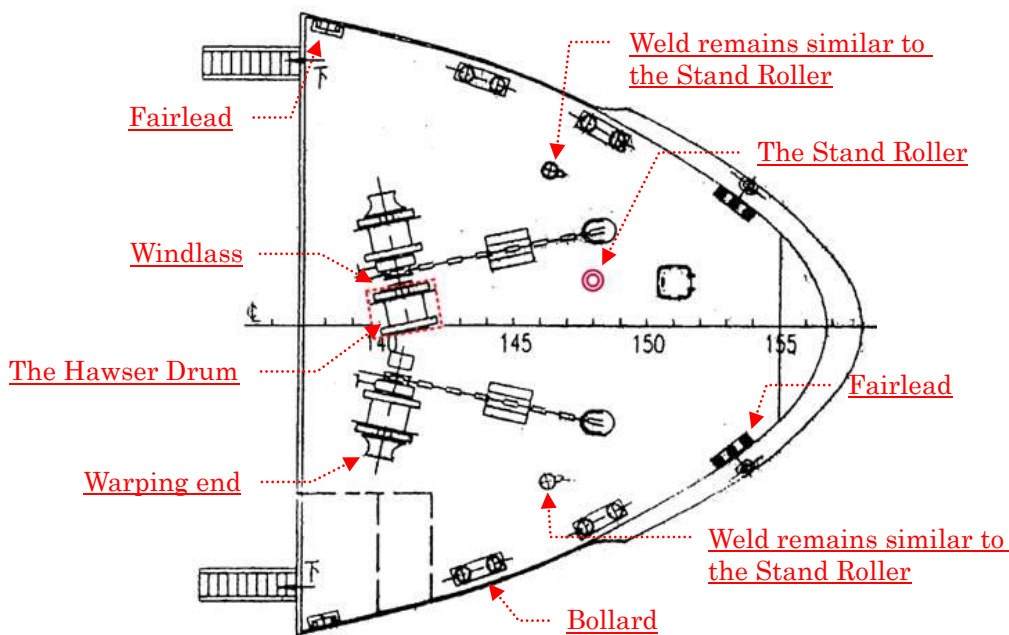
Figure 2.5-2 The Mooring Equipment on the Forecastle Deck

(3) The general arrangement plans of the Vessel shows mooring equipment around the center of both the port and starboard sides but no such equipment near the weld remains of the Stand Roller. The general arrangement plans does not show the Hawser Drum, either. The Stand Roller and the Hawser Drum are shown in Figure 2.1-8 and Figure 2.5-2.

- (1) When installing mooring or other equipment subjected to stress, the owner and the management company of the vessel must ensure that the equipment is designed, installed and reinforced properly in accordance with applicable regulatory requirements and must have the equipment surveyed by a classification society or other survey authorities.
- (2) When berthing the vessel, close communication must be maintained among those on board, especially between those maneuvering the vessel, including the engine, and those at the forward and at the stern to ensure coordinated actions.

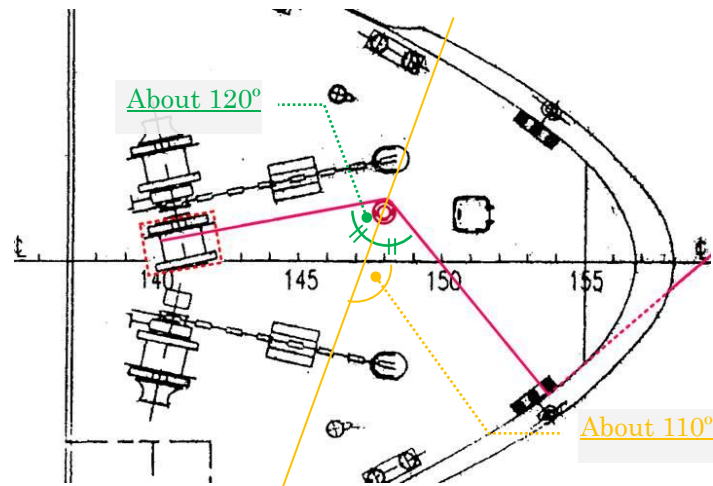
Figure 2.9-1 Direction of the horizontal force acting on the roller relative to the bow

$$\sigma_{eq} = (\sigma^2 + 3\tau^2)^{1/2} \geq \sigma_B$$

where σ_{eq} = equivalent stress, σ = bending stress, τ = shearing stress and σ_B = tensile strength. (See Figure 2.9-1.)
