MA2013-4

**MARINE ACCIDENT
INVESTIGATION REPORT**

Vessel type and name: Chemical tanker KYOKUHO MARU NO.2
Vessel number: 137077
Gross tonnage: 388 tons

Accident type: Fatality of a crewmember
Date and time: February 7, 2012, about between 12:26 to 12:29
Location: Sakai-senboku Section 7, Hanshin Port
Near 204° true, 2,600 m from the south lighthouse
at the south breakwater at Yamato River,
Sakai-senboku, Sakai City, Osaka, Japan
(Approximately 34°34.6'N, 135°23.1'E)

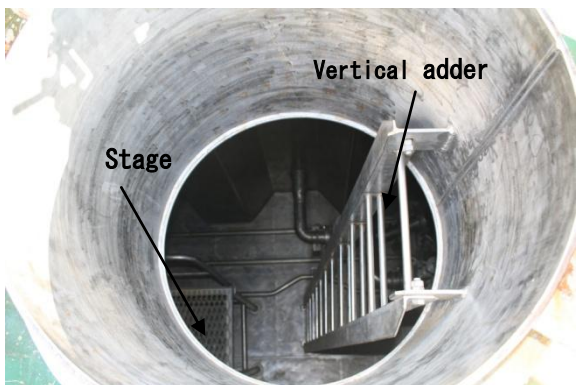
(Photo 2.5-2 Vertical Ladder)

The port No.1 cargo tank was equipped with cargo piping, suction piping for stripping, and a Butterworth washer. At the place 2 m down from the top of a vertical ladder extending from the manhole hatch to the cargo tank bottom, was the stage. The length of the vertical ladder was approximately 3.5 m, and the distance from the ladder bottom end to the suction well was approximately 5 m.

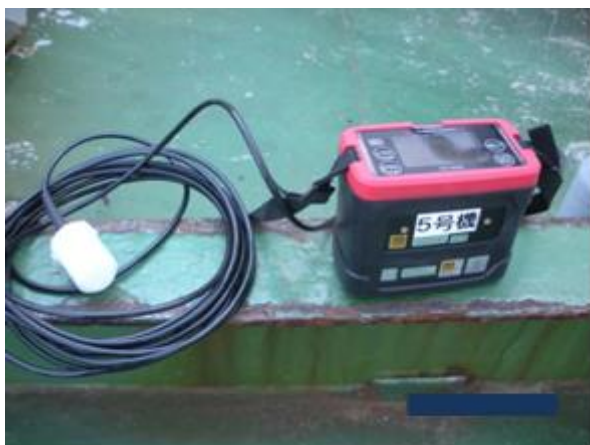
(Photo 2.5-6 Portable Detector)

The Ship was equipped with a portable detector and a pocketable detector for the measurement of oxygen and other gas concentration. The portable detector was for simultaneously measuring the lower explosion limit of combustible gas and oxygen concentration, while the pocketable detector was for simultaneously measuring the lower explosion limit of hydrogen sulfide, carbon monoxide and combustible gases, and oxygen concentration. They both had functions to indicate the measurements down to the first decimal place on their display and to audibly alarm if the measurement exceeds a set level. Although the both detectors were unable to measure incombustible gases, the crew of the Ship mistakenly thought that the detectors were able to measure the concentration of all gases including incombustible gases.

The oxygen and gas concentration detector manuals contained the statements requiring the users to check their specifications prior to the use of them and to apply them properly to applicable gases.
