**MARINE ACCIDENT  
INVESTIGATION REPORT**

Vessel type and name: Container ship PANCON SUCCESS

Accident type: Fatality of a crew member

Date and time: Around 20:25 on February 7, 2013

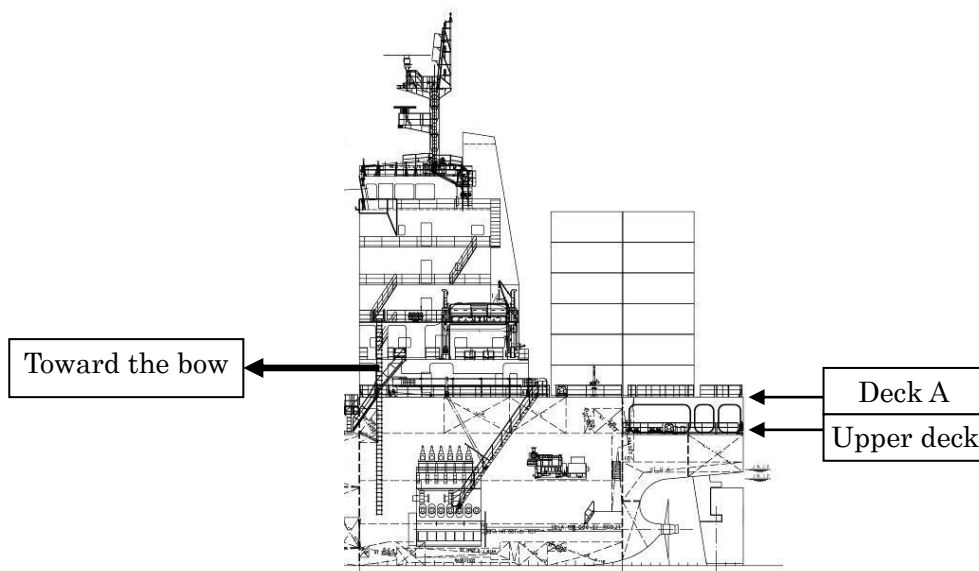
Figure 2-2 Arrangement of Stern

According to the questionnaire responses by the sole agency in Japan, the Vessel is a container ship of an aft bridge type having mooring equipment located in the stern section of the upper deck, and above which Deck A is provided for loading containers.

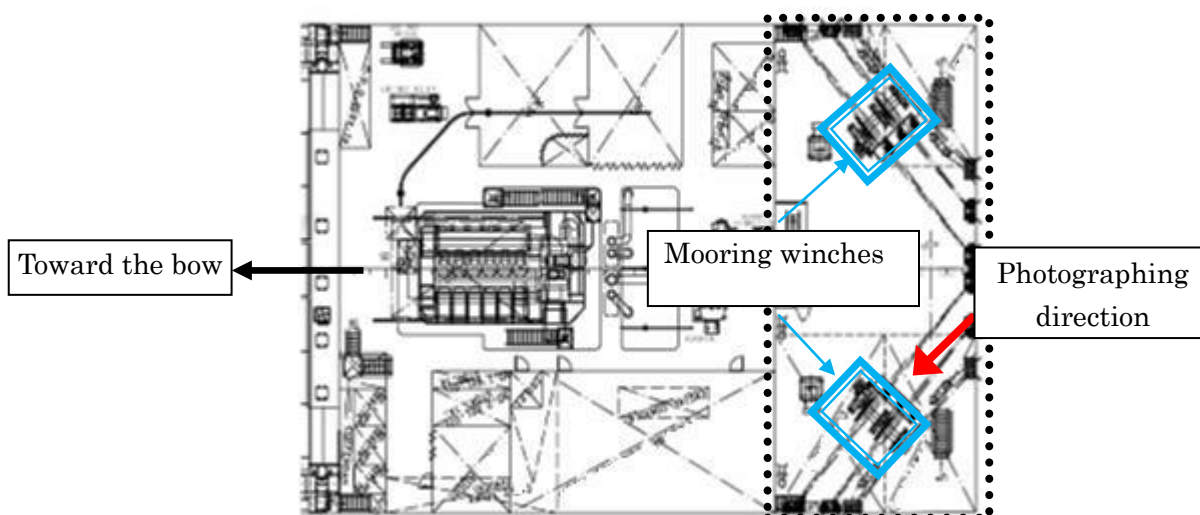
Figure 2-3 Arrangement of Mooring Winches

At the time of the accident, the C/O was operating the mooring winch on the port side; he disengaged the clutch of the winch's starboard side hawser drum while applying its brake and engaged the clutch of the portside hawser drum while releasing its brake.
