MA2015-1

**MARINE ACCIDENT
INVESTIGATION REPORT**

Vessel type and name: Cargo ship JNS-2
IMO number: 8869701
Gross tonnage: 1,500 tons

Accident type: Collision (contact with fishing gear)
Date and time: At around 11:01 on March 8, 2012
Location: Off the west of Iwaishima, Kaminoseki-cho, Yamaguchi Prefecture
On a true bearing of around 255°, at a distance of 8.4 nautical miles from the
Iwaishima Lighthouse (Approximately 33°44.9'N, 131°49.8'E)

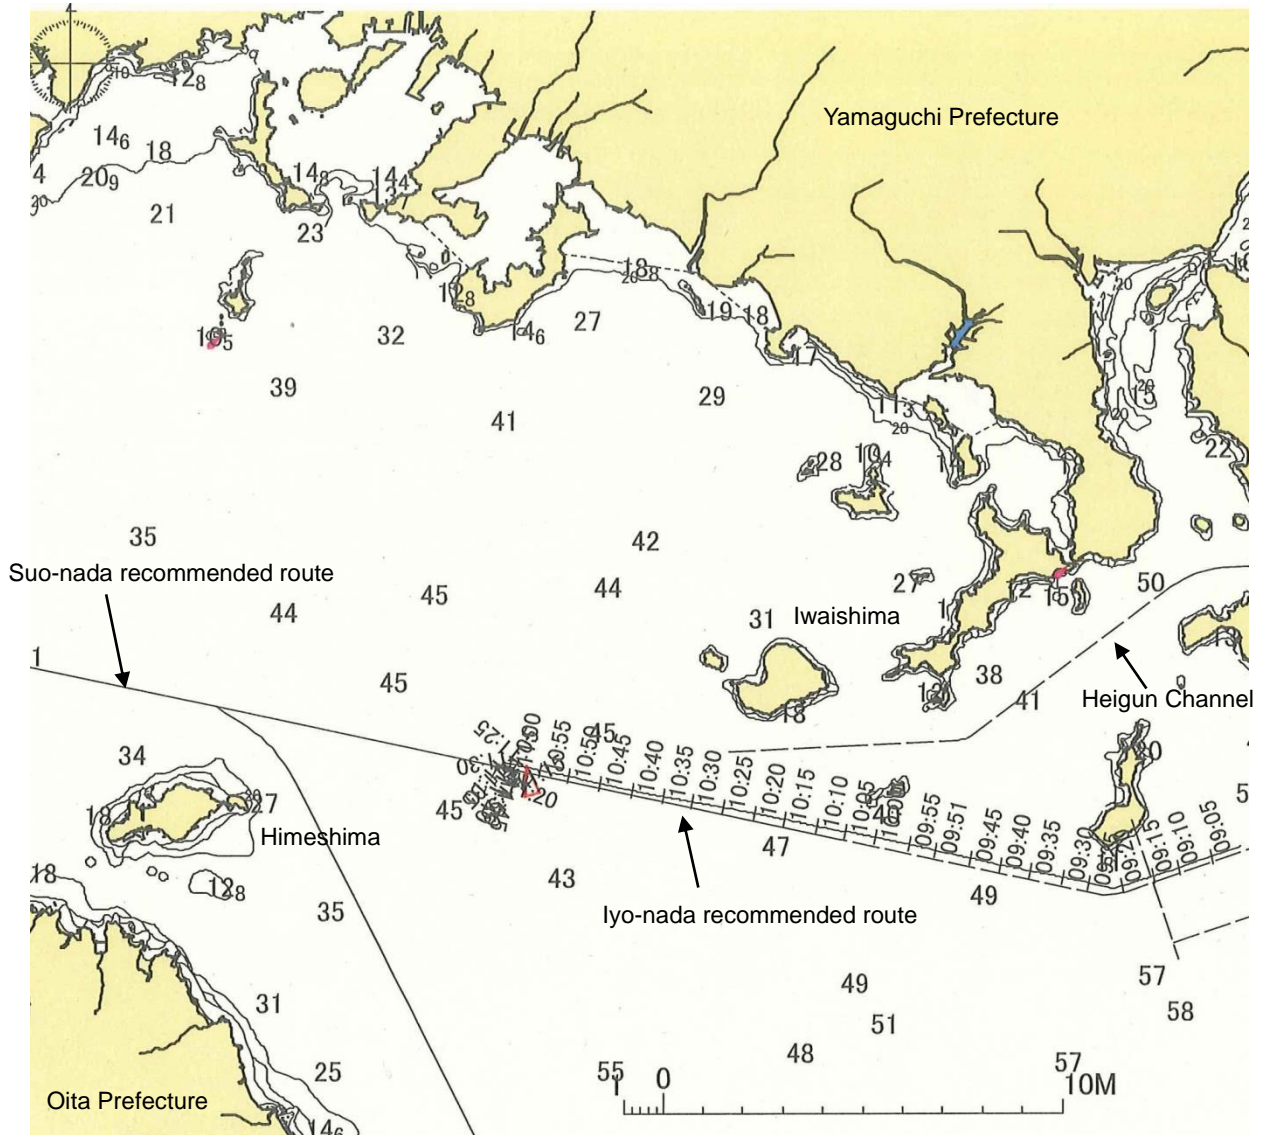
Figure 1 Vessel A's Track According to AIS Records

(See Figure 1: Vessel A’s Track According to AIS Records.)

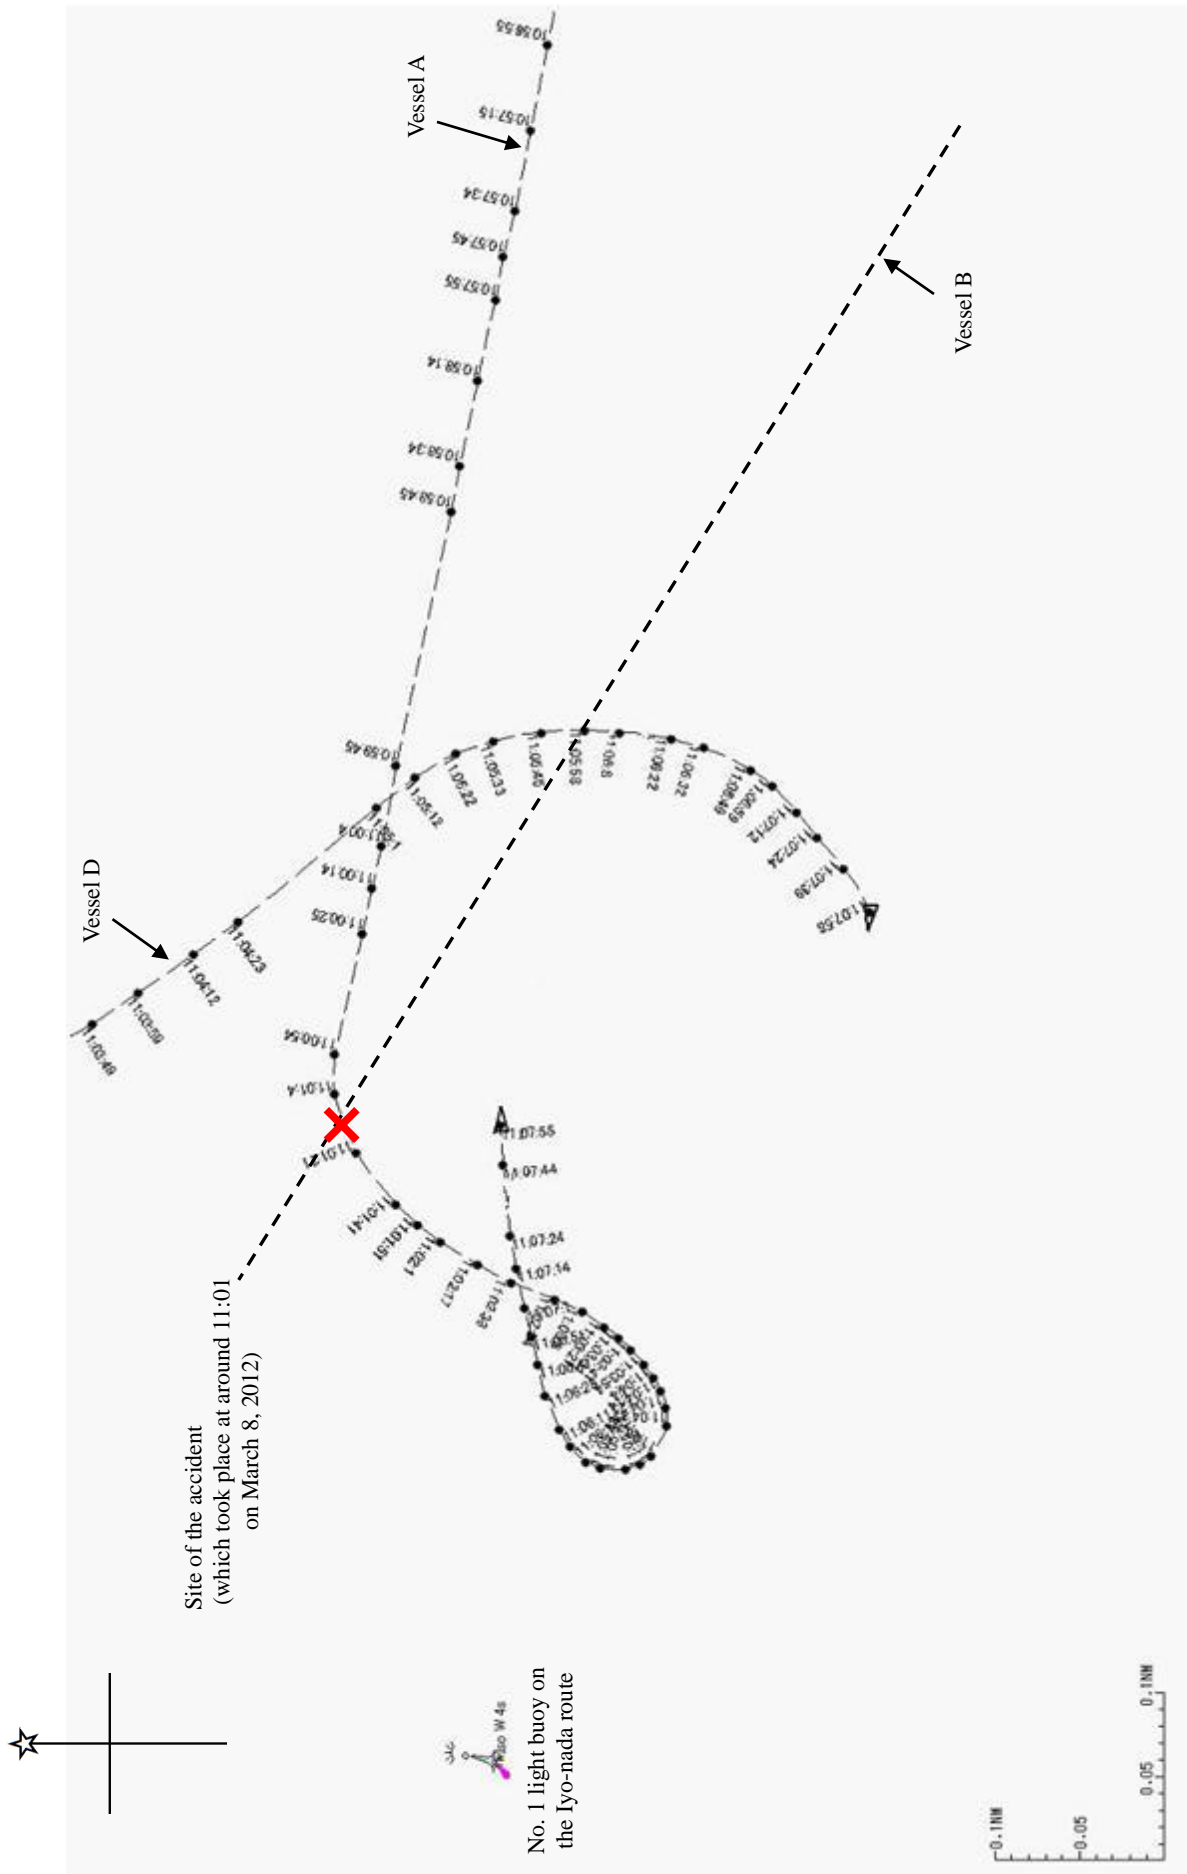
Figure 2 Estimated Tracks

The accident occurred at around 11:01 on March 8, 2012, at approximately 255°, 8.4 M from the Iwaishima Lighthouse. (See Figure 2: Estimated Tracks.)
