**MARINE ACCIDENT
INVESTIGATION REPORT**

MARINE ACCIDENT INVESTIGATION REPORT

Vessel type and name: Cargo ship JIA HUI

Accident type: Collision

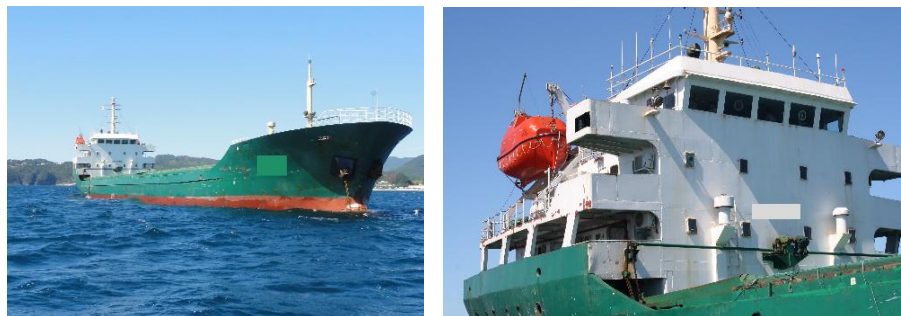
Photo 2.1-1 Vessel A

Officer A found the port side light of Ship B approaching closely, recognized for the first time that Vessel A would collide with Ship B, shifted the engine to neutral, and held the wheel by himself to steer hard starboard, but-Vessel A collided with Ship B.

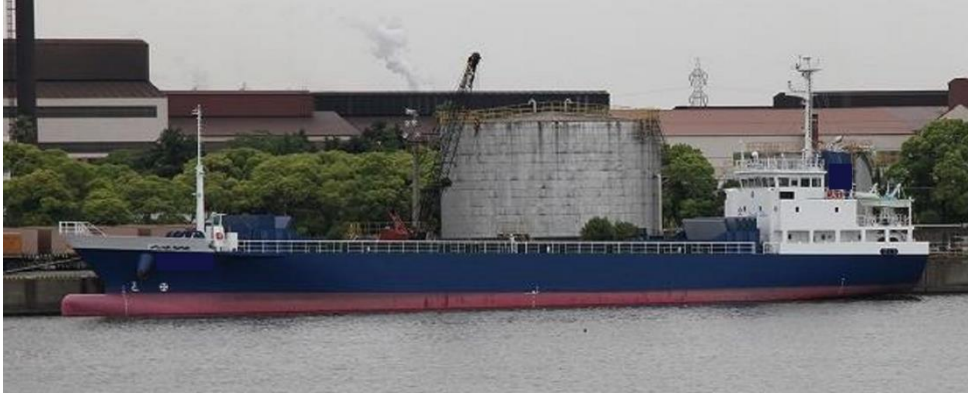
Photo 2.1-2 Ship B

Ship B, with the master (hereinafter referred to as “Master B”), the chief officer (hereinafter referred to as “Chief Officer B”), and 4 other crew members on board, left Nagoya Port, Aichi Prefecture for Chiba Port, and while sailing northeast off the west of Izu Oshima, collided with Vessel A.

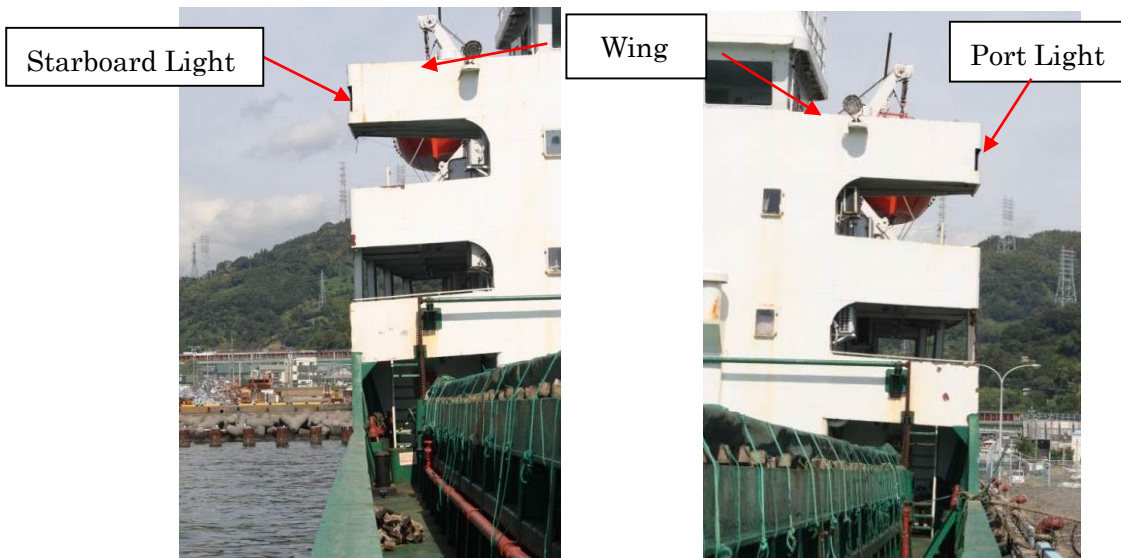
Photo 2.5-3 Installation of the Sidelights

- (1) Vessel A had the sidelights installed in front of both edges of the bridge wing, and the expansion work of the bridge wing to engage on international voyage was performed at the dockyard in the People's Republic of China from December 2012 to April 2013.
- (2) When the sidelights of Vessel A were removed once due to the expansion work, and then restored, although the horizontal shine range of the sidelights (hereinafter referred to as "specified value") specified by the international rules on preventing collision at sea was 22.5° of abeam from each straight heading, the bow direction was hidden by the inner partition in the front, and the sidelights could not be sighted in the range of about 5.4° on the starboard side and about 3.3° on the port side from the front of the straight heading. (See Photo 2.5-3, Photo 2.5-4, Figure 2.5-3, Figure 2.5-4)

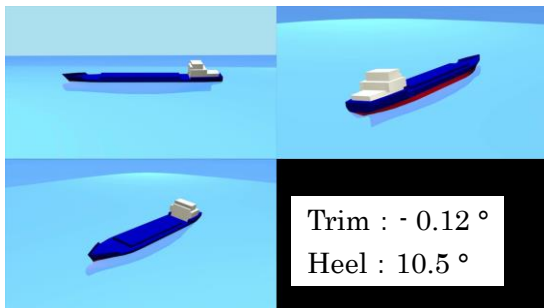
Figure 2.10-7 1 Minute after Flooding Started

Sinkage increased sharply when the flooding started, and as the difference between the sea surface and the water level in the ship became smaller, it increased at an almost constant ratio afterwards and reached about 1.2m after 1 minute, about 1.9 m after 2 minutes, and about 2.4m after 3 minutes.

Before 1 minute after Vessel A moved away, Ship B sank rapidly, listed sideways about 10.5° further to the port, then the sinkage and listing to the port side increased further; the port edge on the deck reached to sea level after 2 minutes, the port deck was under the water after 3 minutes, and a large part of the hull was under water after 3 minutes and 30 seconds.
