MA2016-10

**MARINE ACCIDENT
INVESTIGATION REPORT**

Accident type	Fatality of a crew member
Date and time	Around 22:15 on October 14, 2015 (local time, UTC+9 hours)
Location	Soma Port Berth 5, Fukushima Prefecture On a true bearing of approximately 251° and at a distance of 0.7 nautical miles (M) from North Breakwater Lighthouse, Soma Port (approximately 37° 51.3' N, 140° 57.2' E)
Summary of the Accident	<p>At around 22:15 on October 14, 2015, while the cargo ship ASIAN INFINITY was moored at Soma Port Berth 5 for cleaning work inside the cargo hold with the master and 16 other crew members (all nationals of the Republic of the Philippines) on board, the third officer fell from the 2nd deck of the No.2 cargo hold into the lower cargo hold.</p> <p>The third officer was taken to hospital, where he was pronounced dead.</p>
Process and Progress of the Investigation	<p>(1) Set up of the Investigation The Japan Transport Safety Board appointed an investigator-in-charge and two other marine accident investigators to investigate this accident on October 15, 2015.</p> <p>(2) Collection of Evidence October 16 and 17, November 4, 5, 17 and 26: On-site investigations and interviews</p> <p>(3)

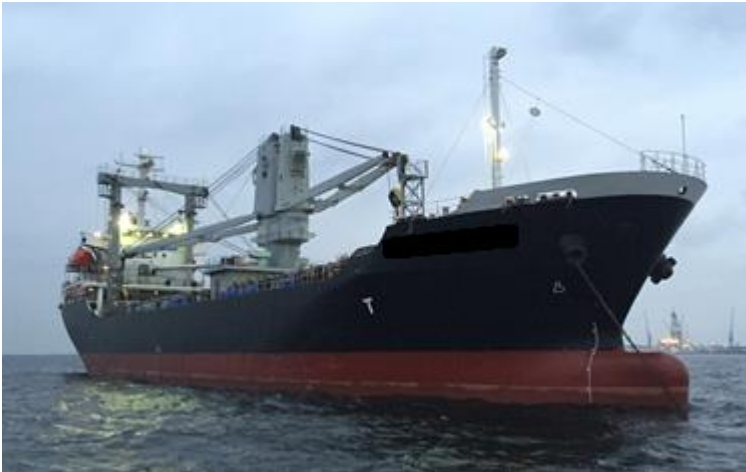
<p>Photo 1 ASIAN INFINITY</p>
<p>Information on the cargo hold, etc.</p>	<p>ASIAN INFINITY (hereinafter referred to as “the vessel”) had two cargo holds numbered 1 and 2 in order from the bow. Each cargo hold had pontoon hatch covers (hereinafter referred to as “hatch covers”) installed at the 2nd deck opening, enabling each cargo hold to be divided into upper and lower parts.</p> <p>Twelve hatch covers were laid inside the No.2 cargo hold, and when loading with bulk cargoes, a chain block was used to raise the hatch covers, move them toward the bow and stern and fasten them there.</p> <p>(See Photos 2 and 3)</p>
