MA2017-7

**MARINE ACCIDENT
INVESTIGATION REPORT**

Vessel type and name: Passenger Ship "BEETLE"

Accident type: Collision

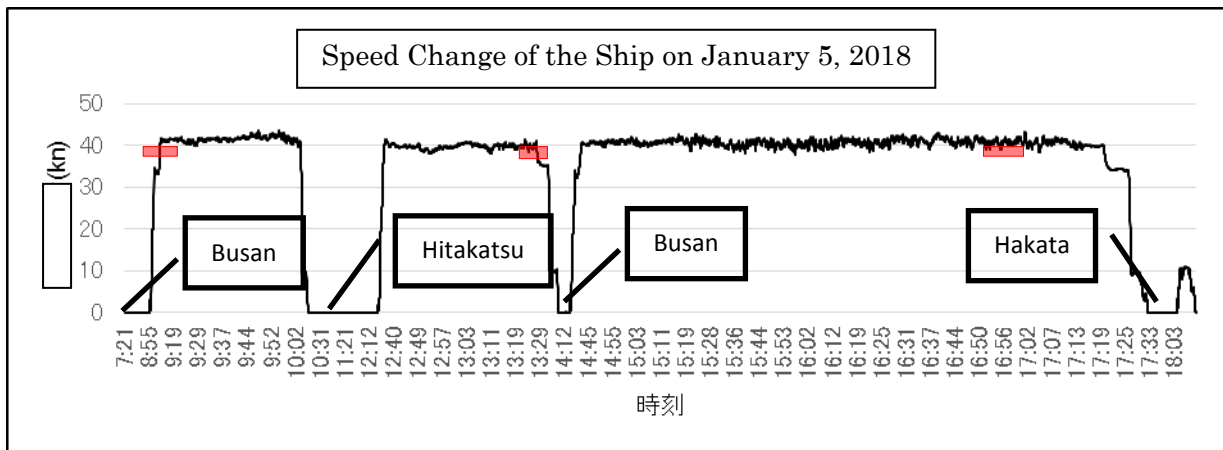
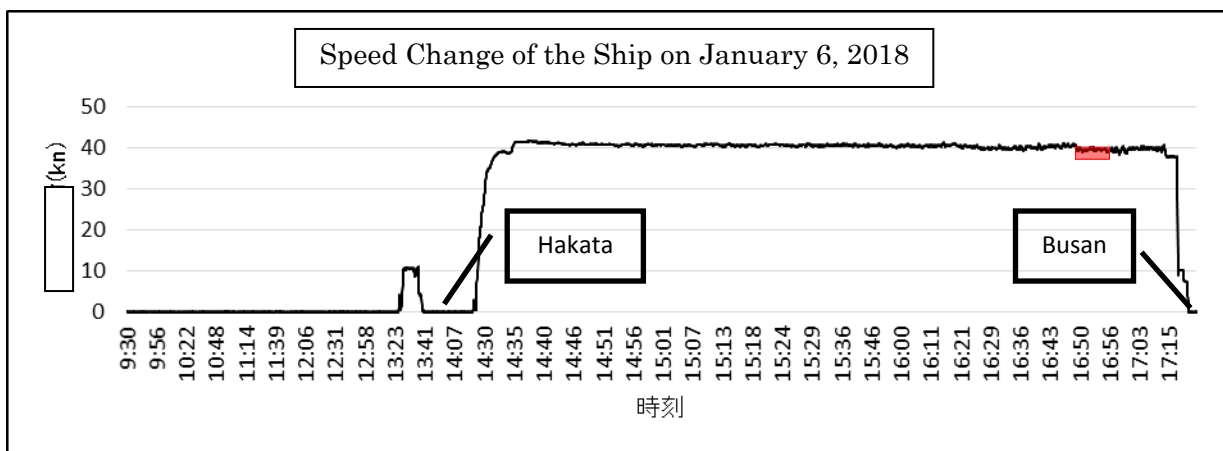
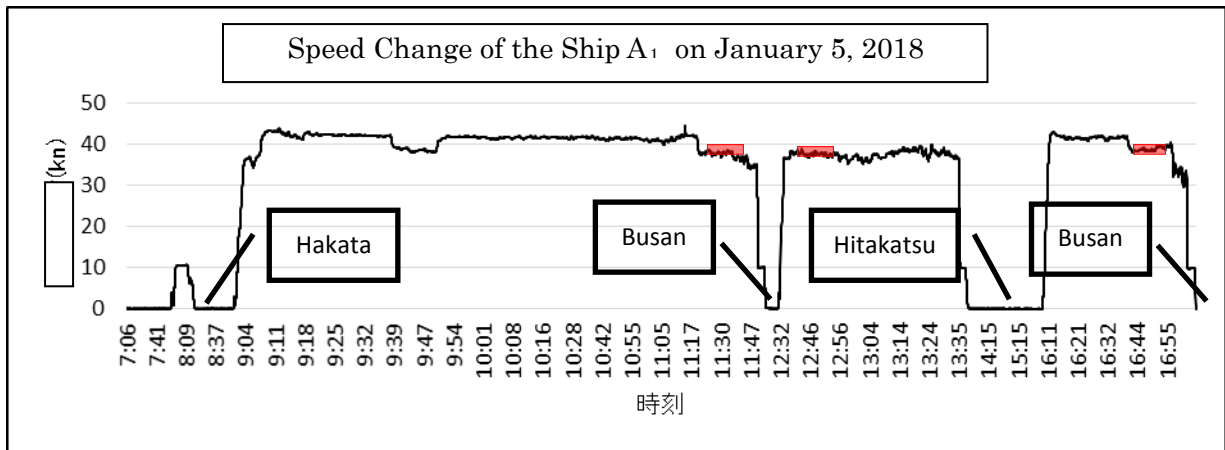
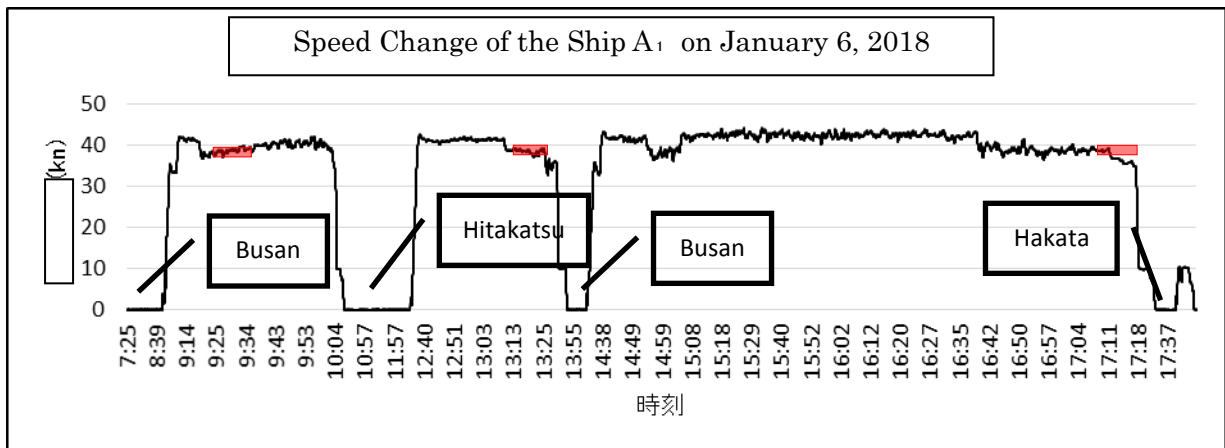
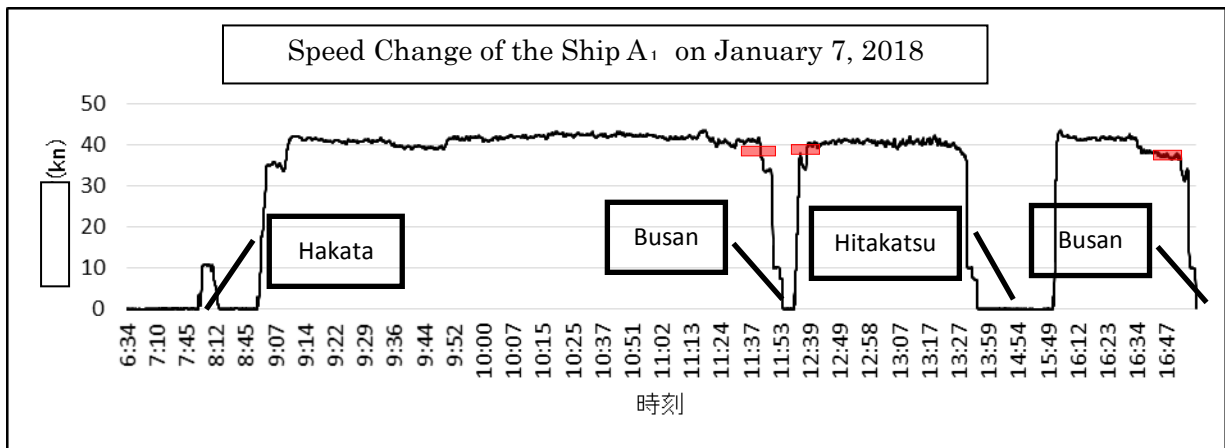
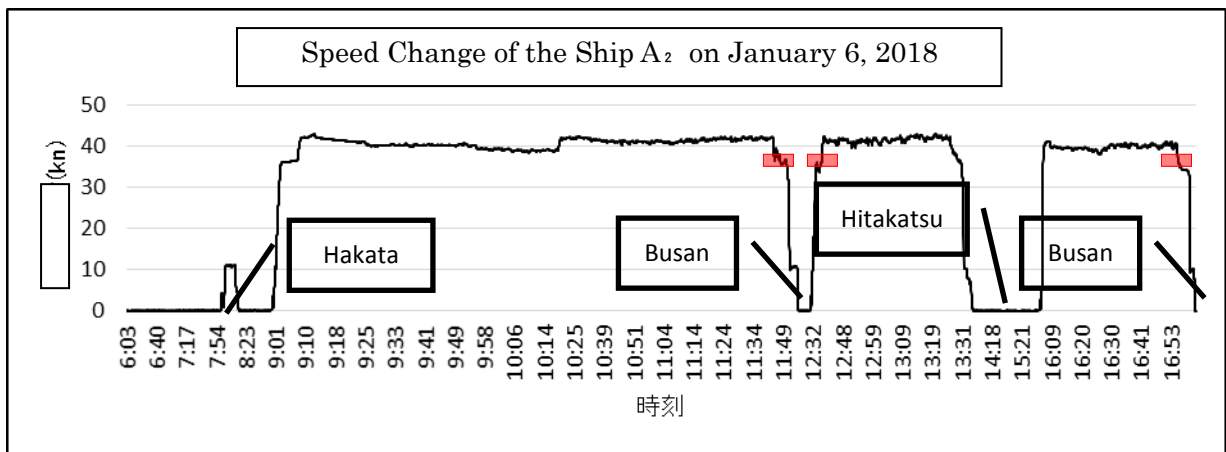
Attached Figure 8 Speed Change Graphs of Passenger Ships of Company A

※ The vertical length and the horizontal length of ■ indicate an estimated passage time of decelerated navigation area and 38 – 36 kn which are designated decelerated speeds respectively.
