**MARINE ACCIDENT  
INVESTIGATION REPORT**

Vessel type and name: Chemical Tanker EASTERN PHOENIX

Vessel type and name: Oil Tanker KEIHIN MARU No. 8

Accident type: Collision

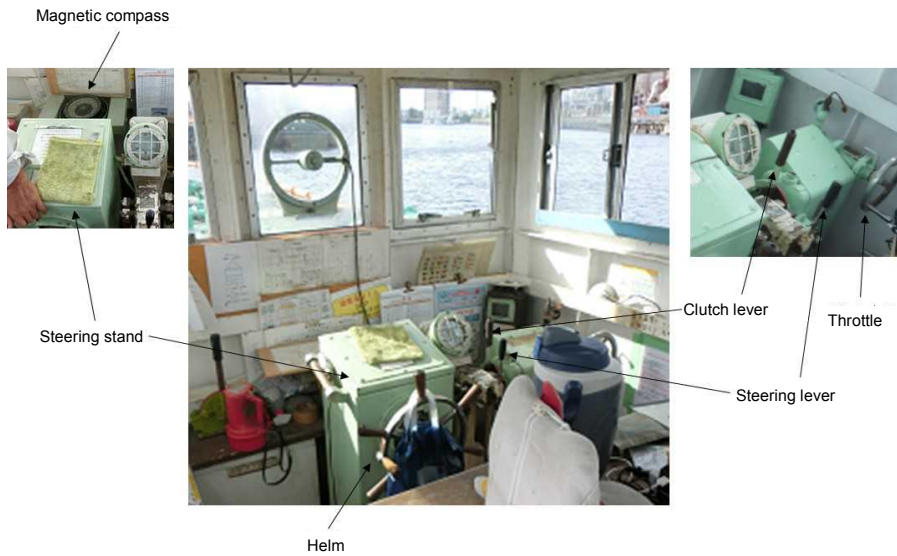
Photo 2.5-3 Vessel B's Wheel House

According to the statement of Master B and the reply to the questionnaire by Company B<sub>2</sub>, Vessel B's whistle (air horn) was in a state that did not permit its immediate use at the time of the accident, as there was a leak in the air tube that supplies air to the whistle and, consequently, the tube's valve in the engine room had been shut. However, other than said air tube, there was no malfunction or failure with the hull, engine, or machineries of the vessel. (See Photo 2.5.3)

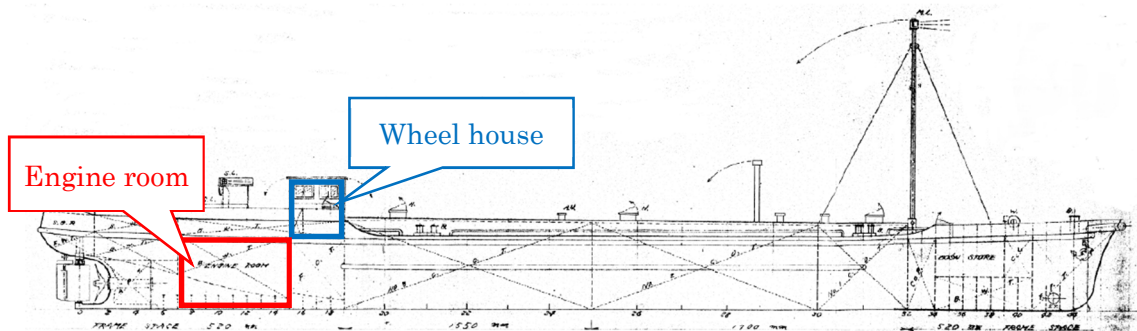
Figure 2.8-2 Locations of Vessel B's Wheel House and Engine Room

According to Vessel B's general arrangement, Vessel B's wheel house was adjacent to the engine room.

It should be noted that, according to a literary source<sup>\*13</sup>, *“The average noise level of an engine room reaches around 100 to 105 dB(A), having little to do with the size of the vessel or the size of the main engine's output.”*

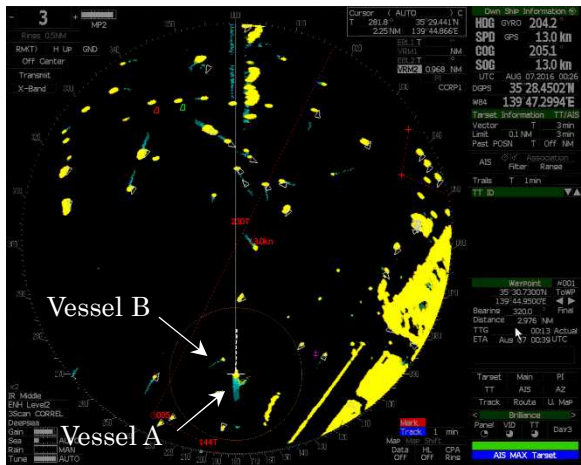
(11) Around 09:26:25

- 4) Given that Master A thought that Vessel A could pass ahead of Vessel B's bow when he first observed Vessel B but then questioned Vessel B's movements at around 09:26:25, it is probable that he sensed the danger of collision with Vessel B and gave the whistle seven short blasts from around 09:26:32.
