**MARINE INCIDENT
INVESTIGATION REPORT**

January 25, 2018

MARINE INCIDENT INVESTIGATION REPORT

Incident type	Unnavigable state (hull list)
Date and time	Around 12:00 on January 11, 2017 (local time, UTC+9 hours)
Location	Off the north of Oshima Island, Munakata City, Fukuoka Prefecture (approximately 33°56.3'N, 130°25.3'E)
Summary of the Incident	While cargo ship TONG DA was proceeding east-northeast in Genkai-nada, with a master and 13 other crew members onboard, her hull listed to port and she was intentionally run aground. TONG DA had seawater damage to her engine, cargo, etc.
Process and Progress of the Incident Investigation	The Japan Transport Safety Board (hereinafter referred to as "JTSB") appointed an investigator-in-charge and two other investigators to investigate this incident on January 13, 2017. January 13, 14 and May 22, 2017: Interviews January 15, 17, 18 and April 25, 2017: On-site investigations April 10, 21 and May 26, 2017: Collection of questionnaire Comments on the draft report were invited from parties relevant to the cause of incident.

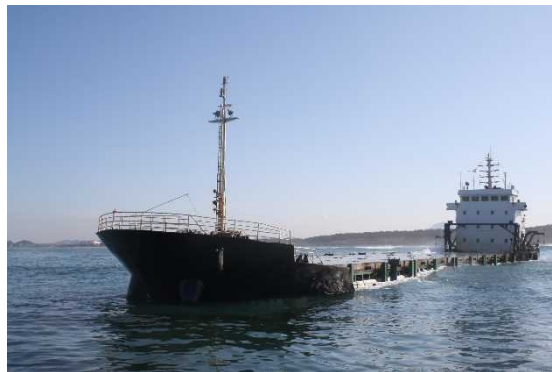
Photo 1 The Vessel

The Vessel was a cargo ship with a forecastle and poop and aft engine. Her hull had a No. 1 cargo hold and a No. 2 cargo hold arranged in order from the bow. Ballast tanks were arranged beneath the No. 1 and No. 2 cargo holds. Cofferdams were arranged along the shell plating on both sides of the cargo holds. (See Photo 1 and Figure 1)
