**MARINE ACCIDENT
INVESTIGATION REPORT**

Vessel type and name: Cargo Ship REAL

Accident type: Grounding

Date and time: Around 00:15, October 23, 2017 (local time, UTC+9 hours)

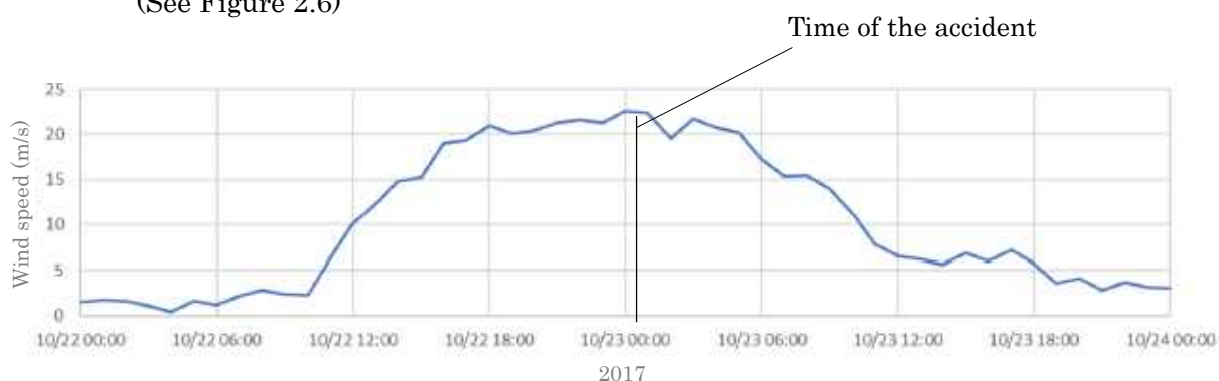
Figure 2.6 Changes in Wind Speed within the Port

Wind direction: NNE. Wind speed: 22.6 m/s

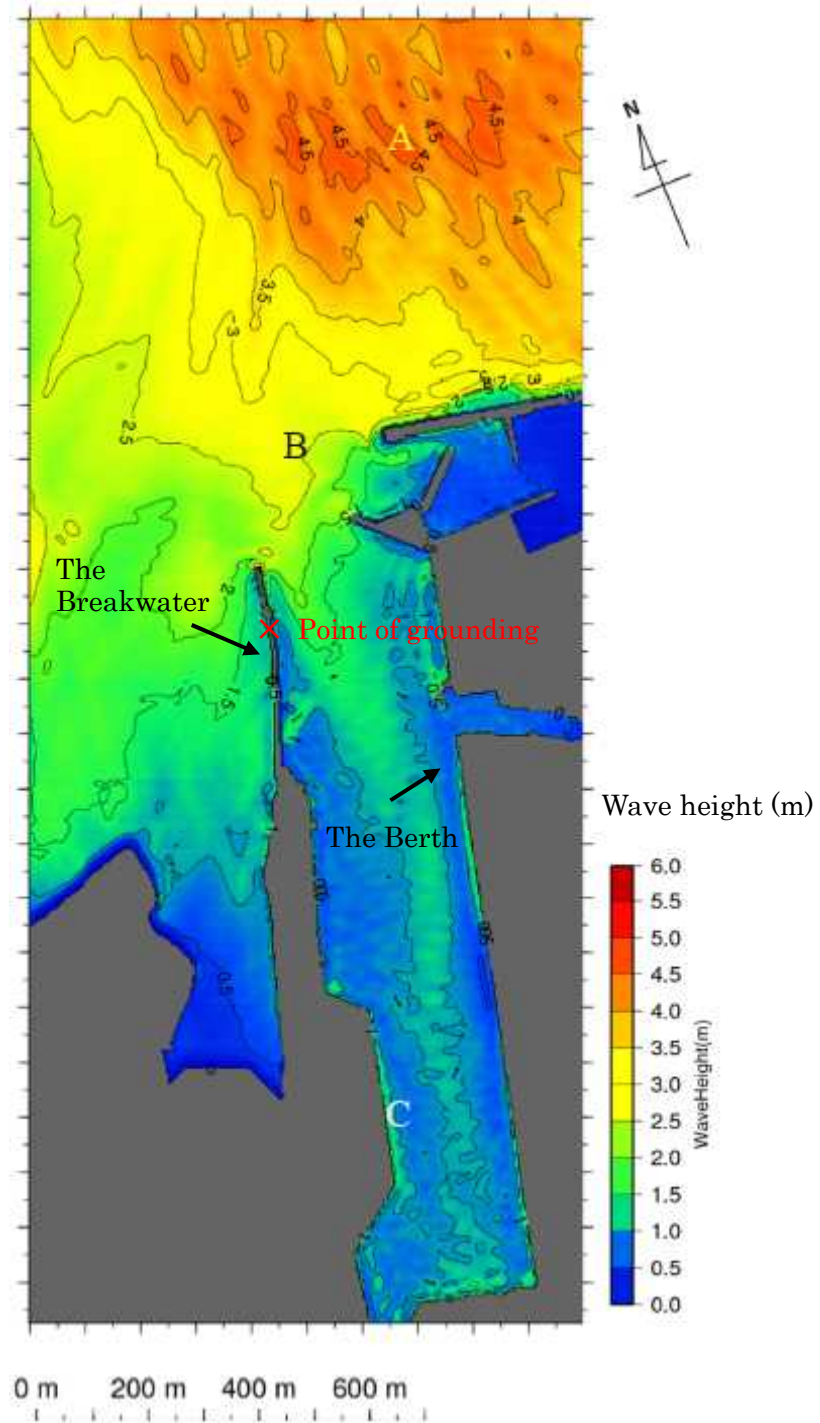
Annex Figure 6 Wave Height in the Port

- 1) Vicinity of the Berth when the first aft mooring rope broke (around 22:38 on October 22)
Wave direction: NNE; Wave height: 0.92 m; Period: 8.2 seconds
- 2) Vicinity of the port's back area after all of the mooring ropes had broken (around 23:56 on October 22)
