MA2019-7

**MARINE ACCIDENT
INVESTIGATION REPORT**

MARINE ACCIDENT INVESTIGATION REPORT

Accident type	Fatality of a stevedore
Date and time	Around 11:14 on January 6, 2019 (local time, UTC+9 hours)
Location	T1 berth of Nabeta wharf, Yatomi city, Aichi Prefecture On a true bearing of approximately 283° and at a distance of 1,400 meters from Nagoya port west passage No.8 light beacon (approximately 35° 01.5' N, 136° 47.8' E)
Summary of the Accident	At around 11:14 on January 6, 2019, while the container vessel HARRIER was moored at the Nabeta wharf, with the master and 17 crew members on board, 7 stevedores were loading containers to the vessel, and a stevedore who was serving as assistant wireless signal person and communicating the conditions of unloading and loading containers by radio apparatus got caught between two containers, then the stevedore was pronounced dead by a doctor.
Process and Progress of the Investigation	<p>(1) Set up of the Investigation The Japan Transport Safety Board appointed an investigator-in-charge and a marine accident investigator to investigate this accident on February 27, 2019, and later appointed a marine accident investigator in addition.</p> <p>

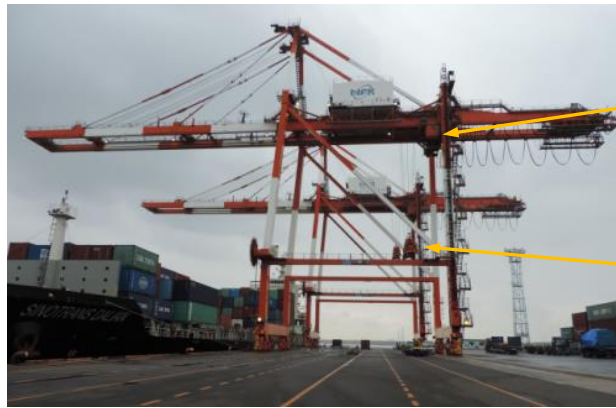
Figure 2 The GC

GC operator A responded to this information, and at that moment diverted his attention to the preparations for the next stage of loading container execution works. He started hoisting the spreader*³ with a hoisting speed of 3 notch by the GC in the situation where the spreader twist locks had not been released from the upper 4 corner metal shoes’ parts of the Container. At that precise moment, he realized that there was something wrong with the hoisting of the Container and stopped hoisting the Container immediately.

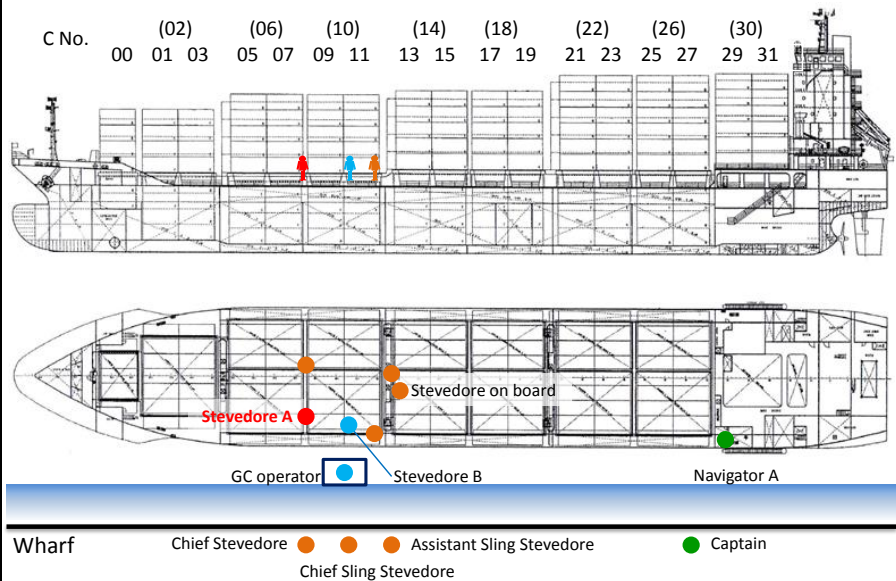
Figure 3 Position of crew members and stevedore group in general arrangement

At around 11:14, Stevedore A was on board around the port side of the passage between No. 07 and No. 09 of the container location number (hereinafter referred to as “C No.”), Stevedore (wireless signal person) (hereinafter referred to as “Stevedore B”) was on board around the port side of C No. 09, and GC operator A was in the operation seat of the GC.

The Container was suddenly pulled from the mid locks and was lifted up, then was swung to aft side by the impact of being pulled and lifted by the GC and bumped to the aft side container (C No. 11) which had already been loaded and the container (C No.11) was damaged recessed part. By the repercussion of the bumping, the Container was swung to the fore side and bumped into the fore side container (C No. 07), which had also already been loaded.

After this, other stevedores on board found out Stevedore A which had been caught between the Container and the loaded container (C No. 07), then he leaned to the fore side container, stood and faced the aft side, was injured when leaving the Container. However, nobody saw the precise moment when the accident occurred.

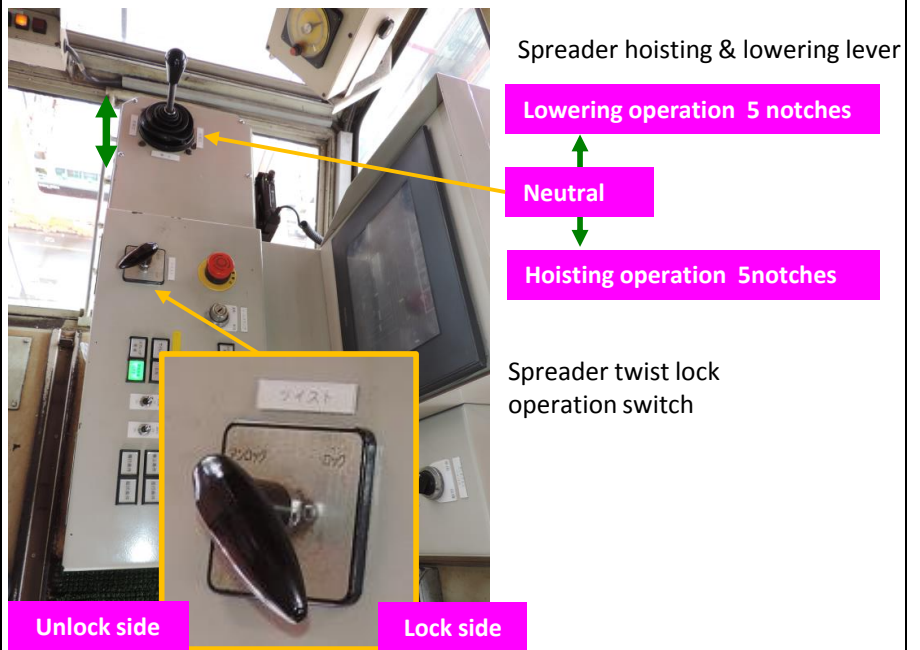
Figure 6 The GC operation panels

indication lamps for the operating conditions of spreader twist locks and grounding container (hereinafter referred to as “indication lamps”) on the top of spreader used to be set in the land side of the spreader and usually adopted a type of rotary lamp.

In the on-site investigation it was found out that the indication lamps were set to the sea side of the spreader of the GC and adopted common lamp lights, so it was difficult to see the light condition due to the incidence of daylight.
