MA2020-7

**MARINE ACCIDENT
INVESTIGATION REPORT**

Vessel type and name: Container vessel OOCL NAGOYA

Accident type: Collision

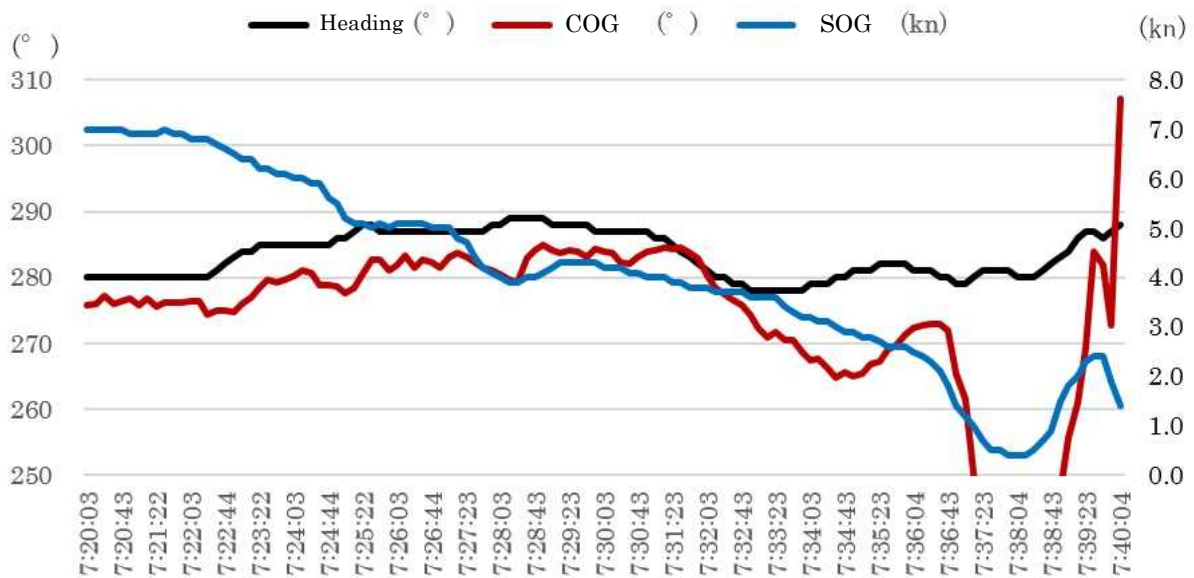
Figure 1 Changes in Speed over the ground (SOG), Course over the ground (COG), and Heading based on AIS records.

Changes in heading, course to ground, and ground speed from 07:20:03 to 07:40:04 in the AIS record were as shown in Figure 1.

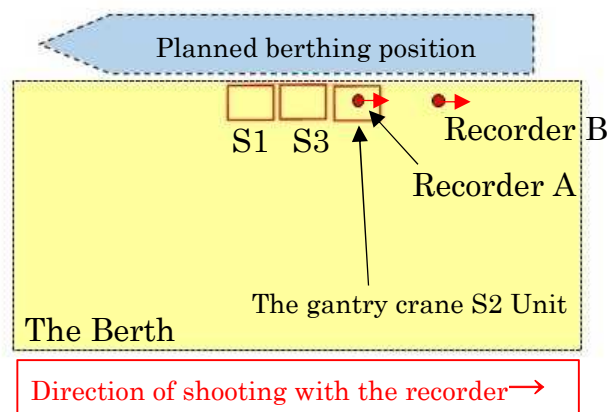
Figure 2 Approximate position of drive recorders

The drive recorder mounted on the vehicle located at 34.9917° north latitude and 136.6655° east longitude is referred to as "Recorder A", and that mounted on the vehicle located at 34.9915° north latitude and 136.6660° east longitude is referred to as "Recorder B".

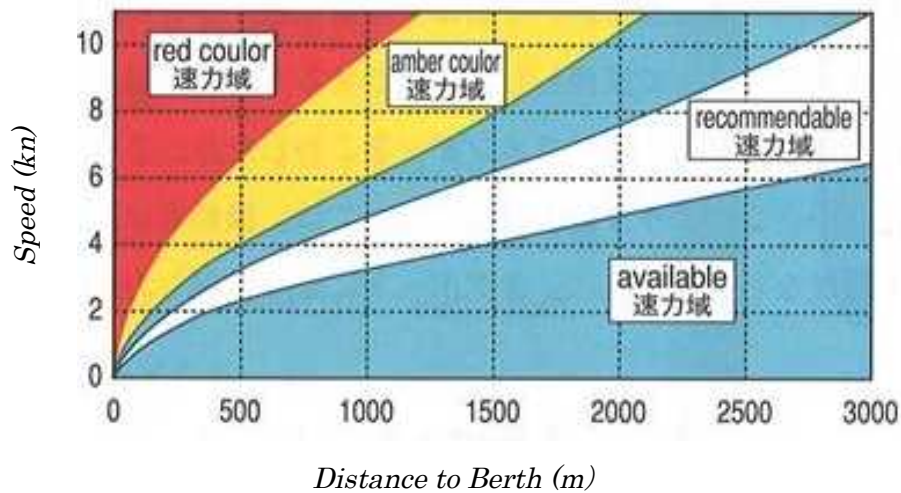
Fig. 3.1.21 shows the guidelines for the ship speed reduction for approach maneuvering of each type of vessel.

In the available speed area, two-thirds of the total pilots are also aware of the safety margin from 0.3 to 0.6. The fact that many pilots concentrate on this area probably suggests that this speed area is the most practical, based on the pilots' long experience. In that sense, here, this speed area is referred to as a recommendable speed area. However, in the available speed area, the safety margin is in the range of 0 to 0.3 based on the braking force of Dead Slow Astern. Some pilots responded that they set the ship speed reduction plan in a somewhat bold manner, with a speed area where the safety margin is lower than 0.6 based on the braking force of Dead Slow Astern, while other pilots answered that they set the speed reduction plan quite carefully. These areas sandwiching the recommendable speed area are positioned in "available" but not "recommendable".

- (3) It is considered probable that at around 07:36, the Vessel had a speed of 2.5 kn, a distance of approximately 260 meters to the planned berthing place and was in the available speed area of *Fig. 3.1.21*, so that the ship speed and the Vessel's attitude were able to be controlled.

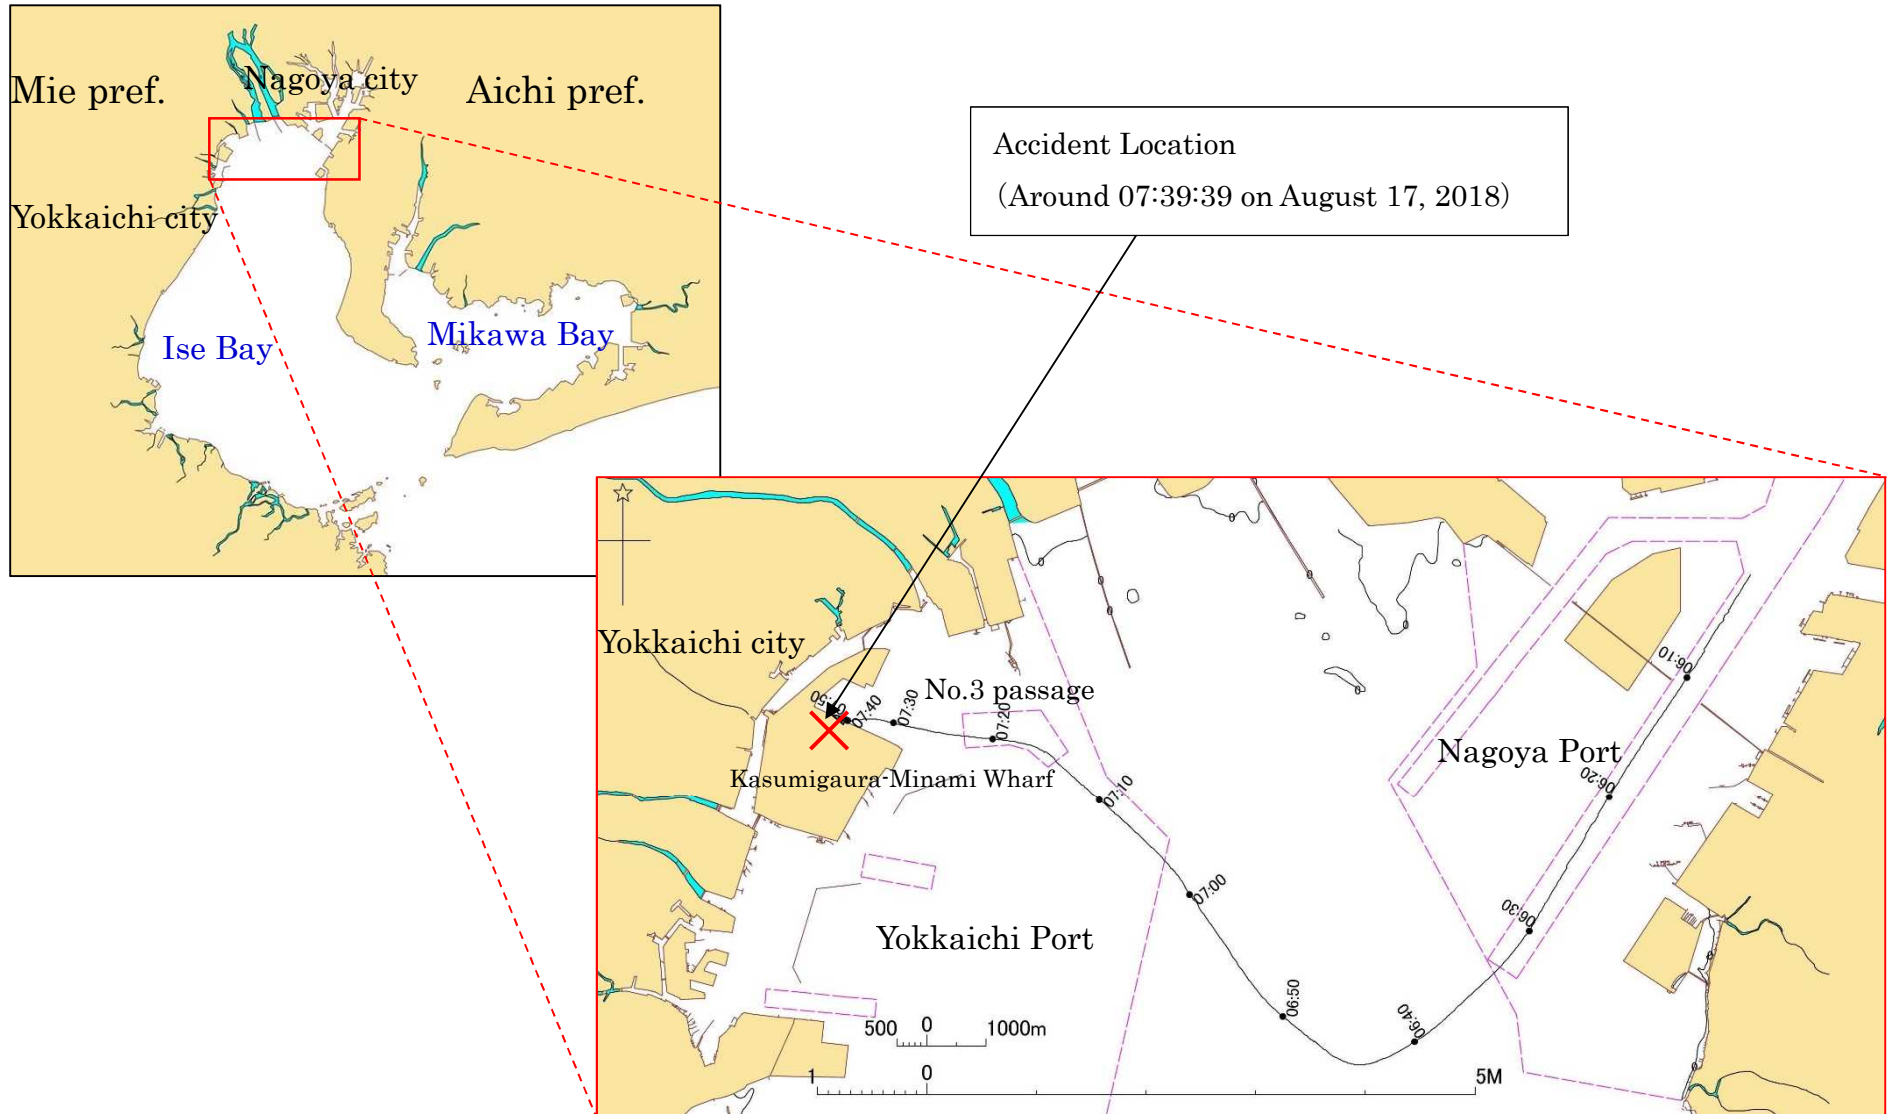
Annex Figure 1: Navigation path

The date and time of occurrence of the accident were at around 07:39:39 on August 17, 2018, and the location was approximately 149° true bearing, 480 meters from Yokkaichi Port Management Association Kasumigaura No.1 range light (front light)
(See Annex Figure 1 Navigation path and Annex Figure 2 Navigation path in Yokkaichi Port)

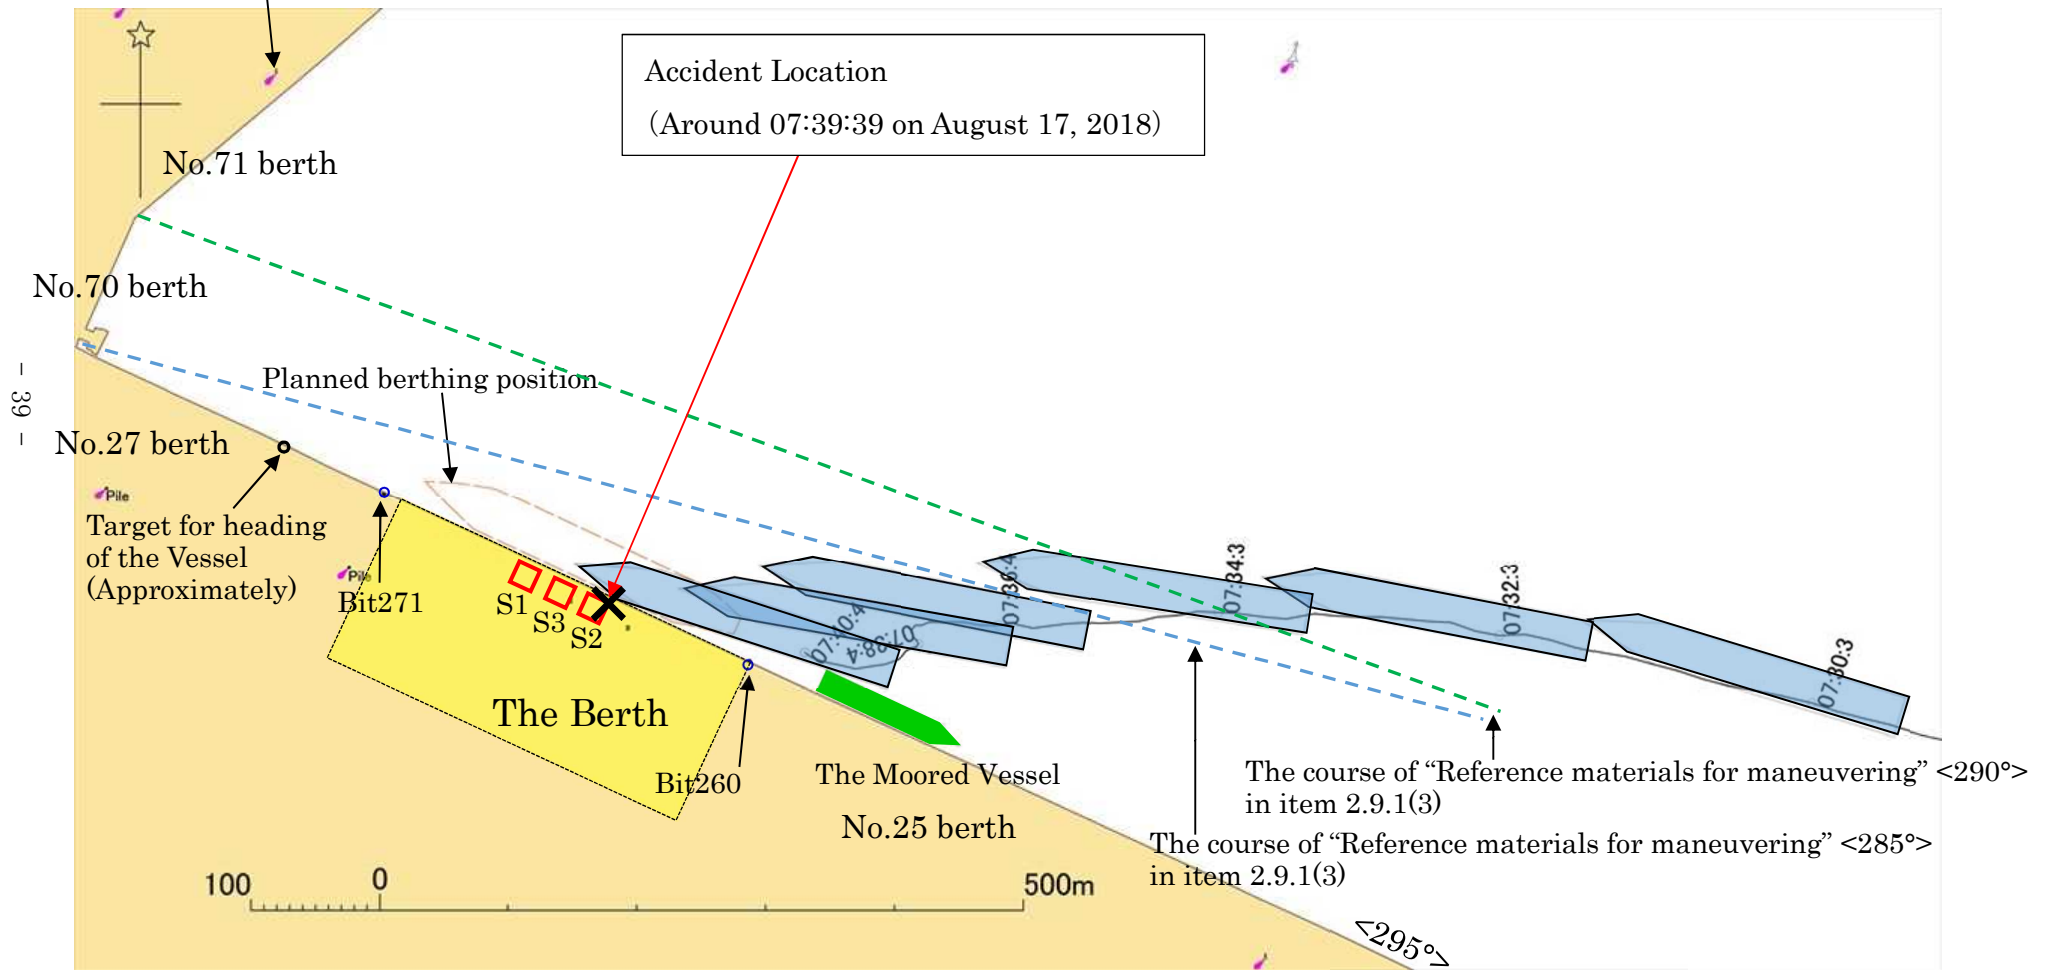
Annex Figure 2: Navigation path in Yokkaichi Port

was planned to use the bit of 257. The installation interval of each bit was 30 meters. (Refer to Attached Figure 2 Navigation path in Yokkaichi Port)
