MA2021-2

**MARINE ACCIDENT
INVESTIGATION REPORT**

Vessel type and name: Cargo vessel JIA DE

Accident/Incident type: Foundering

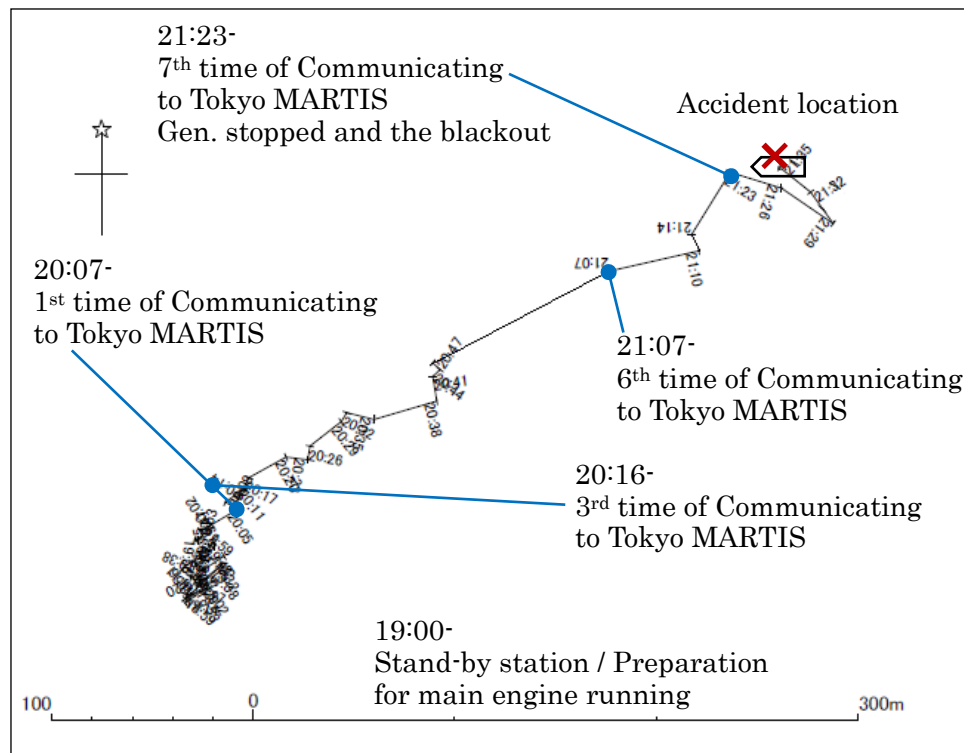
Figure 1 Situation of the Vessel (Time: JST)

The date and the time of occurrence of the accident was at around 21:39 on October 12, 2019, and the location of the accident was around 137°, 1 nautical mile (M) from the lighthouse on the Kawasaki Higashi-Ogi Island breakwater.

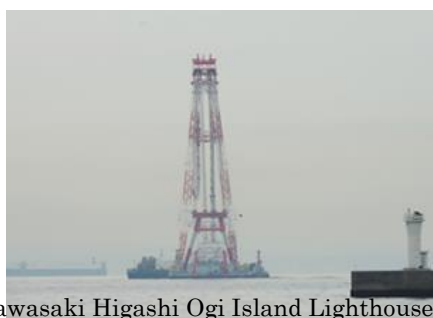
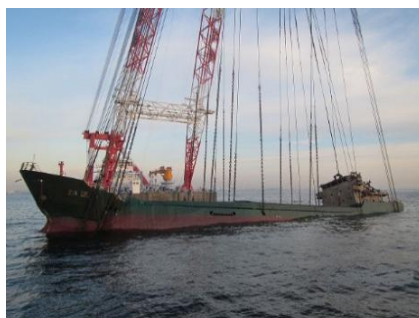
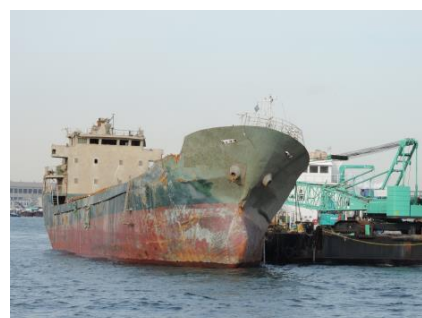
Figure 2 Raising Work for the Vessel

- (vi) Company A raised the foundered Vessel around the accident location by a crane vessel between February 13 and 15, 2020, and at that time, discovered one crewmember in the Vessel interior who had been missing at the time of the accident. JCG received this report from Company A and the SRT recovered the crewmember on February 14. (See Figure 2)

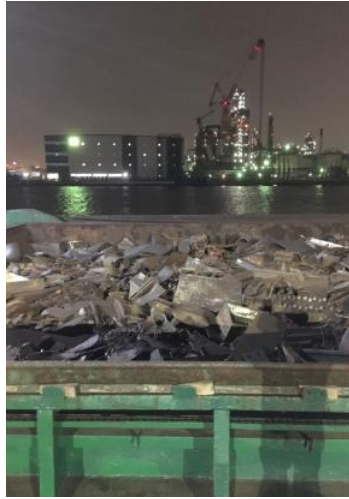
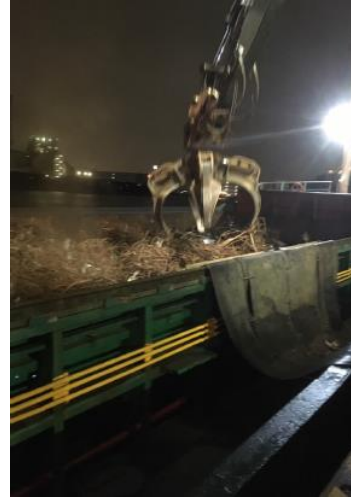
Photo 2 Loading of Steel Scrap in the Cargo Holds in Keihin Port

According to the statements by Master and Chief Engineer, the replies to the questionnaires by the Agent and the Cargo loading company, the loading business record which was delivered by the Cargo loading surveyor and the international LL certificate, the cargo loading condition of the Vessel at the time of departing from the Wharf of Keihin Port, and on the day of the accident, fuel oil storage, the draft, etc. at K1 anchorage were as in Table 3 and Photo 2.

- * The cargo of steel scrap was loaded with heavy equipment, and subsequently the surfaces of steel scrap were pushed down and made level.

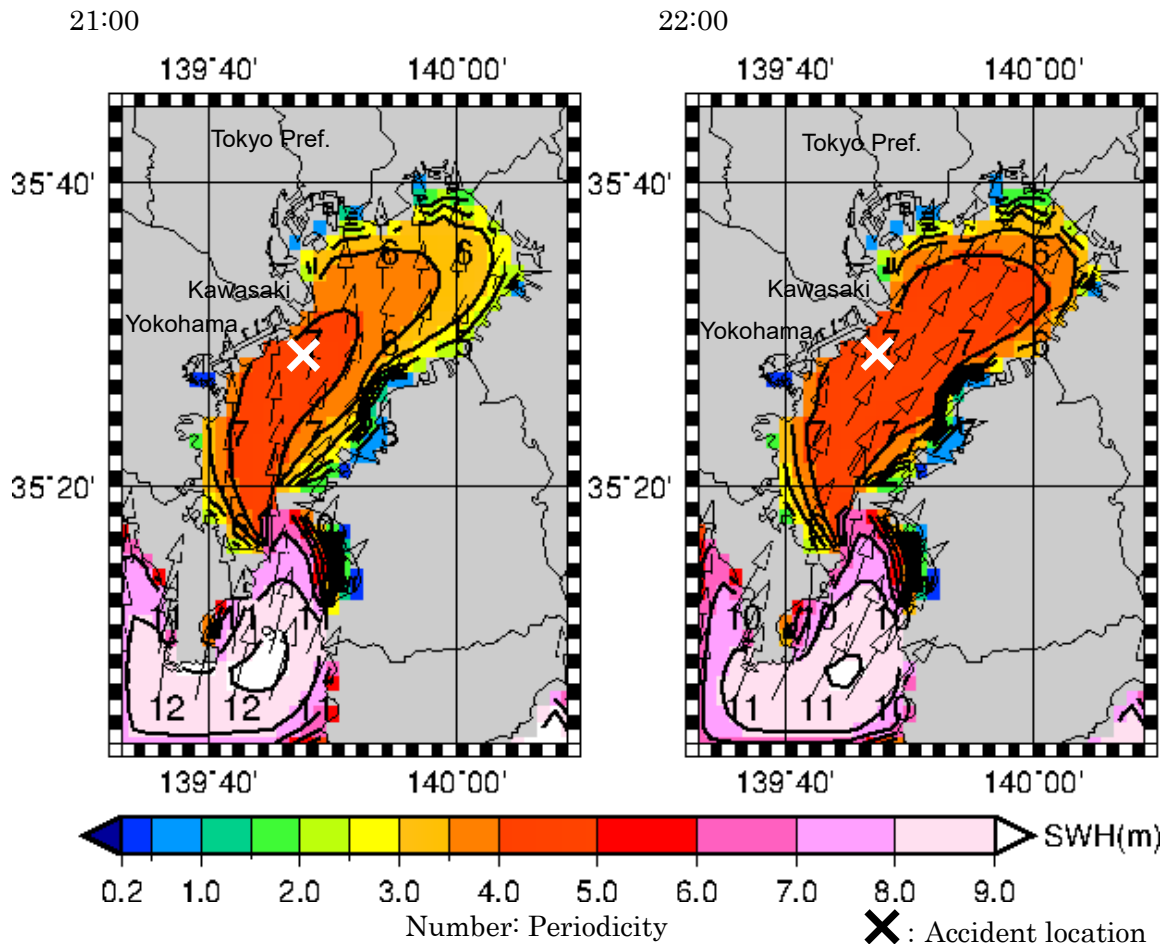
Figure 8 Condition of Waves in Tokyo Wan

The waves condition which JMA estimated with the Waves Model in shallow sea water^{*7} (hereafter referred to as “the Waves Condition”) in Tokyo Wan between 18:00 and 22:00 on October 12 was as shown as Table 7 and Figure 8. The area of wave height from 4.0 to 5.0 m had extended throughout Tokyo Wan from 21:00 to 22:00, and it was a period in which the factor of blowing up from west to east was increasing.

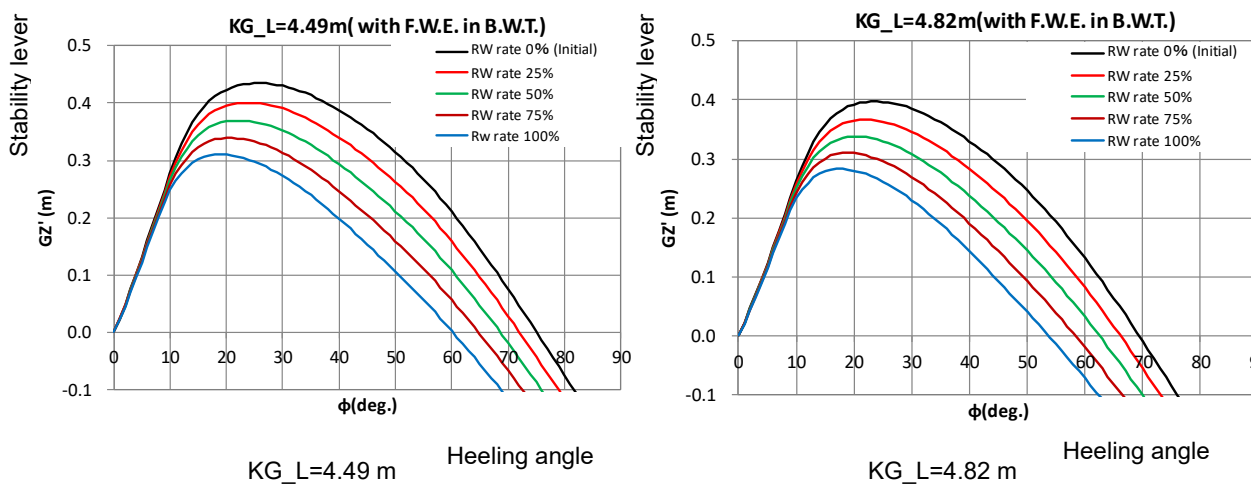
Figure 12 Curve of Stability (Influence of the Retained Water)

The results of analysis for the curve of stability, etc. in case of there being the Retained Water on the upper deck are as shown in Figure 12. The results show that as the height of the weight center is raised, the metacentric height and the stability become lower. However, it

could not be said that the influence of the Retained Water becomes high, even though the metacentric height in the case of a Full Retained Water ratio of 100 % (Full condition) was less than approximately 7 % (GM1=1.34 m, GM2=1.25 m) of the initial condition (GM1=1.44 m, GM2=1.35 m), and thereby it is assumed to be highly probable that the Vessel had significant residual stability, even though she experienced wave uprush and the Retained Water being on the upper deck due to upcoming sea water.

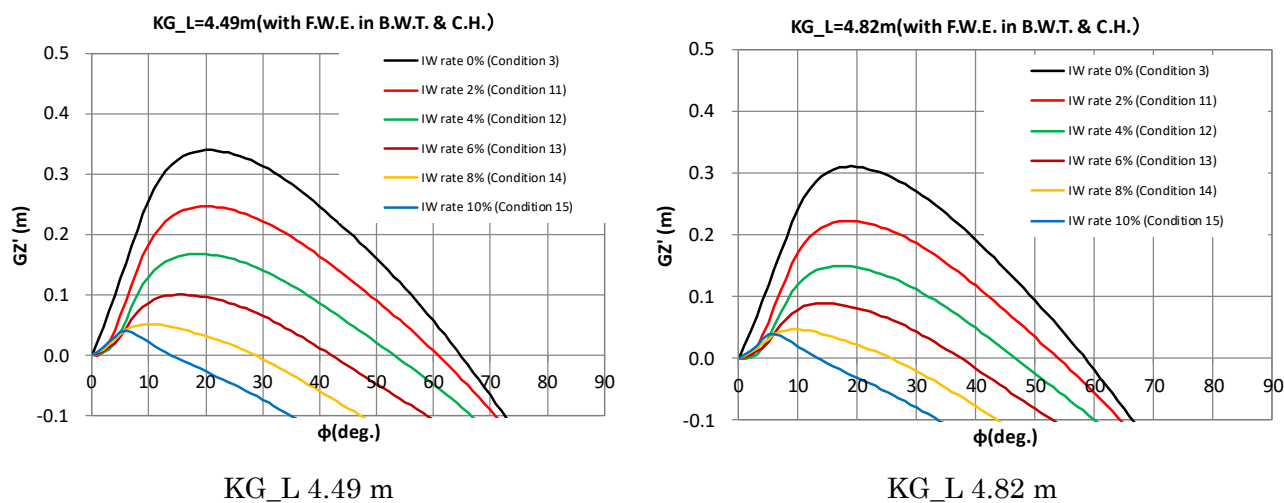
Figure 13 Curve of Stability and Hull Condition (Influence of Ingress Water in Cargo Holds)

At the time of the accident, the Vessel was also assumed to be flooded due to taking on sea water into the cargo holds in addition to the Retained Water, and the stability curves, etc., which were analyzed in case of there being an ingress water ratios in the cargo holds (IW ratio) from 2 % (weight of ingress water 40.8 t) to 8 % (weight of ingress water 203.8 t) against the capacity of the cargo holds are then as shown in Figure 13. Moreover, the Retained Water, in consideration of discharging water outboard from the heel side in rolling condition as well as her hull's heeling, was adopted as a Retained Water ratio (RW ratio) of 75 % in the Analysis.

In case of estimation of flooding due to taking on sea water into the interior of the cargo holds, the metacentric height was reduced significantly due to the large influence of free water movement in comparison with the case of no ingress water in the cargo holds. For example, in the case of Condition 11 (KG_L=4.49 m, IW ratio 2 %), the metacentric height (GM1) was

0.07 m, and the value was 5 % of the metacentric height in Condition 3 in which there was no ingress water in the cargo holds.

As shown in Figure 13, in the case of there being ingress water in the amount of 8 % of the volume of the cargo holds, the Vessel had fallen into a condition of readily rolling over if the heeling angle exceeded the peak of stability, which was approximately 10° , and furthermore, stability was zero when the heeling angle was between 25.5° and 28.5° in such a case of receiving gusts of wind due to the typhoon, and thereby she was in condition of not avoiding rolling over due to the action of a slight moment.

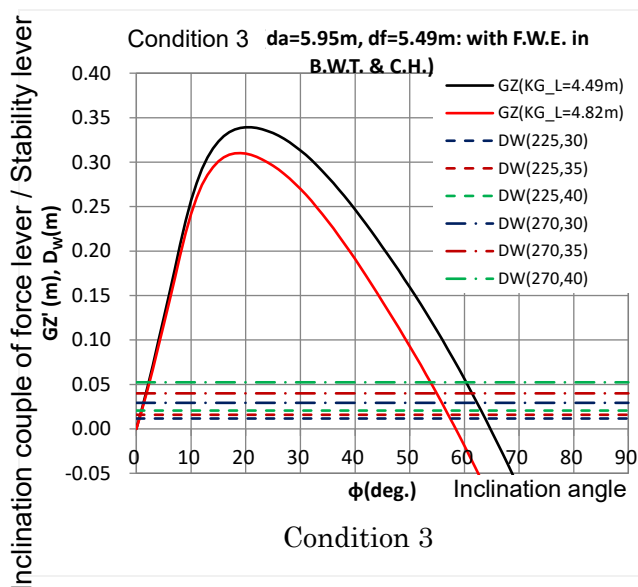
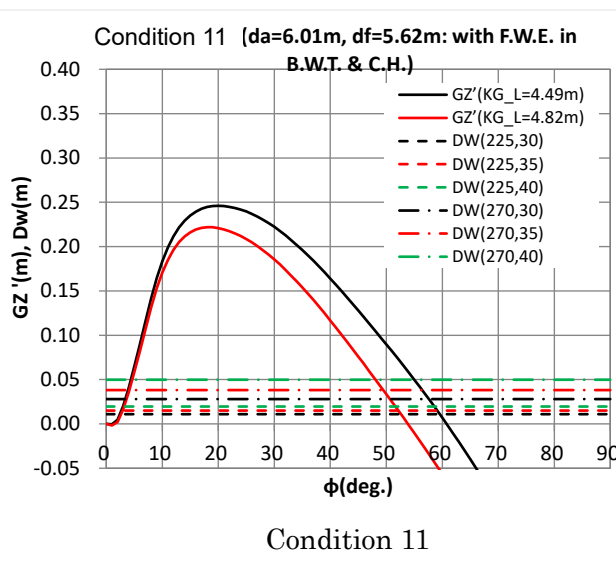
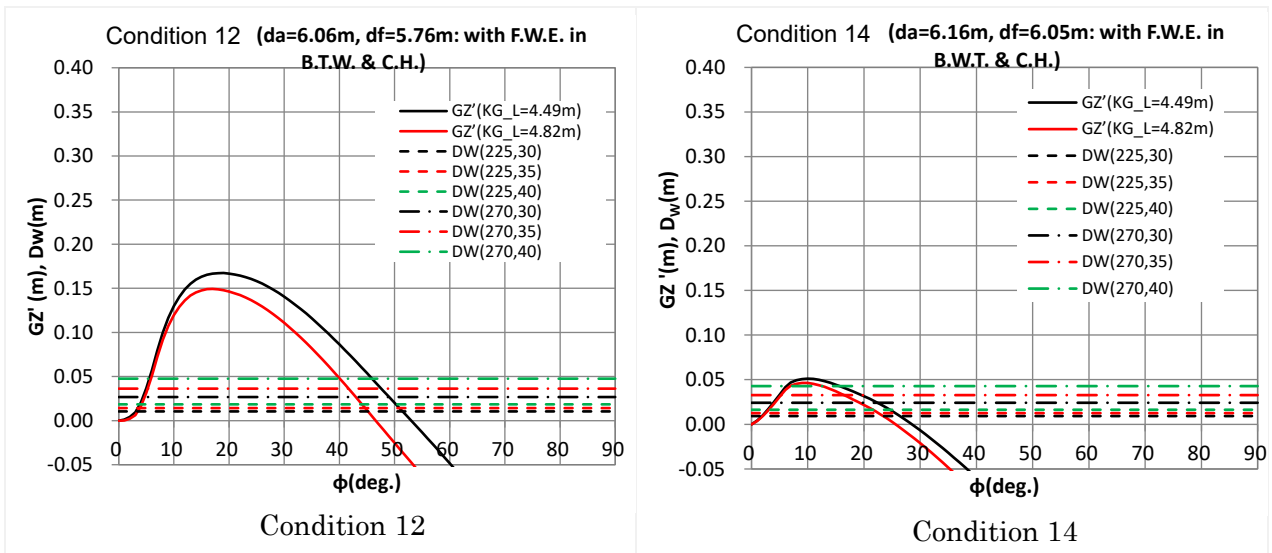
Figure 14 Stability and Heeling Couple of Force Lever due to Winds

The stability and the heeling couple of the force lever of Conditions 3, 11, 12 and 14 are as shown in Figure 14, and the notation shown as “DW(225,30)” in the Figure means the heeling couple of the force lever in the case of the heading of the Vessel being 225° and wind speed being 30 m/s.

As mentioned above, the greater the ingress water in the cargo holds increased, the lower the stability GZ and the heeling couple of the force lever decreased, and thereby the more the reduction in stability is remarkable. Therefore, the residual stability, which responds to the upper part above the heeling couple of the force lever D_w line parallel to the horizontal axis of the stability curve GZ indicated by a solid line in Figure 14, was greatly reducing accompanied by increasing flooding due to taking on sea water into the cargo holds. The effective stability was almost lost in the condition of an ingress water ratio of 8 % (Condition 14), in the case of the heading of the Vessel of 270° and wind speed of 40 m/s (heeling couple of force lever: green dashed line), even if her KG_L was at 4.49 m. (See Figure 14)

- (4) In accordance with 2.11.3 (4) i), the lateral heeling moment increases as wind speed rises, and ingress water increases as stability reduces. In Figure 14, in the case of receiving wind with a wind speed of 30 m/s in Condition 11 and Condition 12, and even though the Vessel had still secured stability, in the case of wind of a similar wind speed in Condition 14 (a Retained Water ratio of 75 % and ingress water ratio of 8 %), the range of stability on the line of heeling couple of force DW (270, 30) was at approximately 19° in KG_L 4.49 m and was at approximately 15° in KG_L 4.82 m. She could not avoid rolling over due to the action of a slight moment when these ranges of stability were exceeded.

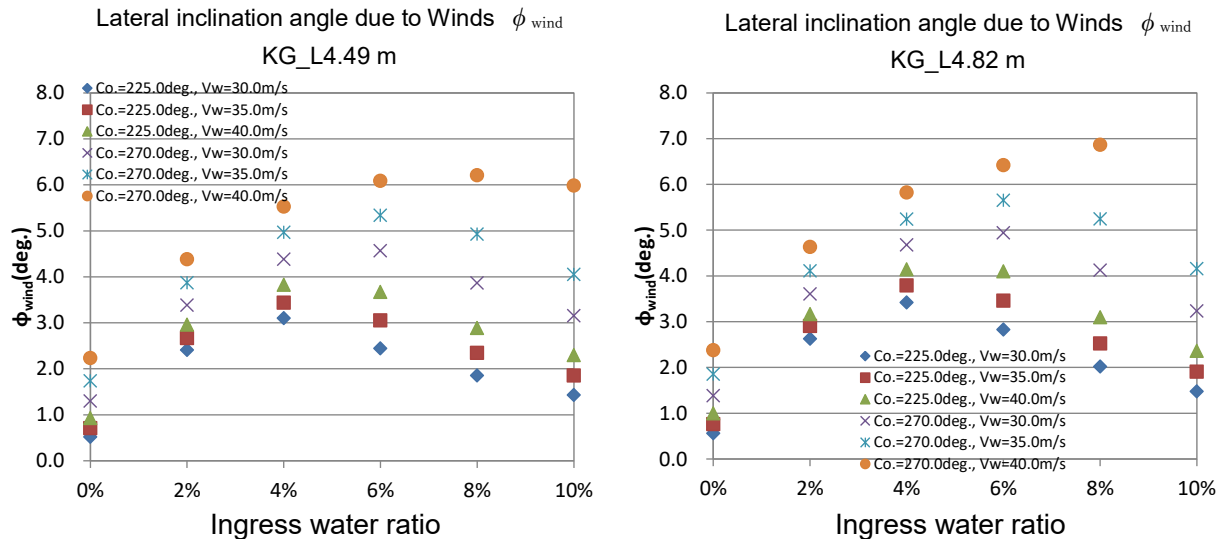
Figure 15 Condition of Ingress Water into Cargo Holds and Heeling Angle Due to Winds

The results for the estimated heeling angle due to winds in the case of Conditions 11 to 15 is shown in Table 14, and the condition of ingress water in the cargo holds and the condition of the heeling angle are shown in Figure 15. The cells shaded with gray in the table show that the heeling angle due to winds indicates a condition of exceeding the angle of the discharging holes of the bulwark being submerged into sea water.

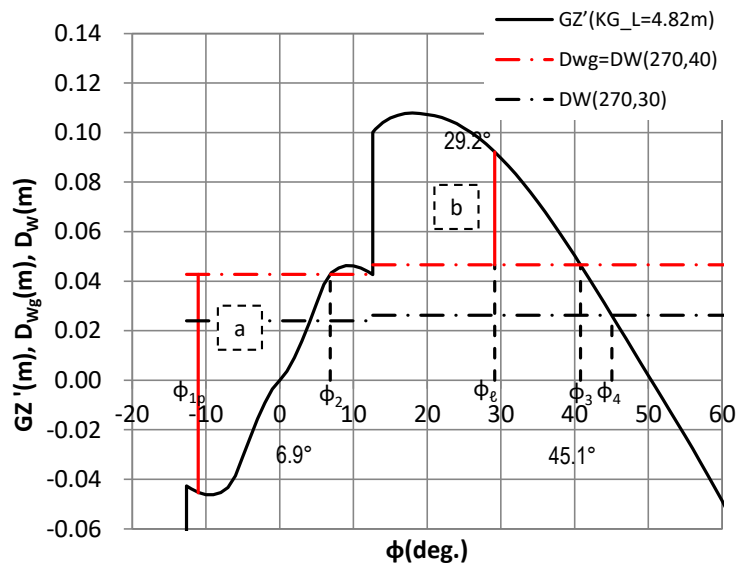
Figure 18 Calculation of Energy Balance

In accordance with the Accident Scenarios c) and d), in case that the Vessel was receiving gusts of wind in a condition of heeling at the maximum angle to the weather side of the waves (port side) ($\phi = \phi_{1p}$), and then heeled back to the lee side (starboard side), the maximum lateral heeling angle is ϕ_e , and thereby, based on a concept of energy balance similar to the C coefficient standard^{*15} of the Rule of Ship Stability, can be calculated using Figure 18.

D_{wg} by means of gusts of wind is defined as the heeling couple of force DW (270, 40) due to wind of a wind speed of 40 m/s in a condition of the heading of the Vessel as 270° and the lateral heeling angle is 6.9° (Table 14) in the case of gusts of wind acting quasi-statically. Furthermore, conducting the analysis utilizing the analyzed value ($\phi_{1p} = -11.1^\circ$) in item (ii) as the maximum heeling angle to the port side, the maximum heeling angle is 29.2° . Moreover, the transit of the stability curve in case of a lateral heeling angle to the starboard side exceeding the submerged angle 12.6° (ϕ_B) of the top of the bulwark is similar to that mentioned above.

On the other hand, as shown in Figure 18, the heeling angle where the maximum value of stability in this condition occurs is approximately 18° , and the heeling of the stability curve is negative at the maximum heeling angle of 29.2° to the starboard side. Therefore, with the Vessel having fallen into an unstable condition at the maximum angle to starboard in case of receiving gusts of wind, and furthermore, due to the submerged bulwark dragging subject to the weight of sea water and the Vessel in a condition of being difficult to stabilize, according to the Accident Scenario e), it is assumed that the lateral heeling angle increased due to continuing to receive the influence of waves.

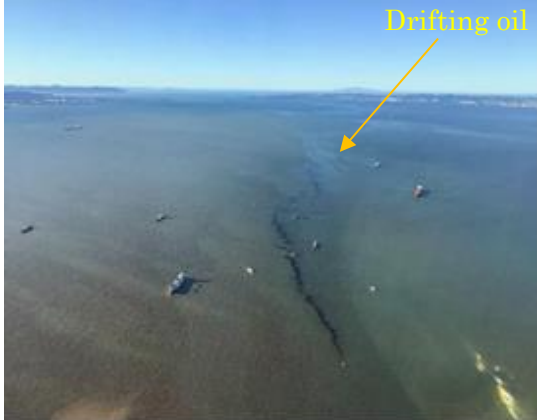
At around 09:00 on October 13

Circumstances of the accident location

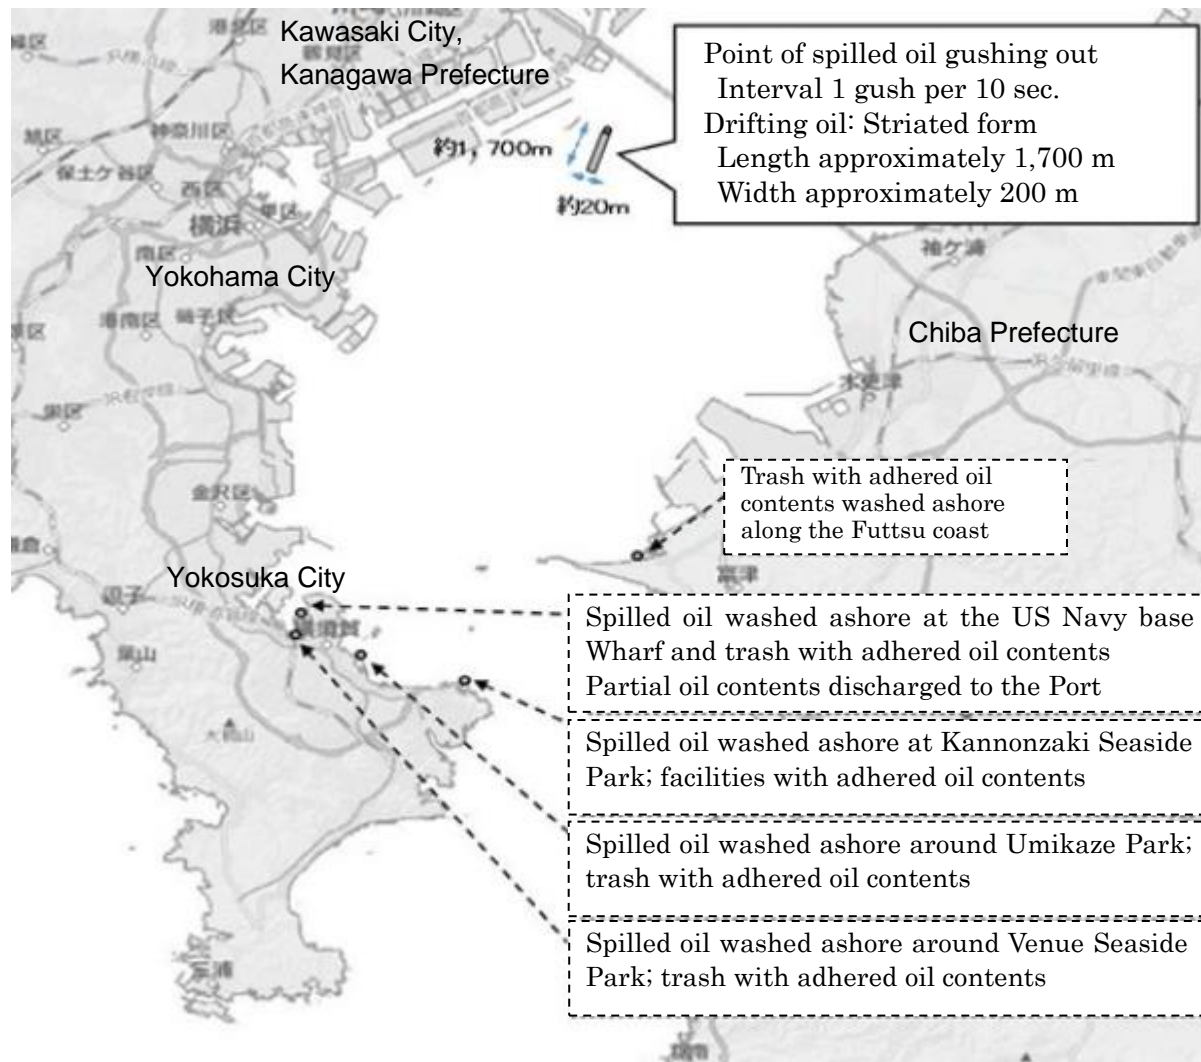
Time & Date: Around 06:35, October 18

Circumstances of drifting oil in Tokyo wan

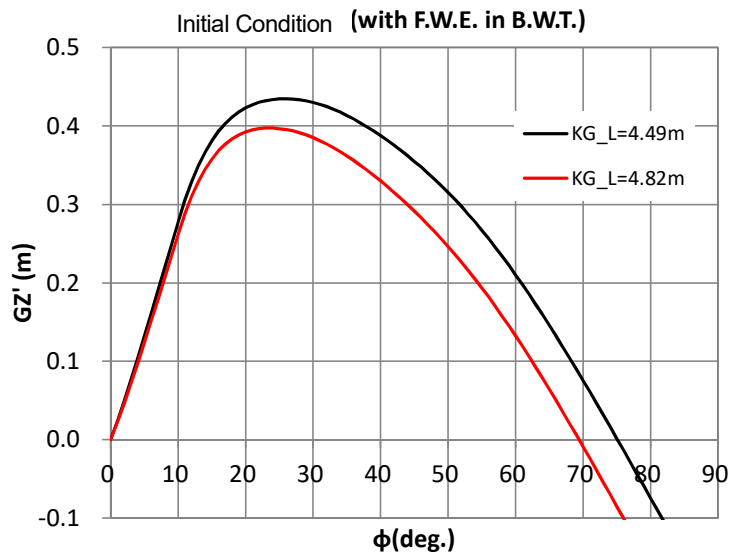
Figure 1 Stability Curve (Initial Condition)

Figure 1 shows the Vessel's stability under the Initial Condition calculated using the values of the weight and the center of gravity in Tables 1 and 2. Table 4 shows the calculated metacentric height (GM), draft (da: draft aft; df: draft fore, dm: draft mid), and trim (τ : positive when trimmed by the stern) calculated taking into account free water effects. GM1 and GM2 denote the metacentric height for when the height of the center of gravity under the light loading condition KG_L is estimated at 4.49 m (Table 1) and 4.82 m (Table 2), respectively.

When the height of the center of gravity under the light loading condition KG_L is 4.49 m, the Vessel's metacentric height (GM1) under the Initial Condition is 1.44 m, the maximum stability (GZ_{max}) is approximately 0.44 m, and the lateral heeling angle at which the maximum stability occurs (ϕ_{max}) is approximately 26 deg. The free water effects of any liquids other than the ballast water were not considered in this calculation, because the volumes of the tanks containing those liquids were unknown. Meanwhile, treating the free water effect of the ballast water as a virtual rise of the center of gravity may result in an overestimation of the free water effect at higher lateral heeling angles, because the amount of ballast water was relatively small compared to the volume of the ballast tanks (Table 3).¹⁾ For this reason, the free water effect of water in each ballast tank was taken into account as a change (due to heeling) in the center of gravity of water contained in a hypothetical tank that has a plane with the same length and area as the plane of the actual tank (i.e. a hypothetical tank that has an approximate rectangular plane). The plane shape and height of each actual tank were determined based on the general arrangement plan.

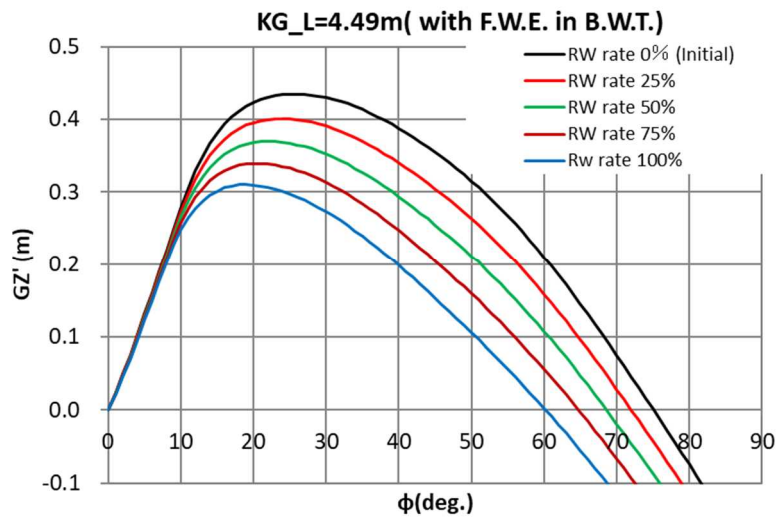
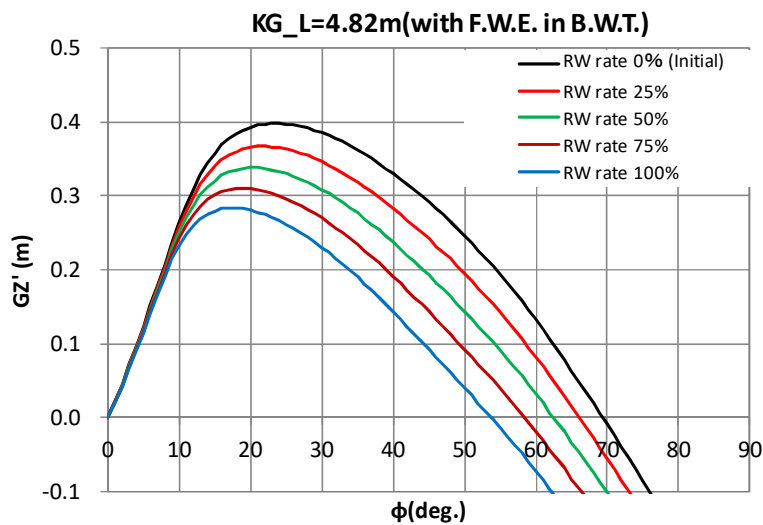
Figure 2 Stability Curve (Effects of Retained Water in Both Passages on Upp. Deck; $KG_L = 4.49$ m)

Figure 3 Stability Curve (Effects of Retained Water in Both Passages on Upp. Deck; $KG_L = 4.82$ m)

Figures 2 and 3 and Tables 6 and 7 show that with increase in Retained Water, the vertical position of the Vessel's center of gravity rises and its longitudinal position shifts toward the center of the hull, which results in a decrease in the trim by the stern, metacentric height, and stability. However, even when the passages on the upper deck are filled with sea water to the top (Condition 4), the volume of Retained Water is only about 210 tf (approximately 5% of the displacement under the Initial Condition) and the metacentric height decreases only by about 7% (GM1 = 1.34 m and GM2 = 1.25 m under Condition 4, as compared to GM1 = 1.44 m and GM2 = 1.35 m under the Initial Condition).

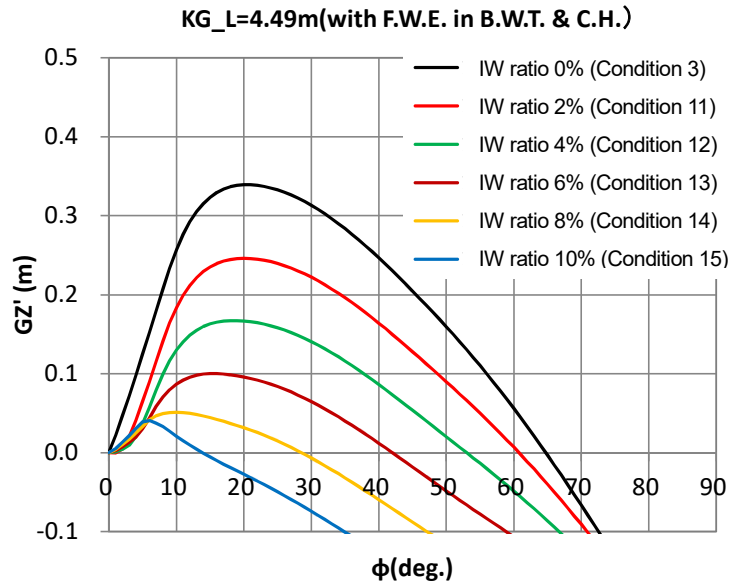
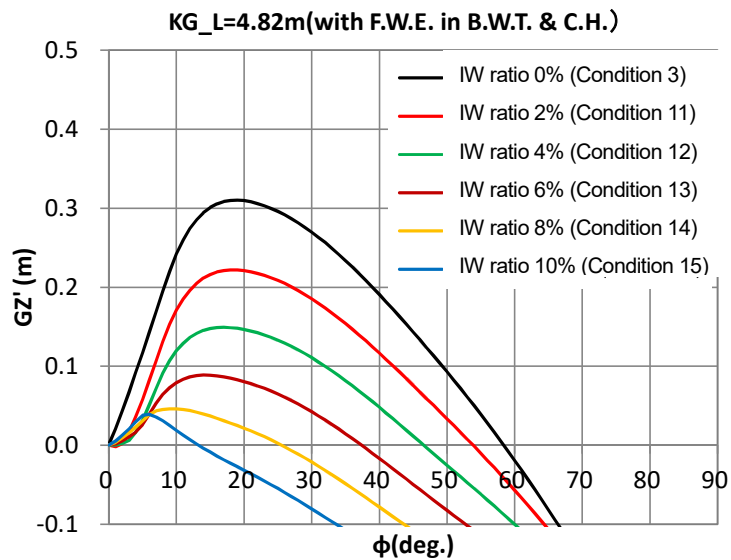
Figures 4 and 5 show the Vessel's calculated stability under each Condition. The stability generally decreases as ingress water increases. At the same time, the angle of loss of residual stability (φ_V) and the range of stability (φ_R), which define the characteristics of a vessel's stability, both decrease, while the maximum stability (GZ_{max}) and the lateral heeling angle at which the maximum stability occurs (φ_{max}) also decline. For example, when the height of the center of gravity under the light loading condition KG_L is 4.82 m and the IW ratio is 4% (Condition 12; weight of ingress water in Cargo Hold No. 1: 81.5 tf; weight of ingress water in Cargo Hold No. 2: 93.2 tf) (the green line in Figure 5), the angle of loss of residual stability (φ_V) is approximately 47 deg., the maximum stability GZ_{max} is approximately 0.15 m, and the lateral heeling angle at which the maximum stability occurs φ_{max} is approximately 17 deg., decreasing by about 20%, 50%, and 10%, respectively, compared to the condition where there is no ingress water in the cargo holds (Condition 3; $\varphi_V \cong 58$ deg., $GZ_{max} \cong 0.31$ m, $\varphi_{max} \cong 19$ deg.) (black line in Figure 5).

Figure 4 Stability Curve (Effects of Ingress Water in the Cargo Holds; KG_L = 4.49 m; RW Ratio: 75%)

Figure 5 Stability Curve (Effects of Ingress Water in the Cargo Holds; KG_L = 4.82 m; RW Ratio: 75%)

Meanwhile, the free water effect of ingress water is only significant at smaller lateral heeling angles, as this analysis assumes relatively small volumes of ingress water. For example, when KG_L = 4.82 m and the IW ratio is 2% (Condition 11), the metacentric height (GM2) calculated taking into account the free water effect is almost 0 m (Table 12); then, the pro-metacentric height starts to grow around a lateral heeling angle of 2 deg. and it becomes approximately 0.22 m at maximum, a significant stability value, at a lateral heeling angle of about 18 deg. (Figure 5).

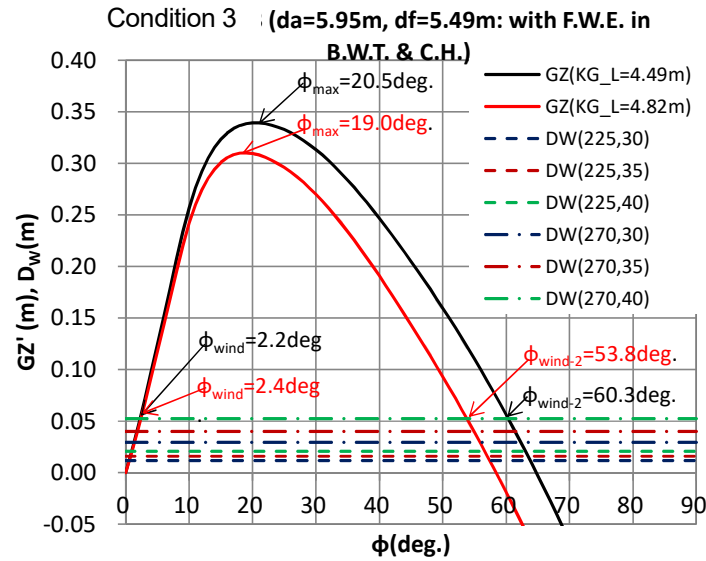
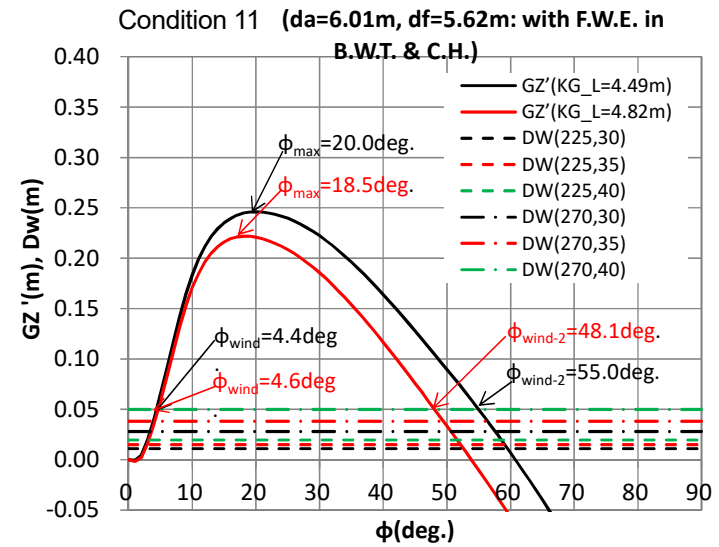
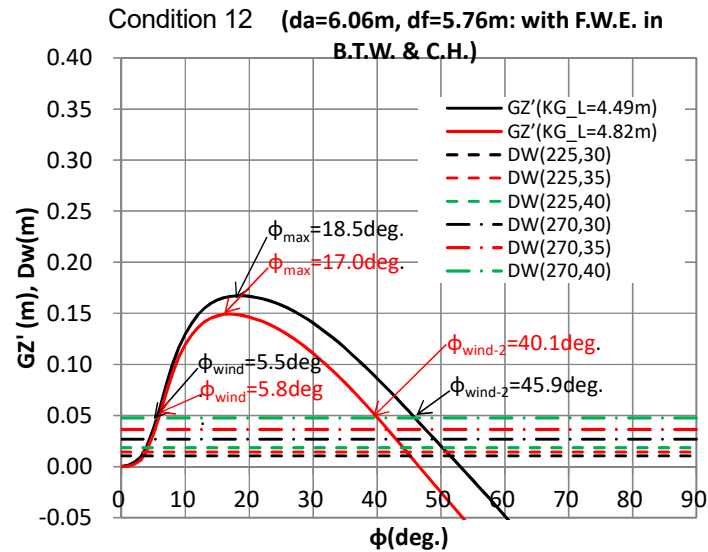
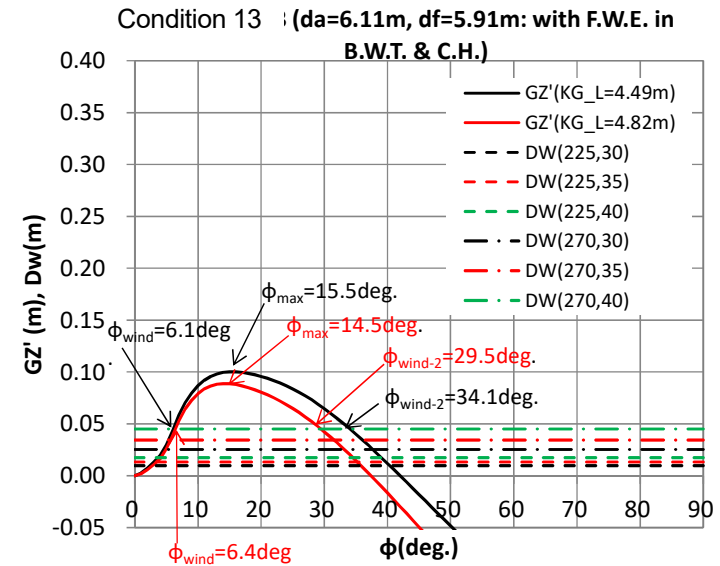
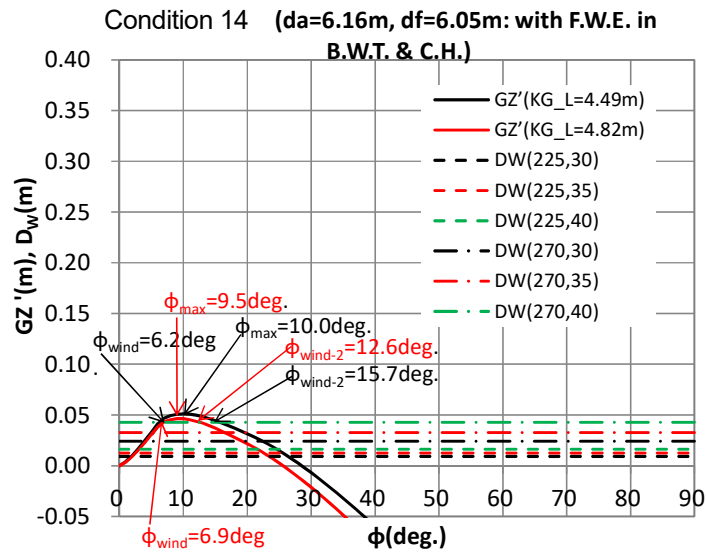
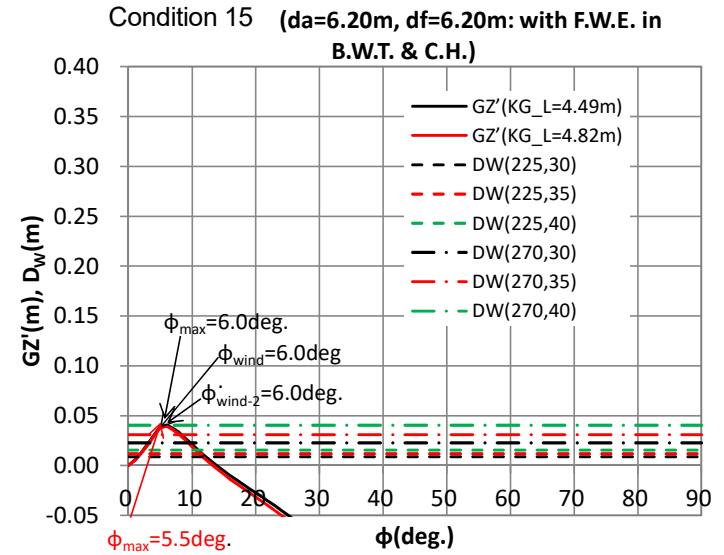
Figures 6 to 11 show the comparison of the Vessel's calculated stability and the calculated heeling couple of the force lever due to winds under each Condition. In the legends, the figures in the brackets are the Vessel's heading and the wind velocity (e.g. "DW (225, 30)" denotes the heeling couple of the force lever when the Vessel's heading is 225 deg. and the wind velocity is 30 m/s). For reference, the Figures also show the lateral heeling angle at which the maximum stability occurs (ϕ_{max}) and the value of lateral heeling angle at the intersection of the stability curve and the line of DW(270, 40) (i.e. the heeling couple of the force lever when the Vessel's heading is 270 deg. and the wind velocity is 40 m/s) (ϕ_{wind} and ϕ_{wind-2} ; ϕ_{wind} is further discussed in Section 2.1.2).

While, as mentioned above, both the Vessel's stability (GZ') and the heeling couple of the force lever (D_W) decrease as the IW ratio increases, the former decreases more rapidly. Figures 6 to 11 show that the residual stability (GZ'_R), which corresponds to the stability curve (GZ') represented by the solid line above the line of the heeling couple of the force lever (D_W) parallel to the lateral axis, drops rapidly as the IW ratio increases. In particular, in Figure 11, where the IW ratio is 10% (Condition 15), when the Vessel's heading is 270 deg. and the wind velocity is 40 m/s (heeling couple of the force lever: green dash-dotted line), the effective stability is almost null even when the height of the center of gravity under the light loading condition KG_L is 4.49 m (black solid line).

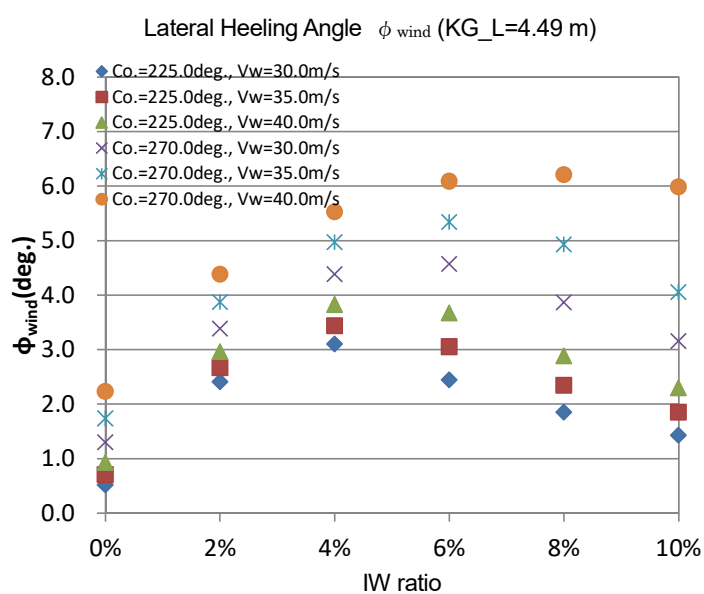
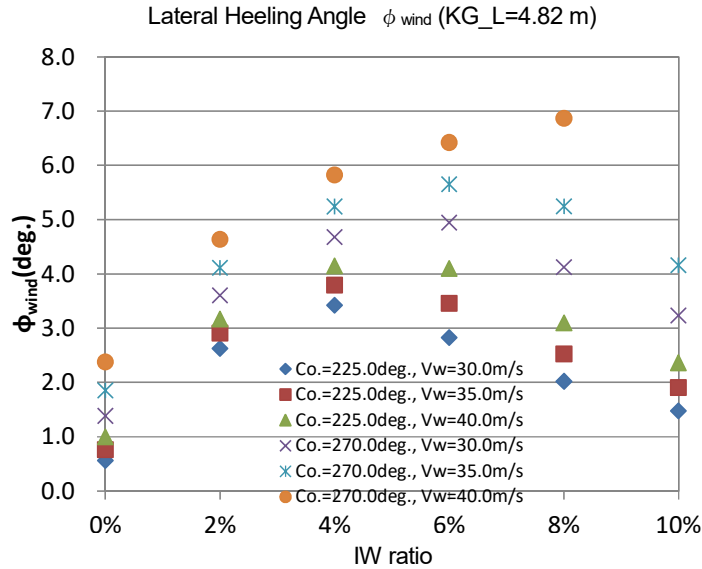
Based on Tables 18 and 19 and Figures 12 and 13, it is found that: [1] the lateral heeling angle due to winds at a heading of 270 deg. where the relative wind direction is close to lateral is about 1.4-3.5 times greater than that at a heading of 225 deg.; and [2] the lateral heeling angle due to winds becomes 5 deg. or greater only when the heading is 270 deg. and the IW ratio is 4% or greater.

Figure 12 Lateral Heeling Angle Due to Winds
(Effects of Ingress Water in the Cargo Holds; KG_L = 4.49 m)

Figure 13 Lateral Heeling Angle Due to Winds
(Effects of Ingress Water in the Cargo Holds; KG_L = 4.82 m)

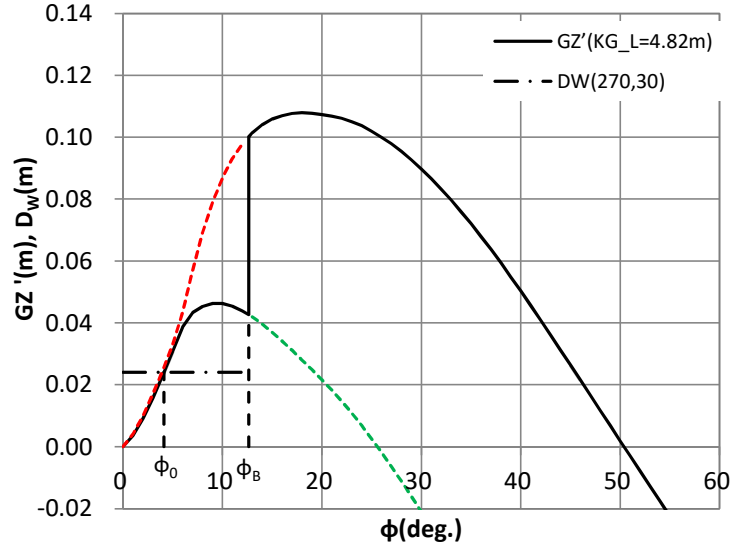
Figure 14 shows the stability curve when the IW ratio is 8%. The submerged angle of the top of the bulwark (φ_B) is 12.6 deg. when the RW ratio is 75% and the IW ratio is 8% (Condition 14) (Table 13). According to the logic discussed above, when $0 \leq \varphi \leq \varphi_B$ (φ denotes the lateral heeling angle), the Vessel's stability equals that estimated in Condition 14 (RW ratio: 75%); when $\varphi_B \leq \varphi$, it is equal to that estimated under the condition where the RW ratio is 0% and the IW ratio is 8% (Appendix 1; Condition 24). In Figure 14, the red dotted line is the stability curve under Condition 24 (an RW ratio of 0%) when $0 \leq \varphi \leq \varphi_B$, and the green dotted line is the stability curve under Condition 14 (an RW ratio of 75%) when $\varphi_B \leq \varphi$.

Figure 14 Stability Curve at the Time of the Accident occurred (Conditions 14 and 24; KG_L = 4.82 m) and the Heeling Couple of the Force Lever due to Winds (Heading: 270 deg.; Wind Velocity: 30 m/s; Condition 14)

The estimated heeling angle due to winds at the time of the accident shown in Tables 18 and 19 corresponds to ϕ_0 , the angle at which the stability GZ' equals the heeling couple of the force lever due to winds D_w in Figure 14. Figure 14 shows the stability GZ' when the height of the center of gravity under the light loading condition KG_L is 4.82m (solid line) and the heeling couple of the force lever due to winds D_w (270, 30) (i.e. the heeling lever at a heading of 270 deg. and a wind velocity of 30 m/s) (dash-dotted line). Here, ϕ_0 is 4.1 deg. (Table 19), a heel to starboard.

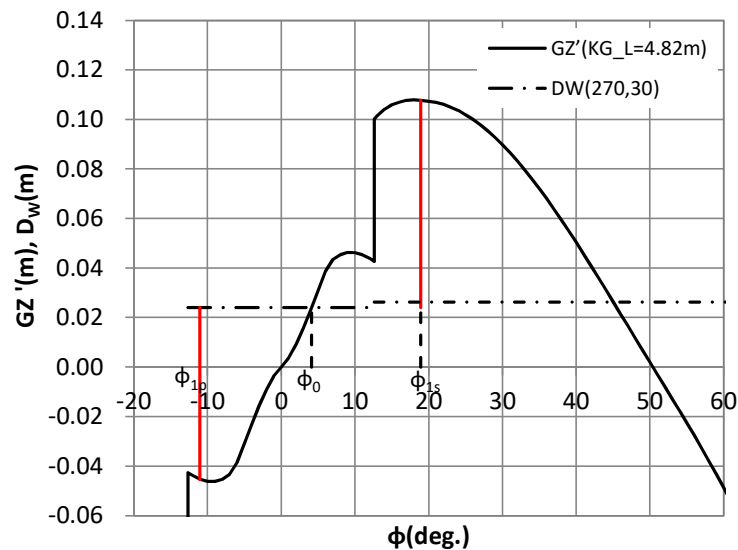
Under the condition shown in Figure 14, if a roll amplitude (φ_a) of 15 deg. (the median of 10-20 deg.) ((ii) of the Accident Scenario) is applied to Formulas (4) and (5), the maximum heeling angle to the port side φ_{1p} is 11.1 deg. and the maximum heeling angle to the starboard side φ_{1s} is 18.9 deg. (Figure 15). Note that Formula (4) was calculated based on an assumption that the Vessel's stability and heeling couple of the force due to winds shift to those under Condition 24 (the condition where only the cargo holds are flooded and there is no Retained Water in the passages) when the lateral heeling angle exceeds the top of the bulwark's submerged angle (φ_B) (=12.6 deg.).

Figure 15 Calculated Roll Amplitude When the Vessel Has a Steady Heeling (Conditions 14 and 24; $KG_L=4.82$ m; Center of Rolling (φ_0): 4.1 deg.; Wave Roll Amplitude: 15 deg.)

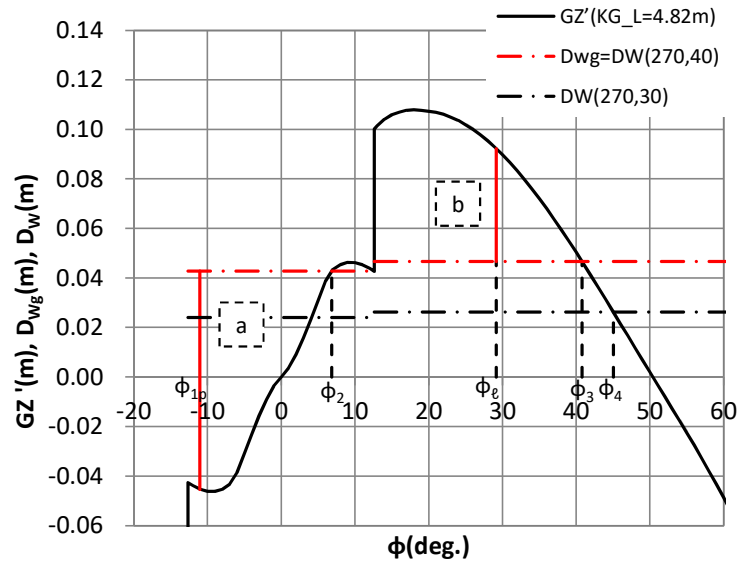
Figure 16 Calculated Energy Balance

Figure 16 was used for the calculation of the energy balance. Assuming that the heeling couple of the force lever due to a gust of wind (D_{wg}) is equivalent to the heeling couple of the force lever due to winds at a heading of 270 deg. and a wind velocity of 40 m/s ($D_w(270,40)$), the lateral heeling angle ϕ_2 is 6.9 deg. when the gust of wind acts quasi-statistically (Table 19). By applying the maximum heeling angle to the port side calculated in 2) ($\phi_{1p} = -11.1$ deg.) to Formulas (6) to (8), the maximum heeling angle to the starboard side (ϕ_l) is 29.2 deg. and the ratio of the dynamic stability to the heeling energy ($c = b/a$) is 1.29. Note that Formulas (7) and (8) were calculated based on an assumption that the Vessel's stability and heeling couple of the force due to winds shift to those under Condition 24 (the condition where only the cargo holds are flooded and there is no Retained Water in the passages) when the lateral heeling angle exceeds the top of the bulwark's submerged angle (ϕ_B) (12.6 deg.).

Meanwhile, the heeling angle at which the maximum stability occurs is approximately 18 deg. At the maximum heeling angle to the starboard side (29.2 deg.), the slope of the stability curve is negative (Figure 16). This means that the Vessel was unstable at the maximum heeling angle to the starboard side.³⁾ At the same time, the stability was undermined due to the submerged bulwark dragging, subject to the weight of sea water. In this situation, the continuous effects of waves could have further increased the lateral heeling angle ((v) of the Accident Scenario). The angle of loss of residual stability ϕ_4 is calculated to be 45.1 deg. when the average wind velocity is 30 m/s under the condition assumed in Figure 16.

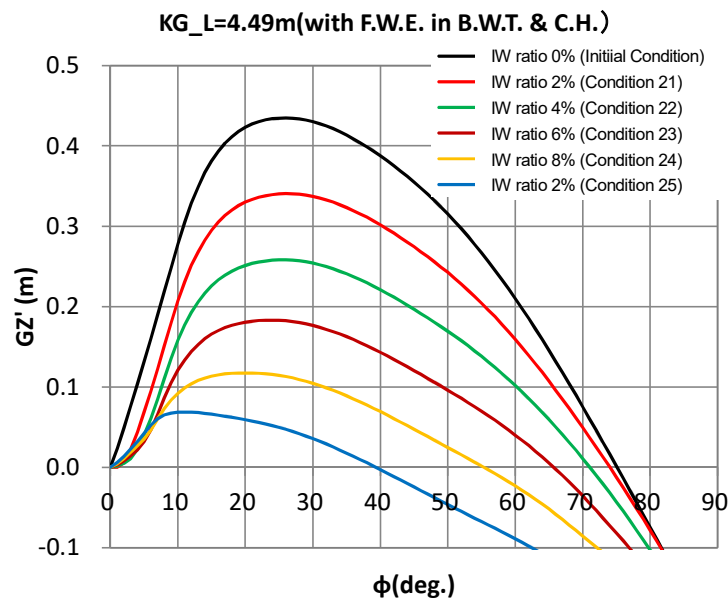
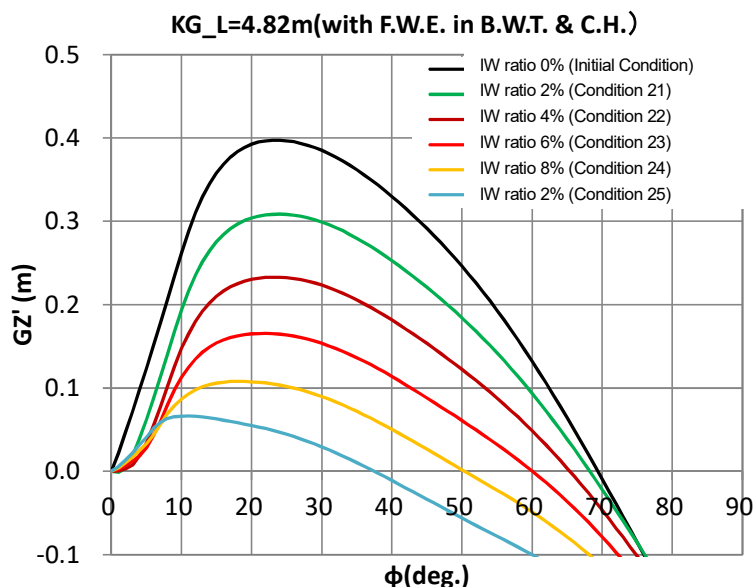
Figure A1-1 Stability Curve (Effects of Ingress Water in the Cargo Holds; KG_L = 4.49 m)

Figure A1-2 Stability Curve (Effects of Ingress Water in the Cargo Holds; $KG_L = 4.82$ m)

The Vessel's calculated stability for each condition is shown in Figures A1-1 and A1-2. In the same manner as Section 1.2, the free water effect of ingress water in each cargo hold was taken into account as a change (caused by heeling) in the center of gravity of water contained in a hypothetical cargo hold that has a plane with the same length and area as the plane of the actual cargo hold (i.e. a hypothetical cargo hold tank that has an approximate rectangular plane).¹⁾

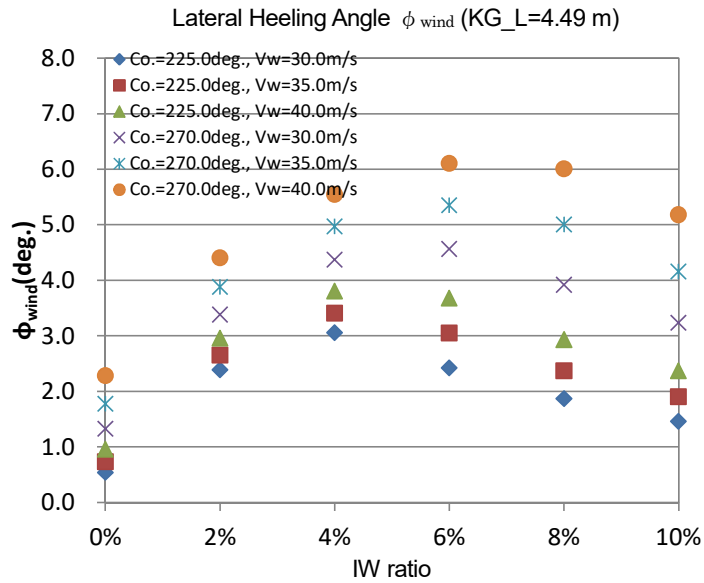
Figure A1-9 Lateral Heeling Angle Due to Winds
(Effects of Ingress Water in the Cargo Holds; KG_L = 4.49 m)

Table A1-10 shows the estimated lateral heeling angle due to winds when the height of the center of gravity under the light loading condition (KG_L) is 4.49 m, and Table A1-11 shows that for when KG_L is 4.82 m. In addition, the estimated lateral heeling angle due to winds is plotted on the ordinate and the IW ratio is plotted on the abscissa in Figures A1-9 ($KG_L = 4.49$ m) and A1-10 ($KG_L = 4.82$ m).

Under the Conditions assumed in this analysis, the lateral heeling angle due to winds increases with the volume of ingress water up to 4% (Condition 22) if the heading and the wind velocity stay the same. If the IW ratio is greater than 4%, the lateral heeling angle may decrease as ingress water increases, depending on the combination of the heading and the wind velocity, since the stability (GZ') and the heeling couple of the force due to winds (D_w) decrease at different rates against the increase in ingress water. Also, when the IW ratio is greater than 6%, the lateral heeling angle decreases with the increase in ingress water with any combinations of the headings and wind velocities.
