MA2021-2

**MARINE ACCIDENT
INVESTIGATION REPORT**

MARINE ACCIDENT INVESTIGATION REPORT

Accident type	Fatality of a crew member
Date and time	Around 11:20 on November 16, 2019 (local time, UTC+9 hours)
Location	Wakayama Shimotsu Port, Wakayama Prefecture Around 252 true bearing, 1.6 nautical miles (M) from Wakayama Hokko West Breakwater Lighthouse (approximately 34°13.6'N, 135°05.3'E)
Summary of the Accident	While the cargo ship ORANGE PHOENIX with the master and 20 crew members aboard was anchoring at Wakayama Shimotsu Port, Wakayama Prefecture, a crew member died of a fall from a lifeboat to the deck when engaging in the lifting and recovery of the lifeboat in an abandon ship drill.
Process and Progress of the Investigation	(1) Set up of the Investigation The Japan Transport Safety Board appointed an investigator-in-charge and one other investigator to investigate this accident on November 18, 2019. (2) Collection of Evidence November 19, 2019: On-site investigations and interviews November 28, December 16, 2019, March 2, 5, 6 and 26, August 5, 12 and 18, 2020: Collection of questionnaires (3) Comments from Parties Relevant to the Cause Comments on the draft report were invited

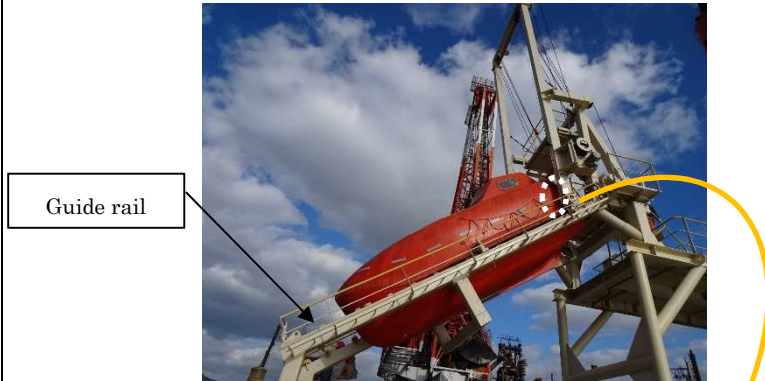
Figure 2 Lifeboat stored in the boat davit

the stern deck of the Vessel in an empty state to the sea surface while hanging it with a hoisting wire. After that, they hoisted the lifeboat up to the original lifting and recovery position and hooked the hook of the release system installed at the stern of the lifeboat on the ring of the boat davit. (See Figures 2 and 3.)
