**MARINE ACCIDENT  
INVESTIGATION REPORT**

Vessel type and name: Container Ship ONE APUS  
Vessel No. 143426 (IMO No. 9806079)  
Gross tonnage: 146,694 tons

Accident/Incident type : Damage to container hatchcover,etc.

Date and time : November 30, 2020, around 23:22(ship time)(First heavy rolling) -  
December 1, 2020, around 00:59 (ship time)(Second heavy rolling)

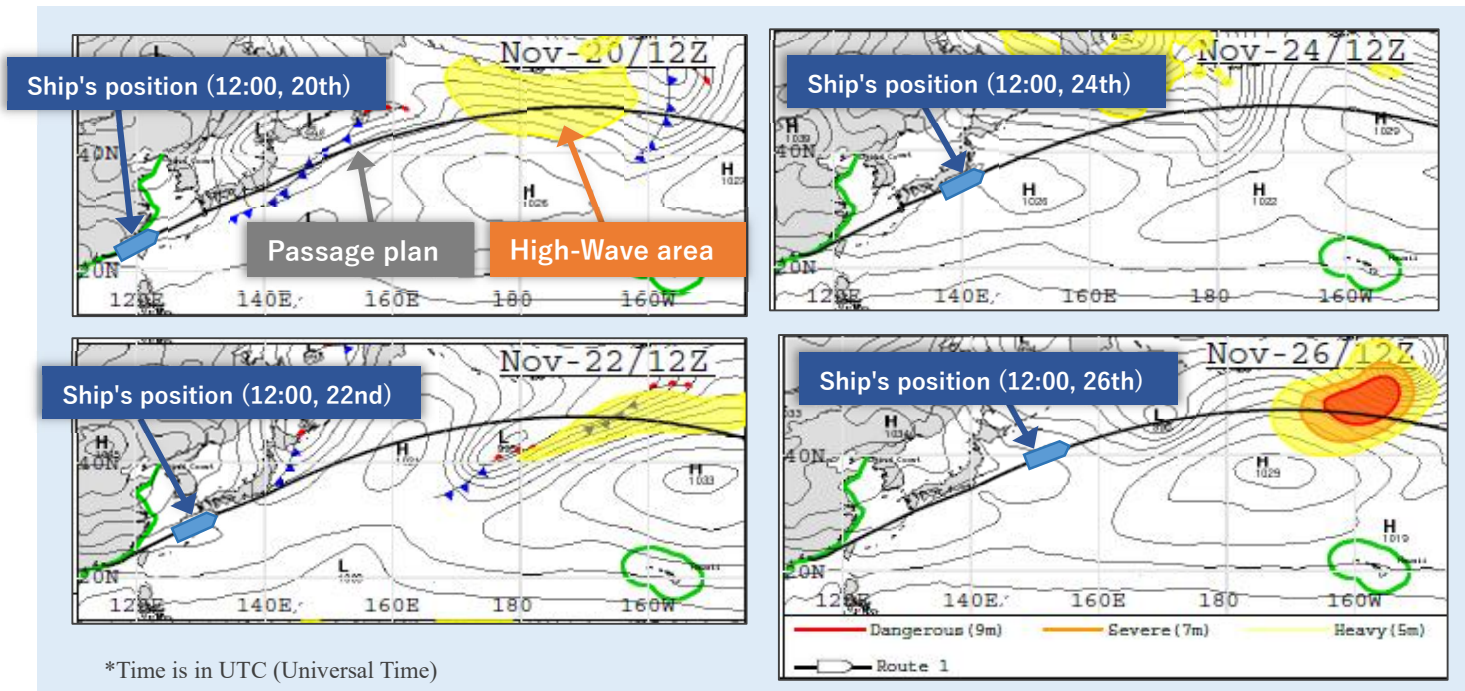
Figure 1 Passage Plan (received November 19)

Although the master of the vessel was concerned about the High-Wave area, he predicted that the waves would be around 5 meters by the time the vessel passed through the high-wave area and decided to adopt this Passage plan (see Figure 1).

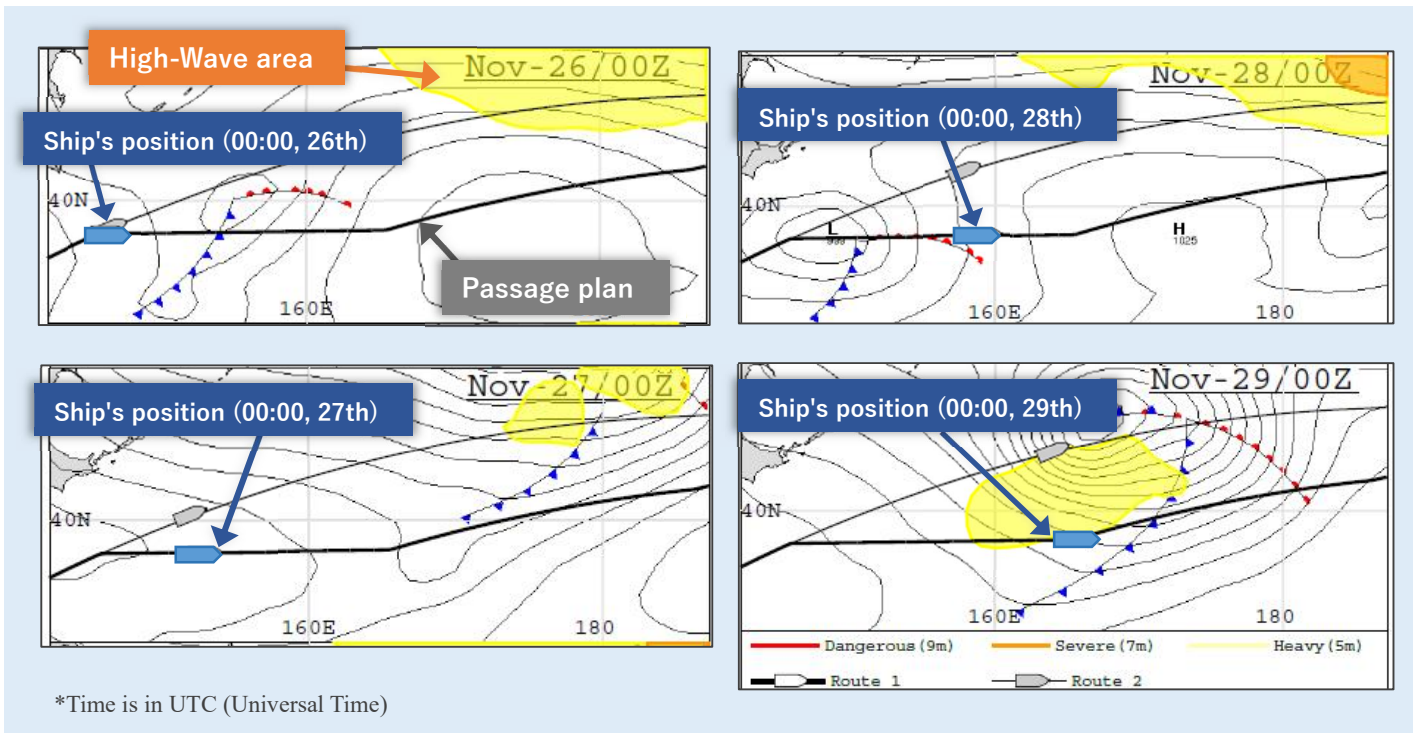
Figure 2 Change 1 plan (received November 26)

On November 25, while sailing off the south coast of the Japan, the master of the vessel, having ascertained weather information from weather charts, notified Company W of the danger of approaching the High-Wave area under the current Passage Plan, and requested that the Passage Plan be change 1 Plan") from Company W by e-mail at around 06:30 on November 26. (See Figure 2.)

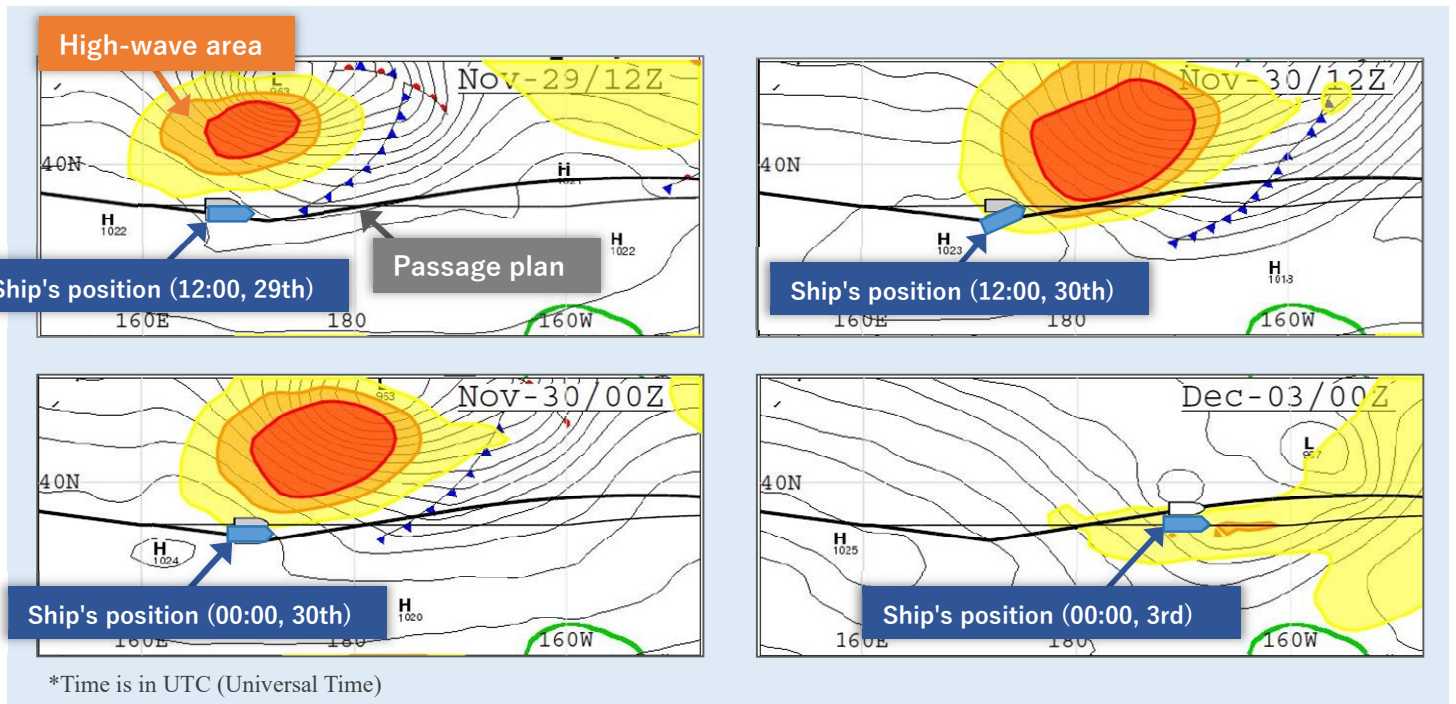
Figure 3 Change 2 plan (received November 28)

The master reported the change of course to approximately 099° to Company W and requested a change in the passage plan, and at around 18:50 on the 28th, the master received an e-mail from Company W stating that the vessel would maintain the course at approximately 099° to avoid the high-wave area in question and then proceed to the destination on the Great circle route (Change 2) (hereinafter referred to as the "Change 2 Plan"). (See Figure 3).

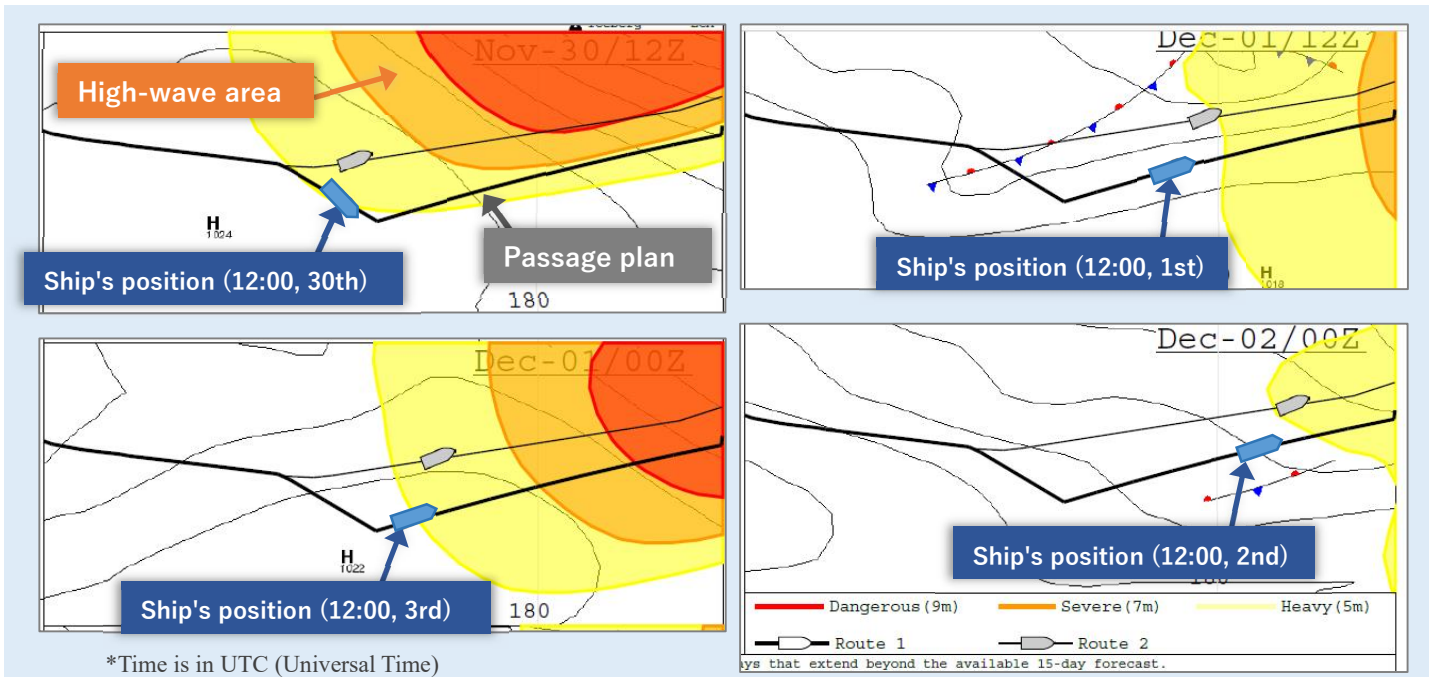
Figure 4 Change 3 plan (received November 30)

According to the Change 3 plan, the speed was increased to approximately 14.5 kn, the course was changed further south, and the plan was to head towards 32°20' north latitude and 174°00' east longitude, which is the southern point of the high wave area. In addition, since large swells are expected to come from the stern of the vessel up to the same point, a cautionary note is written to adjust the course and speed to reduce rolling according to the situation. (See Figure 4).

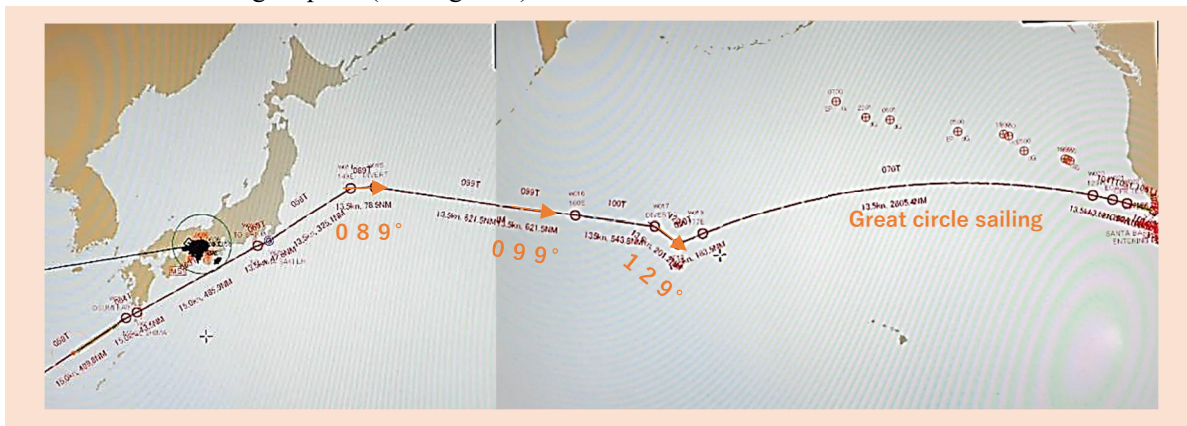
Figure 5 Planned course of Change 3 plan displayed in ECDIS

The master increased the speed to approximately 14.5 kn at around 12:20, and changed the vessel's course from approximately 099° to approximately 129° at around 15:30, in accordance with the change 3 plan. (See Figure 5)

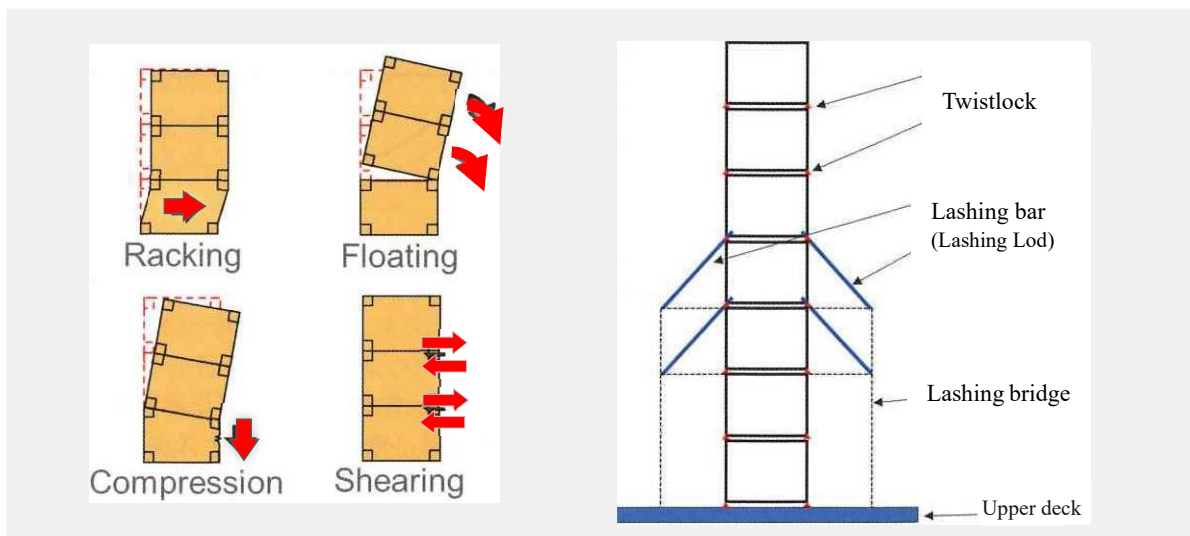
Figure 10 Container collapses, etc.

Container stacks are generally subject to various types of deformation, namely, racking, floating of the corner castings, compression and shearing. It is necessary to determine the container securing method, the weight of the containers to be stowed and the container stacking sequence so as not to exceed the allowable loads that occur during these types of deformation. In cases where lashing rods\*<sup>9</sup> are connected, attention must also be paid to the allowable load of the lashing rods because tensile loads are generated in the lashing rods when racking deformation occurs in a container stack. (See Figure 10)

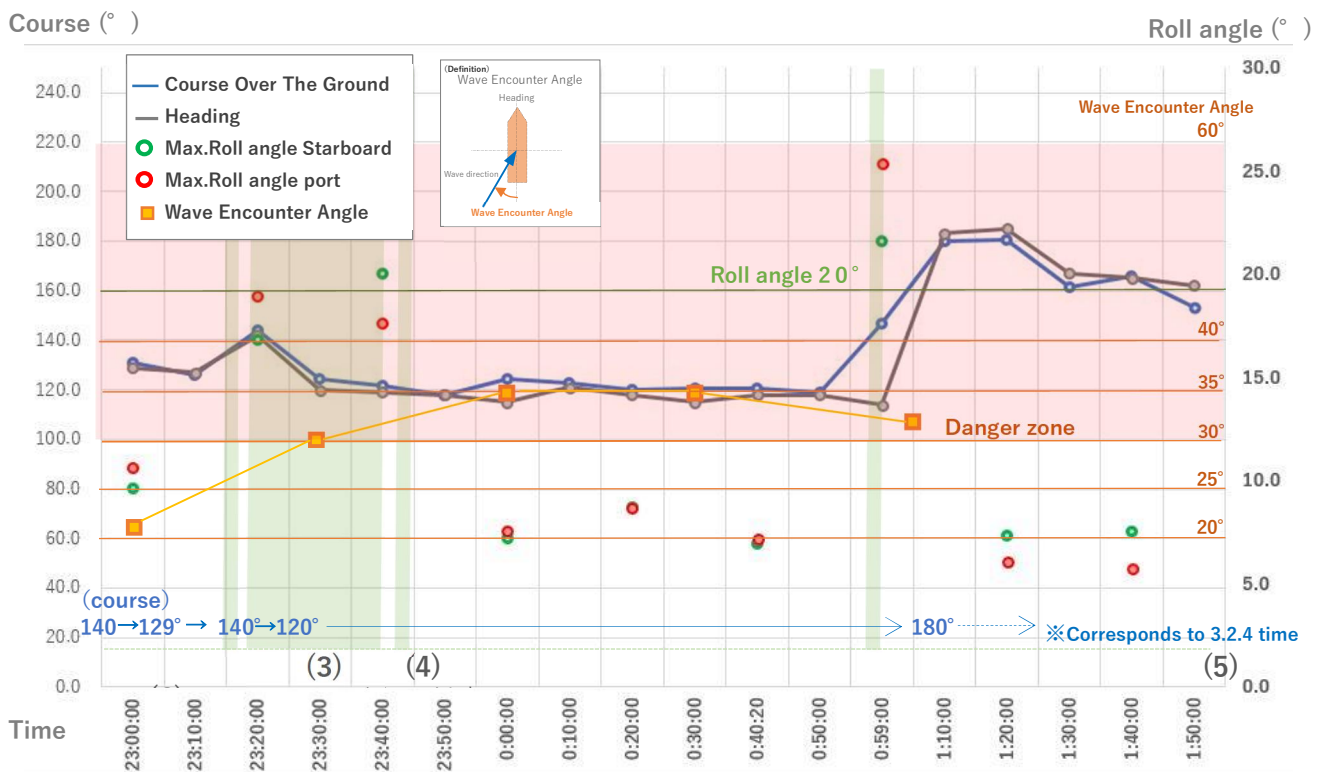
Figure 12 Course (COG and Heading) and roll angle with Wave Encounter Angle

- (6) At approximately 00:58 on December 1, while sailing on a course of approximately 120° and at a speed of approximately 11.7 kn, the master suddenly increased the roll angle to approximately 25°, and at approximately 00:59, following an instruction to set the course to 150°, changed the course to approximately 180°. (See Figure 12)
