# **RAILWAY SERIOUS INCIDENT INVESTIGATION REPORT**

## **Overrun on main track**

# Railway Serious Incident Investigation Report

Railway operator	WILLER TRAINS Inc.
Serious incident type	Overrun on main track, railway serious incident related with "the situation that the train or the vehicle overrun on the main track between stations" stipulated in Article 4, paragraph (1), item (iv) of the Ordinance on Report on Railway Accidents
Date and time	About 21:04, October 4, 2020
Location	Around 18,500 m from Nishimaizuru station, between Tangoyura station and Kunda station, Miyazu Line, Miyazu City, Kyoto Prefecture

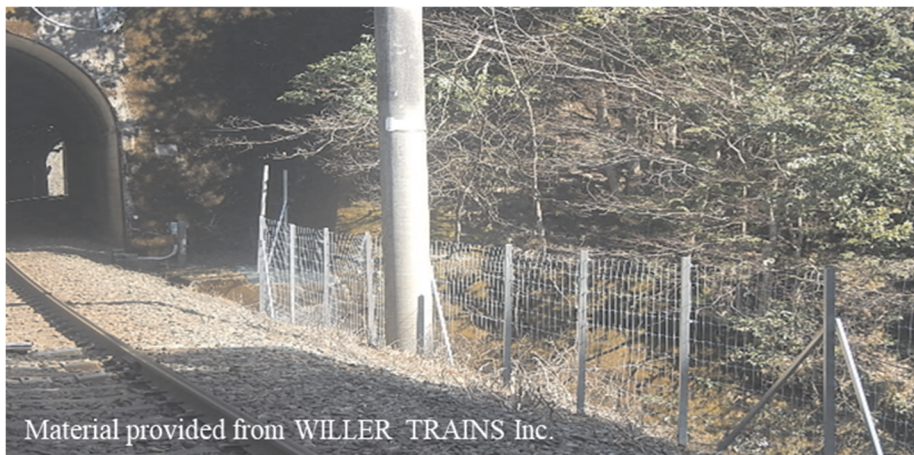
Figure 3. Measures to prevent invasion of animals installed in Miyafuku Line

Additionally, as the measures to prevent the collision with animals, the protective fences as the measure to prevent invasion of animals were installed in the track side in 5 places between Oeyamaguchinaiku station and Futamata station of Miyafuku Line on 2016, *refer to Figure 3*, but the protective fence was not installed in Miyazu Line at all. The Company and the Tango Railway Co., discuss each other on the installation of the protective fence, and the Tango Railway Co.,

arrange the budget and install the fences. Furthermore, the measures other than the protective fence had not also been implemented in Miyazu Line.
