**Railway Accident Investigation Report
(Excerpt)**

Train Derailment Accident between Tsukaguchi and Amagasaki Stations of the
Fukuchiyama Line of the West Japan Railway Company

June 28, 2007

Aircraft and Railway Accidents Investigation Commission

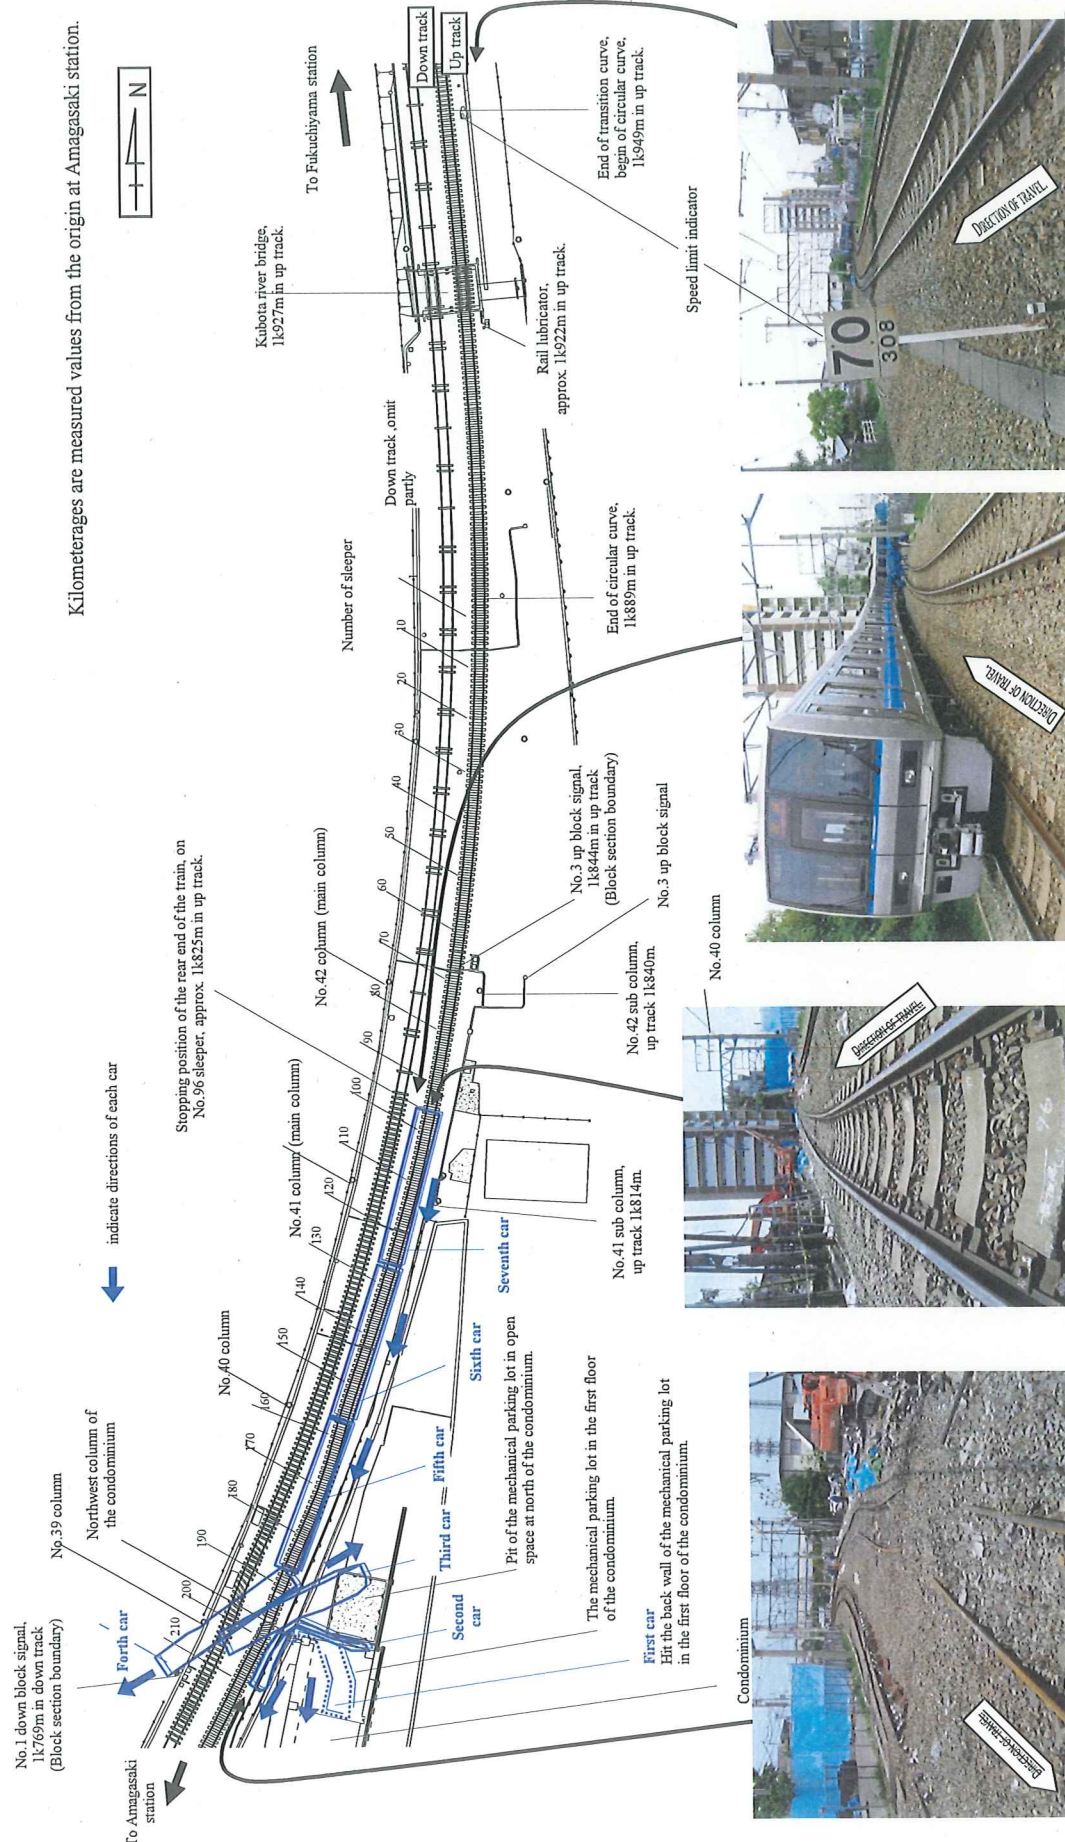
Figure 5 - Simplified Diagram of the Accident Site

(4) The white powder on the top surface of the left rail after the No. 85 sleeper (number of sleeper : see Figs. 5), described in 2.16.2, contained homogeneous components with the ballast.

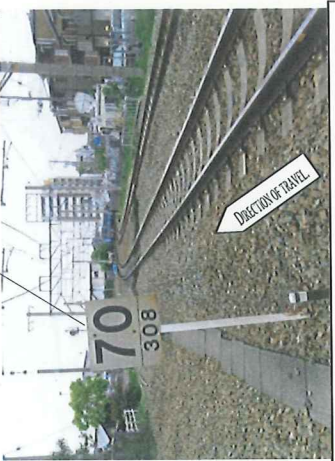
Photo taken from around end of transition curve and speed limit indicator to the direction of Amagasaki station.

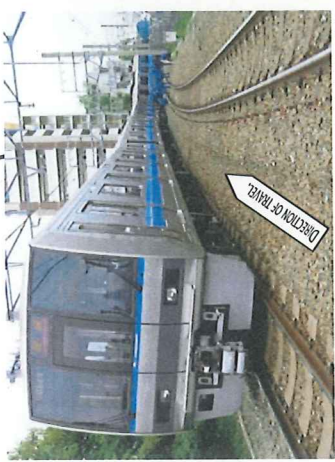
Photo taken from around the rear end of the accident train to the direction of Amagasaki station.

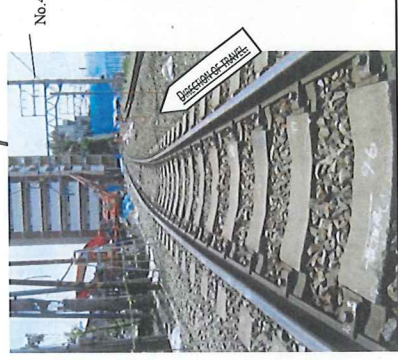
Photo taken from around the rear end of the accident train to the direction of Amagasaki station, after removal of the accident train.

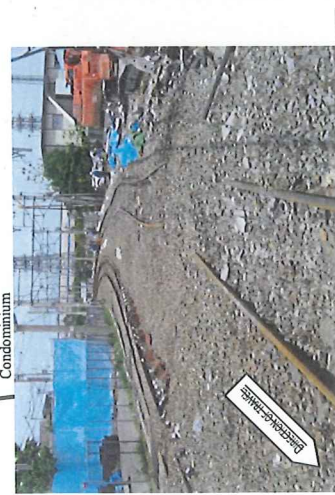
Photo taken from near the condominium to the direction of Fukuchiyama station, after removal of the accident train.

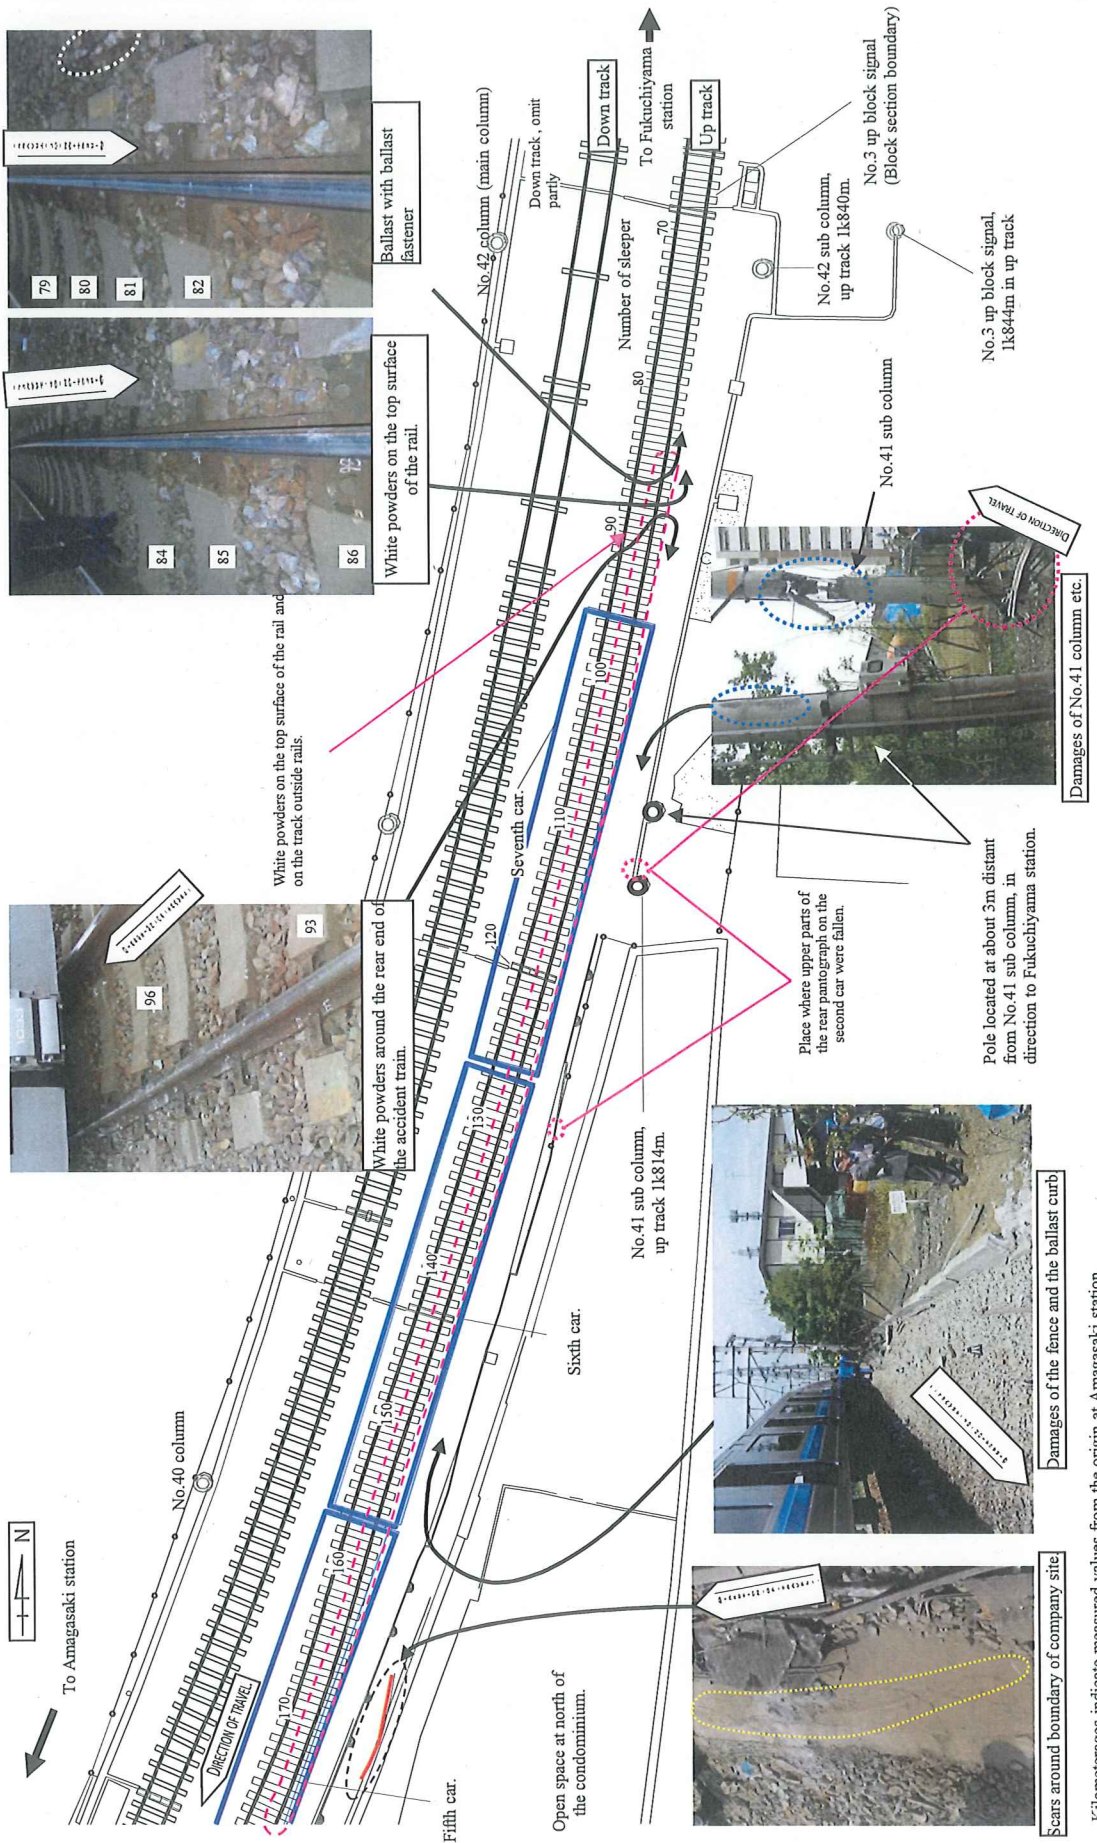
Figure 7 - States of Damage to Railway Facilities etc. (1)

(See Fig. 7 (Part 1) and Fig. 8 (Parts 1 and 2))

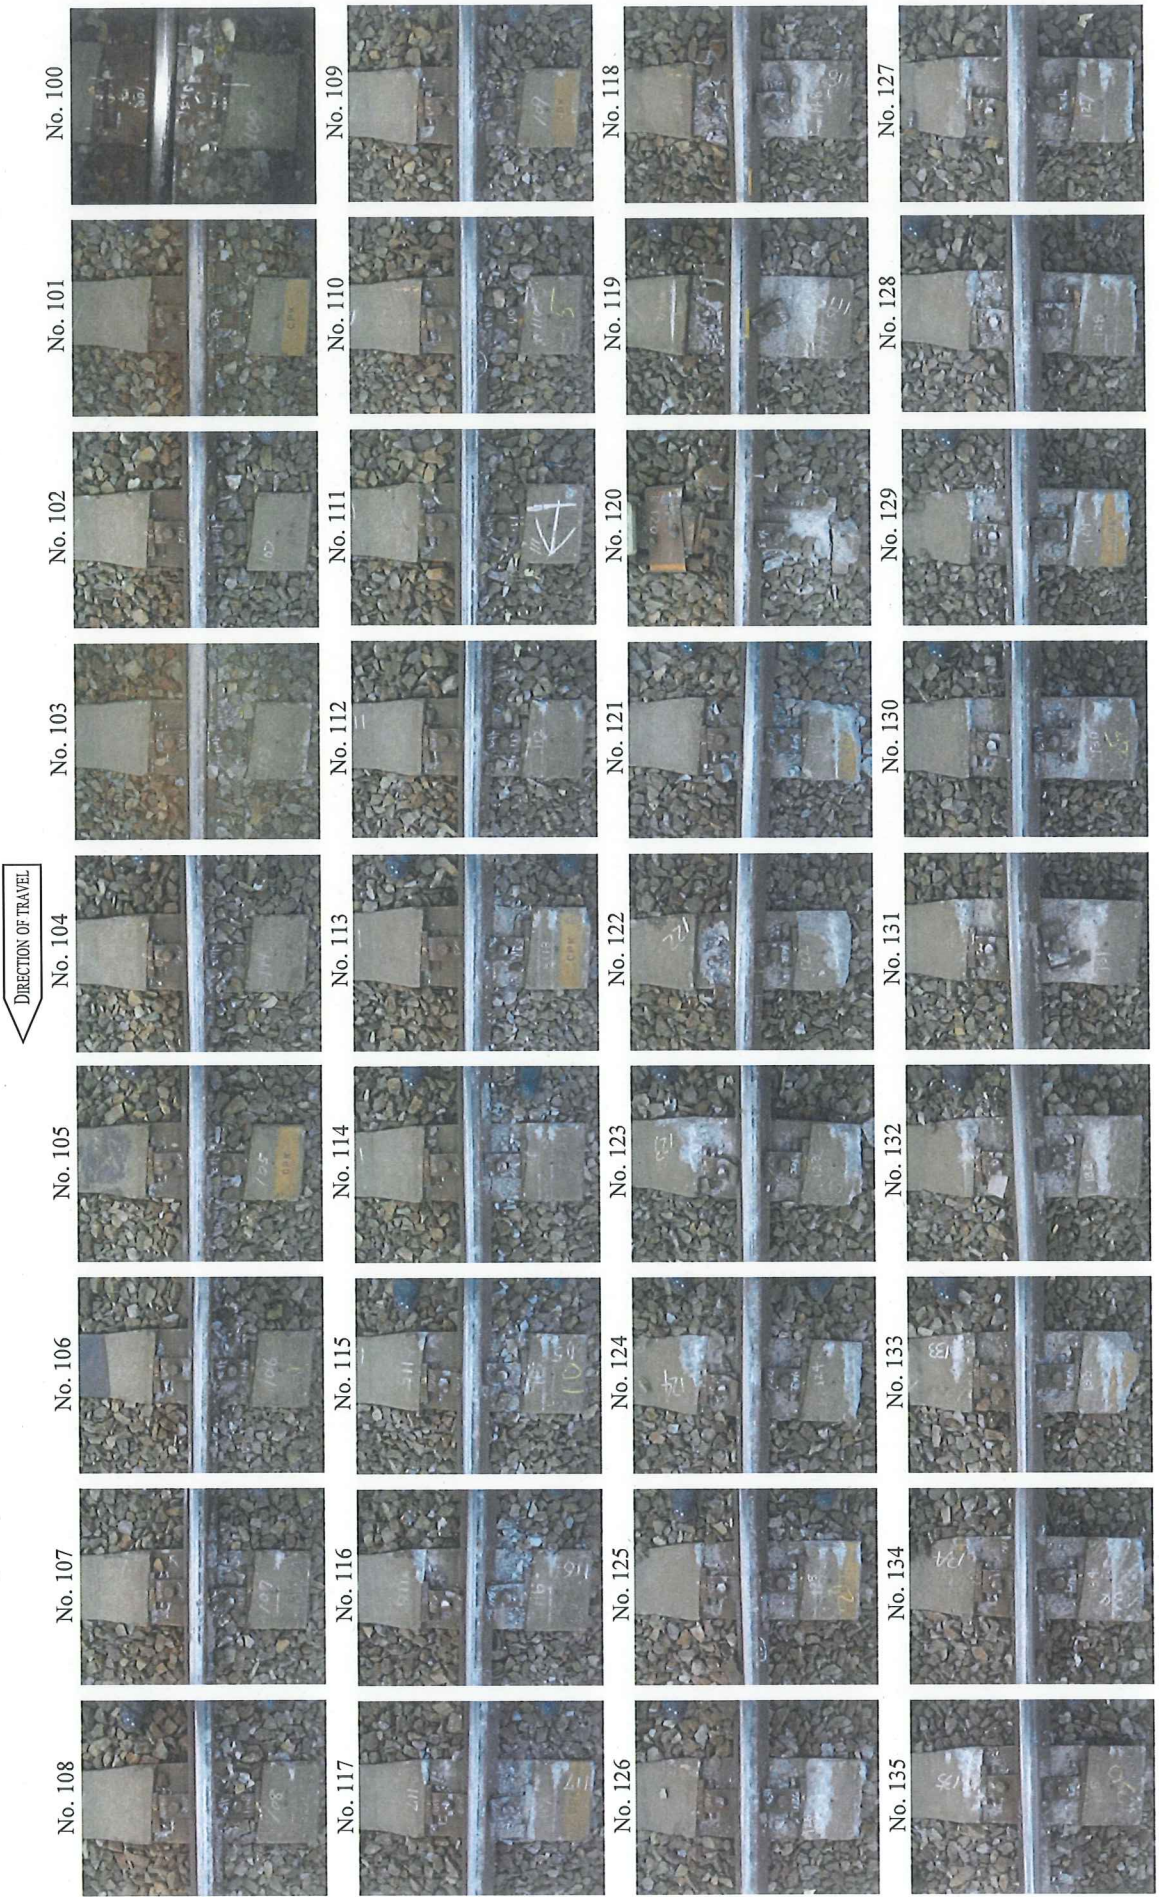
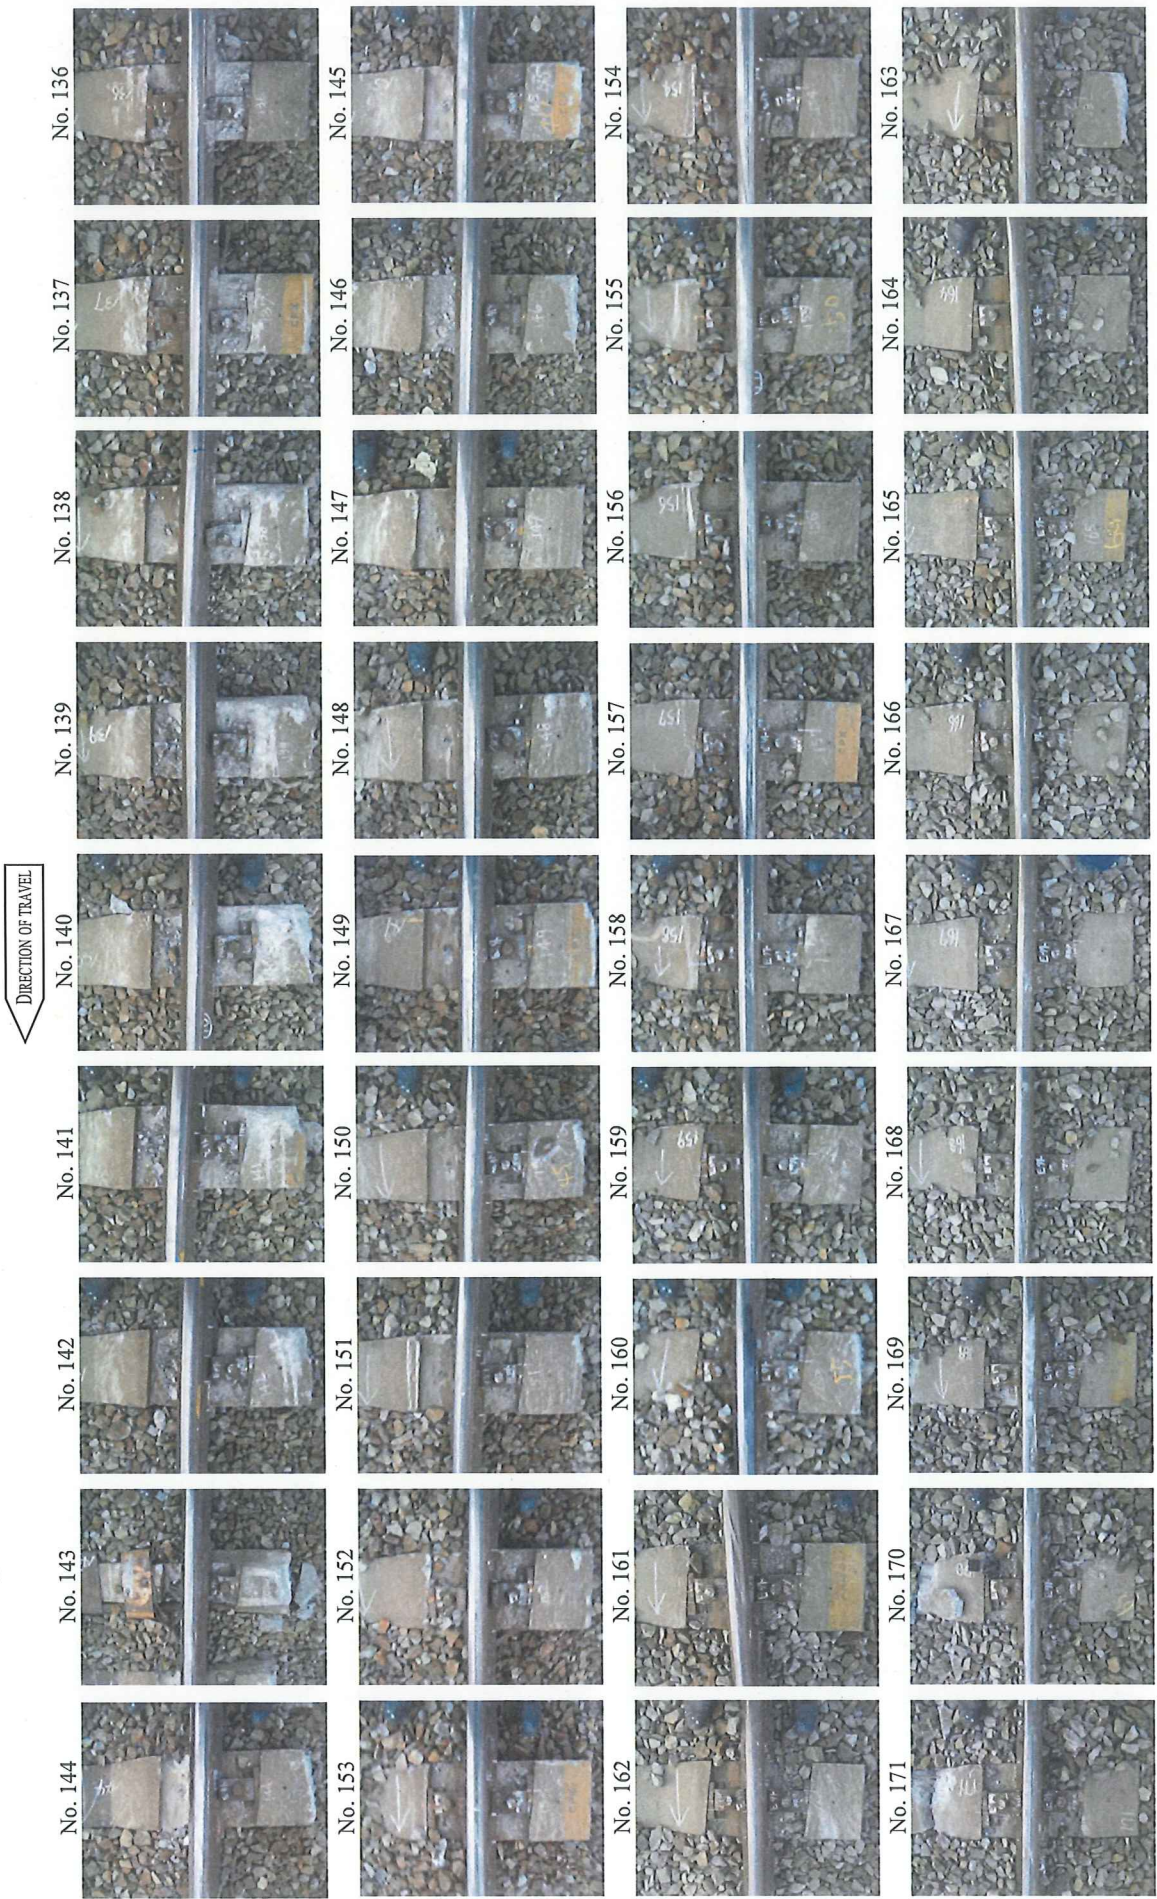
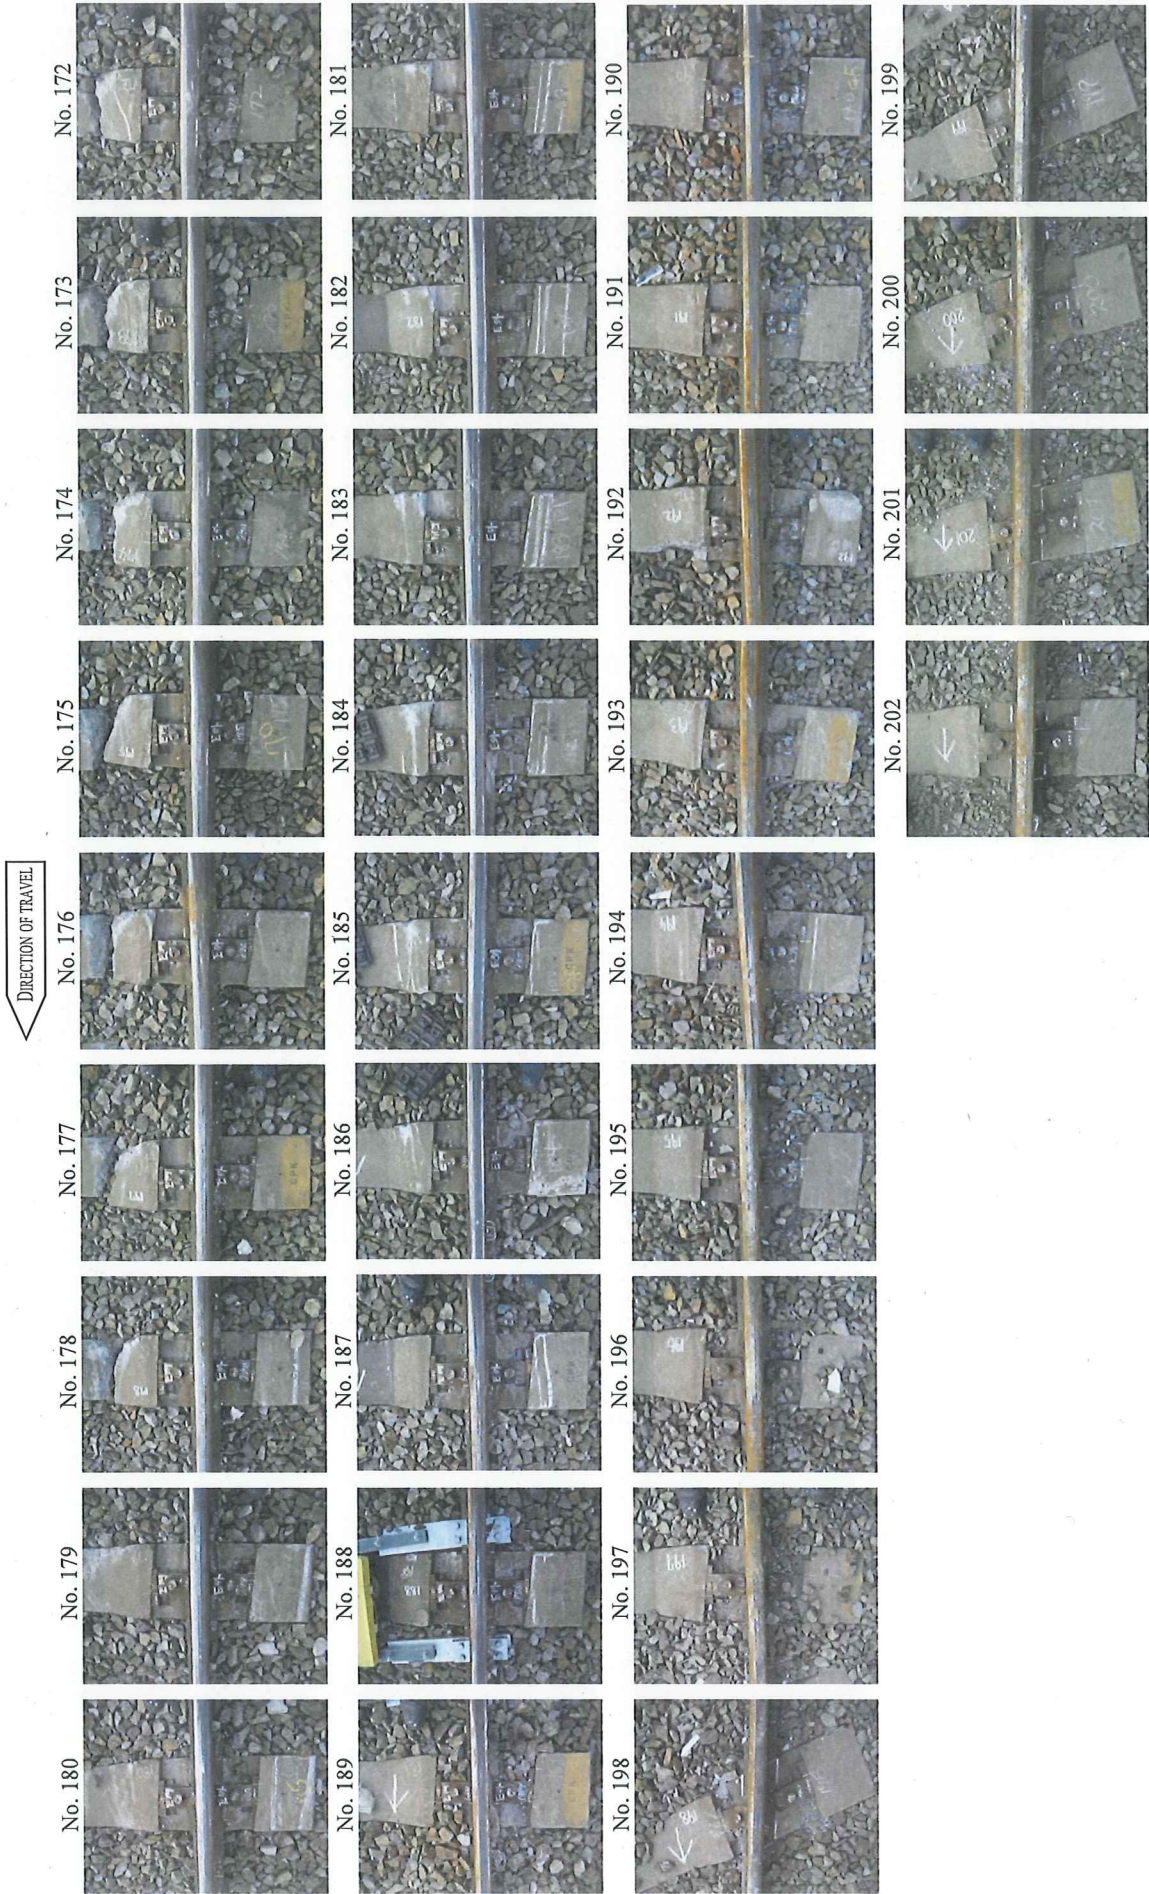
(See Figs. 5 and 7 (Parts 2 to 4))

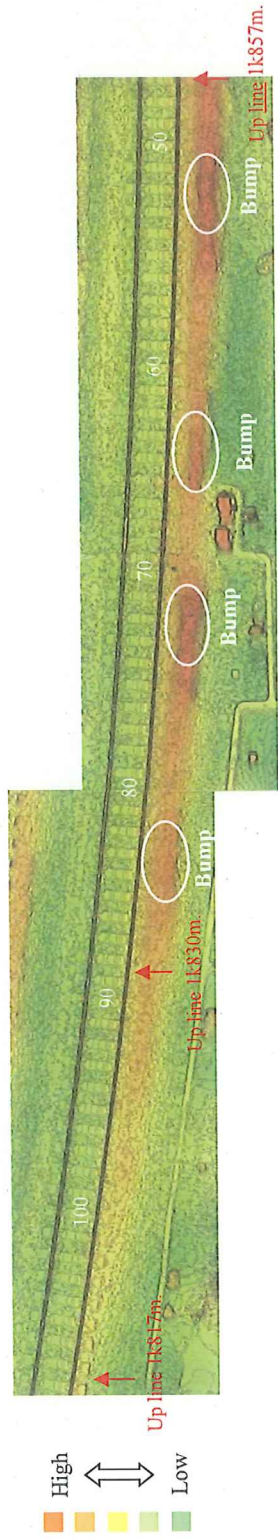
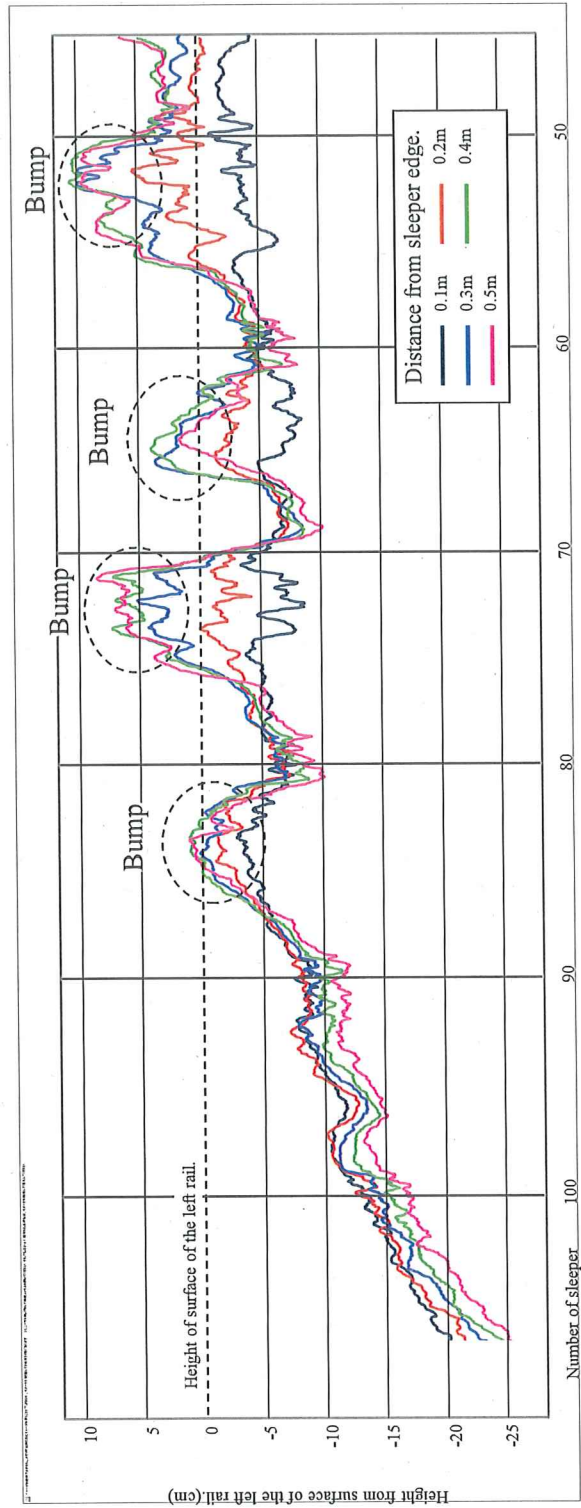
Figure 8 - Three-Dimensional Track Measurement (1) (Contour Line Map of the Accident Site)

(See Fig. 8 (Parts 1 and 2))

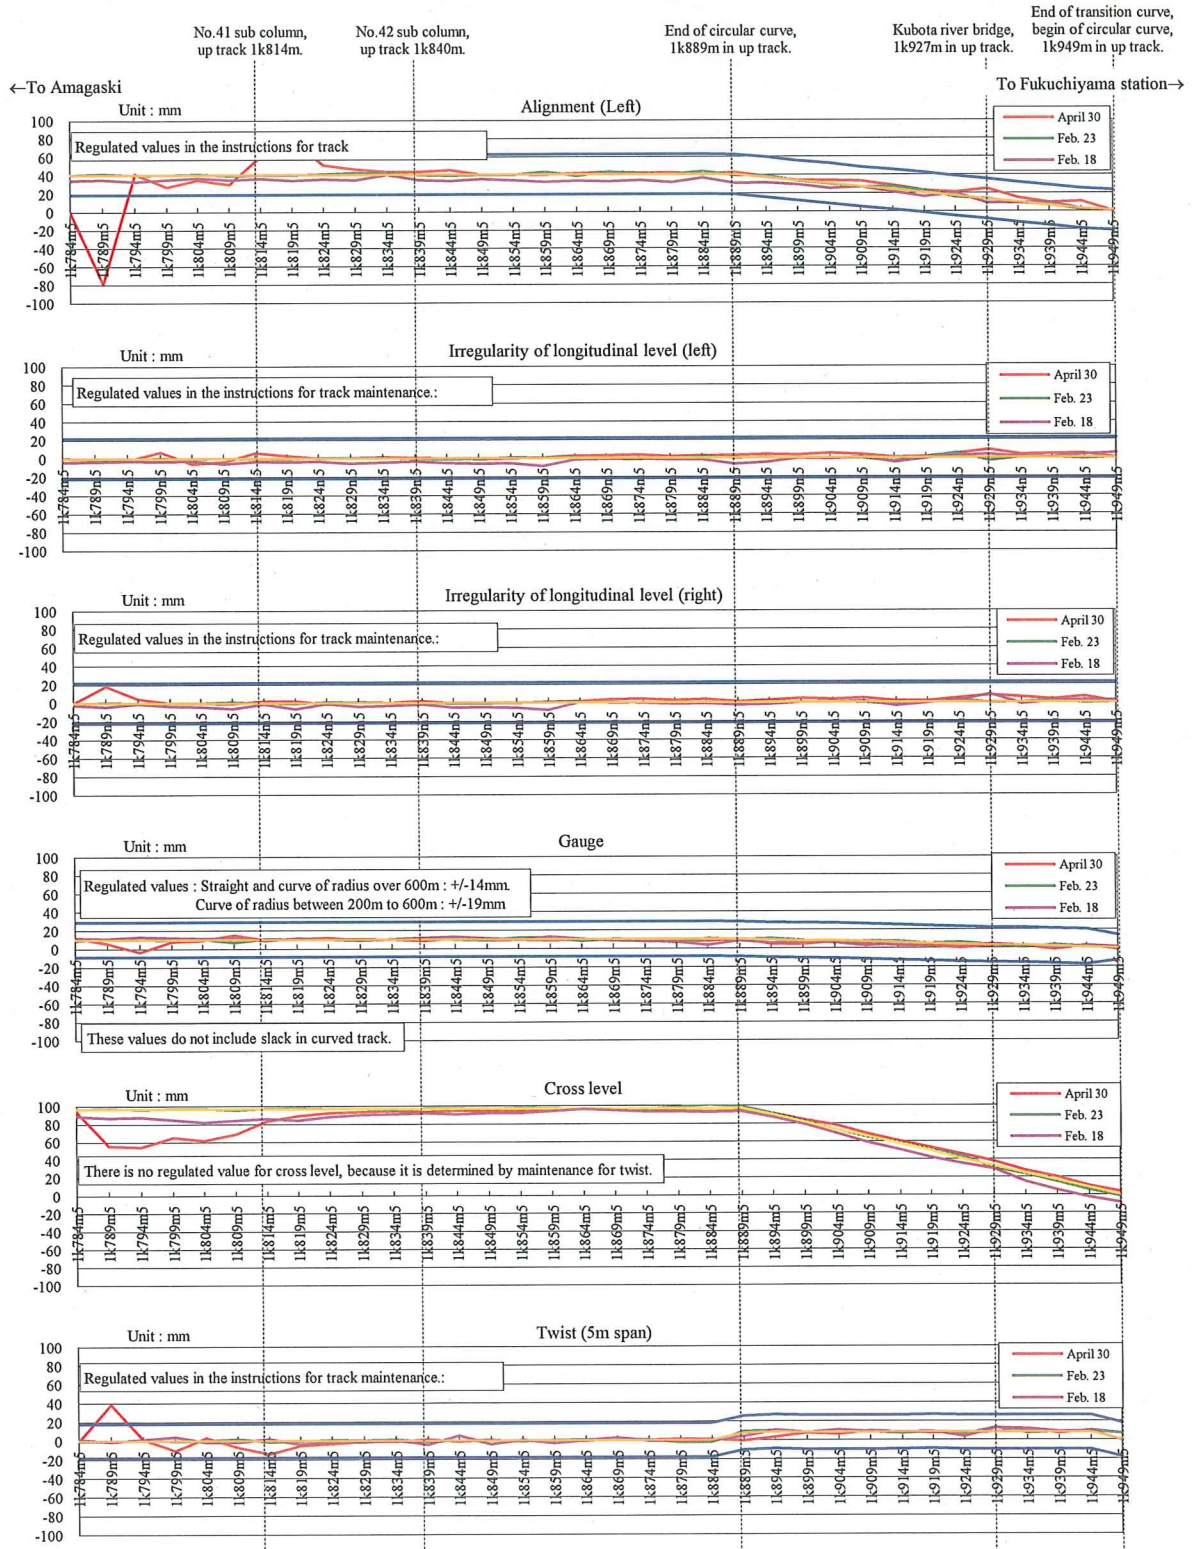
Figure 9 - Track Caused by the Accident

(See Fig. 9)

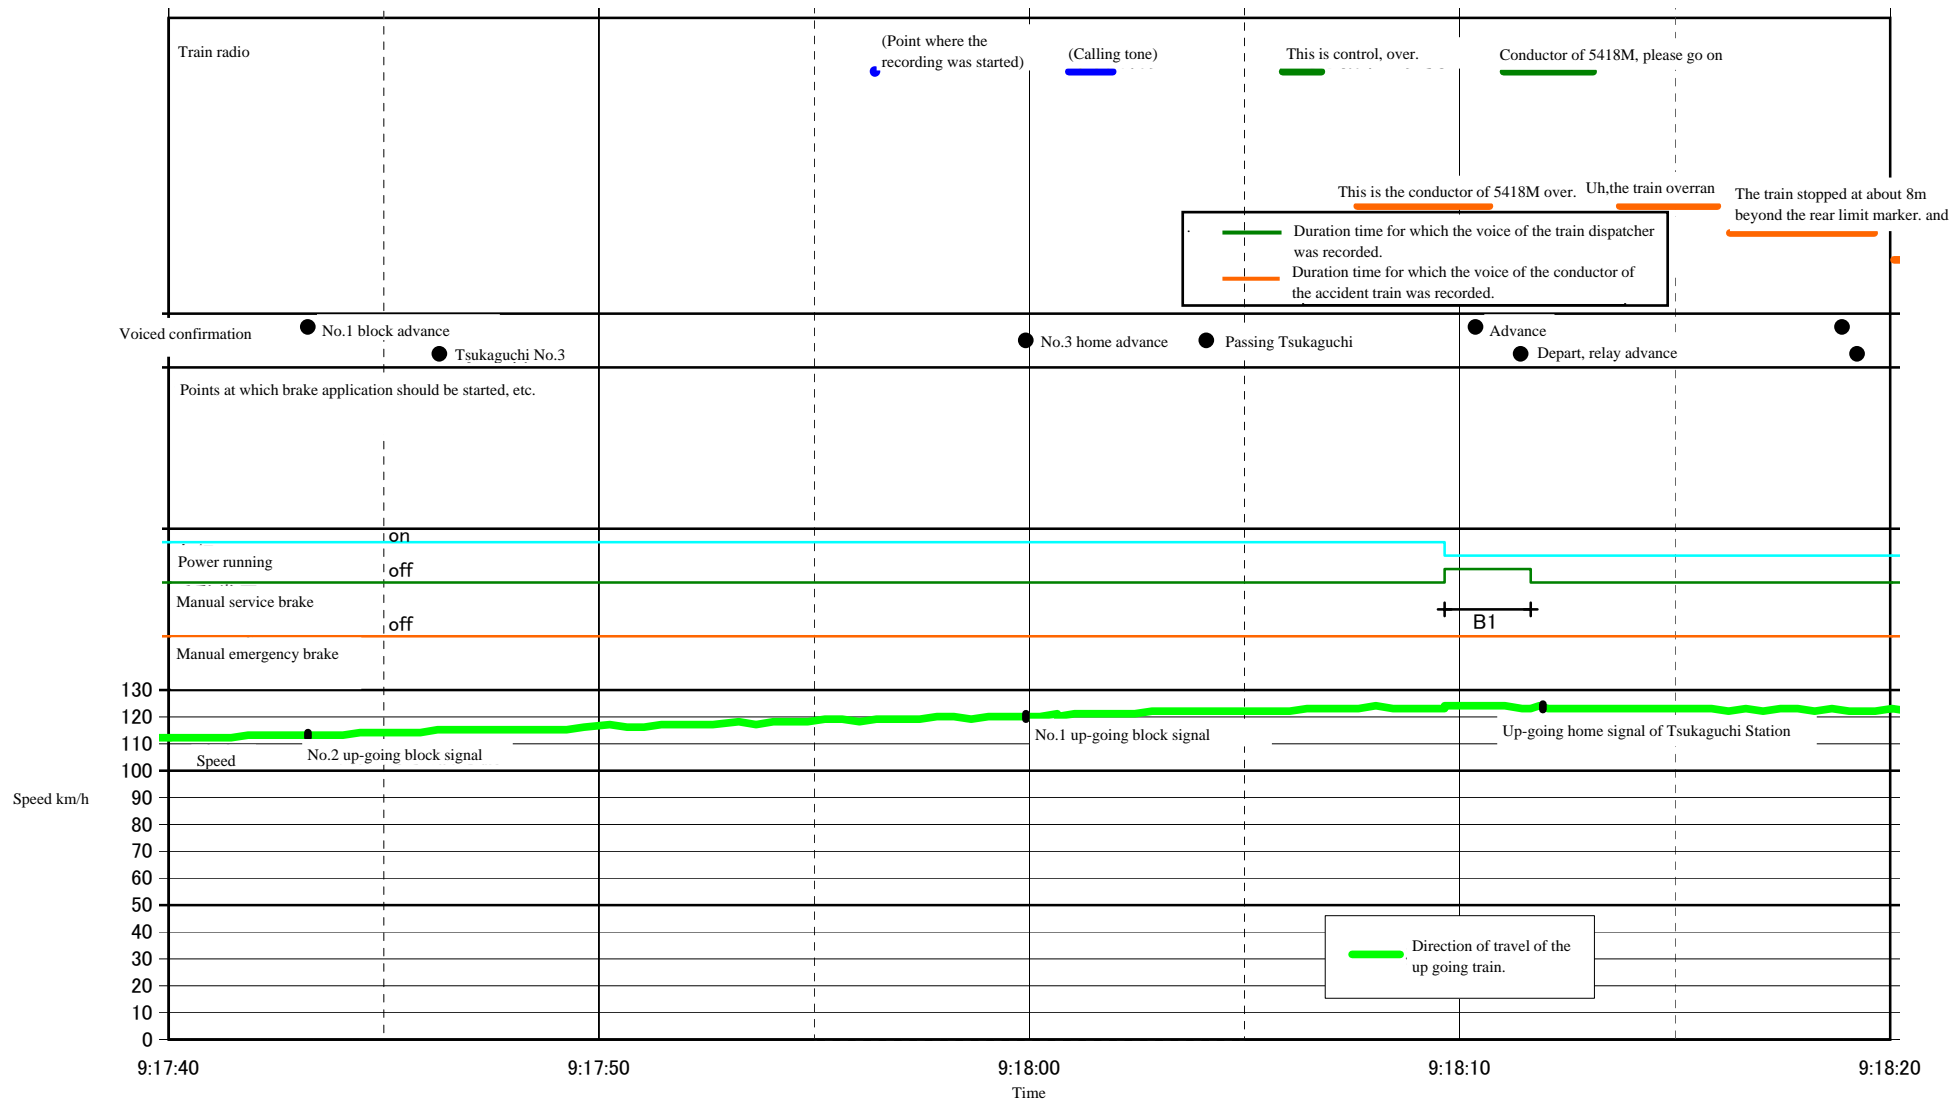
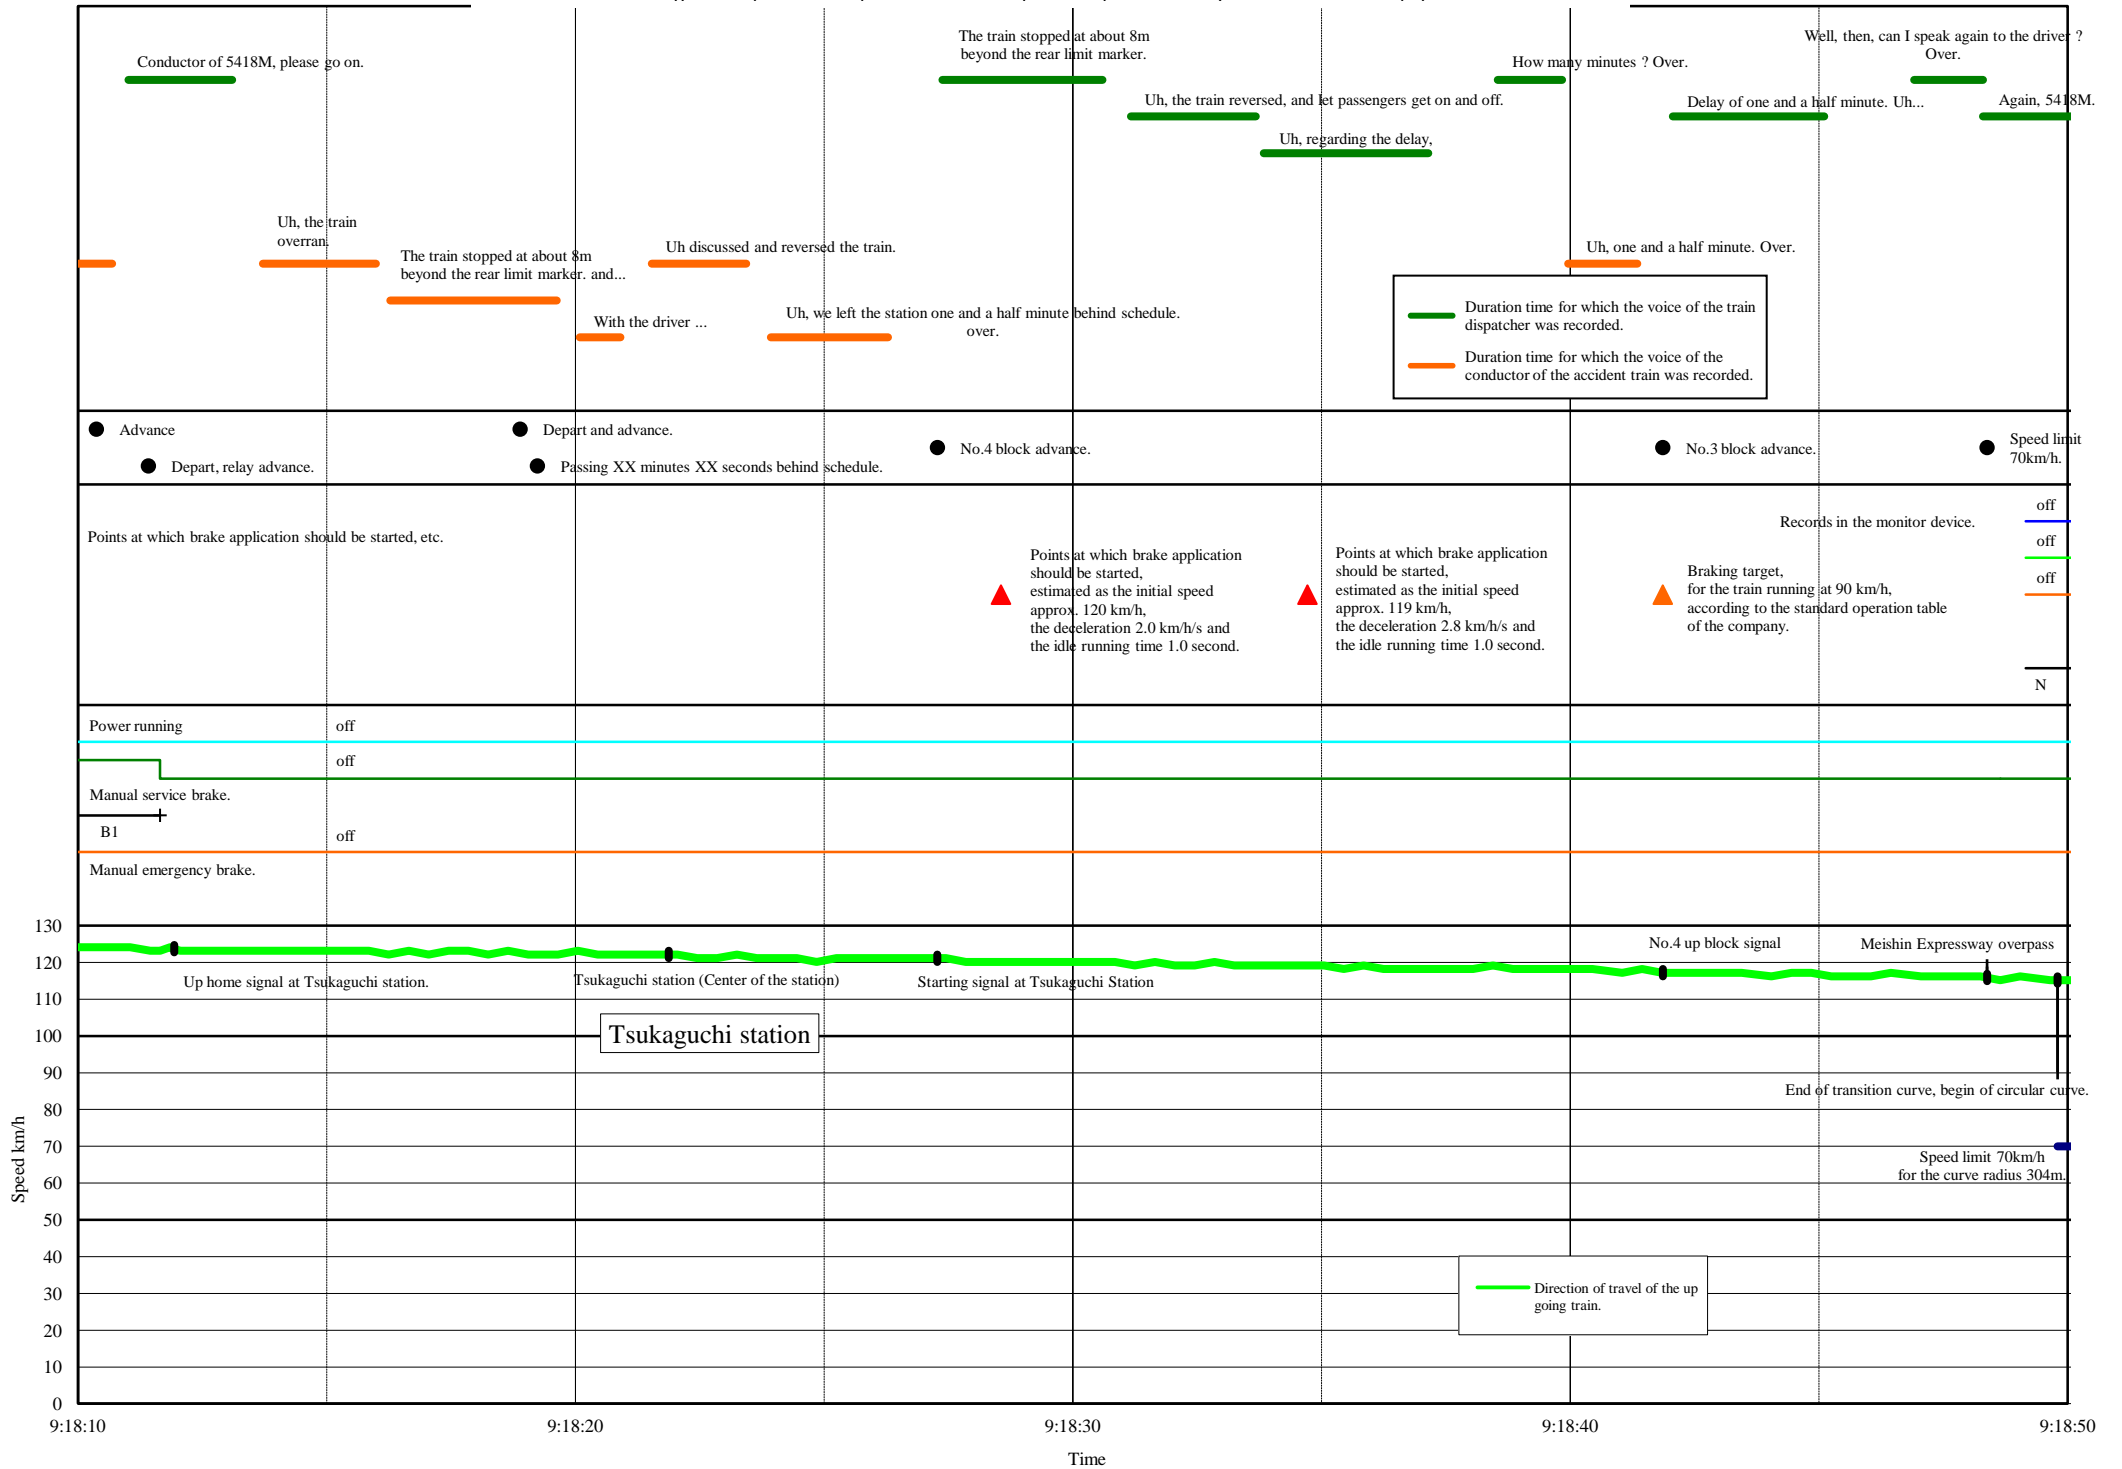
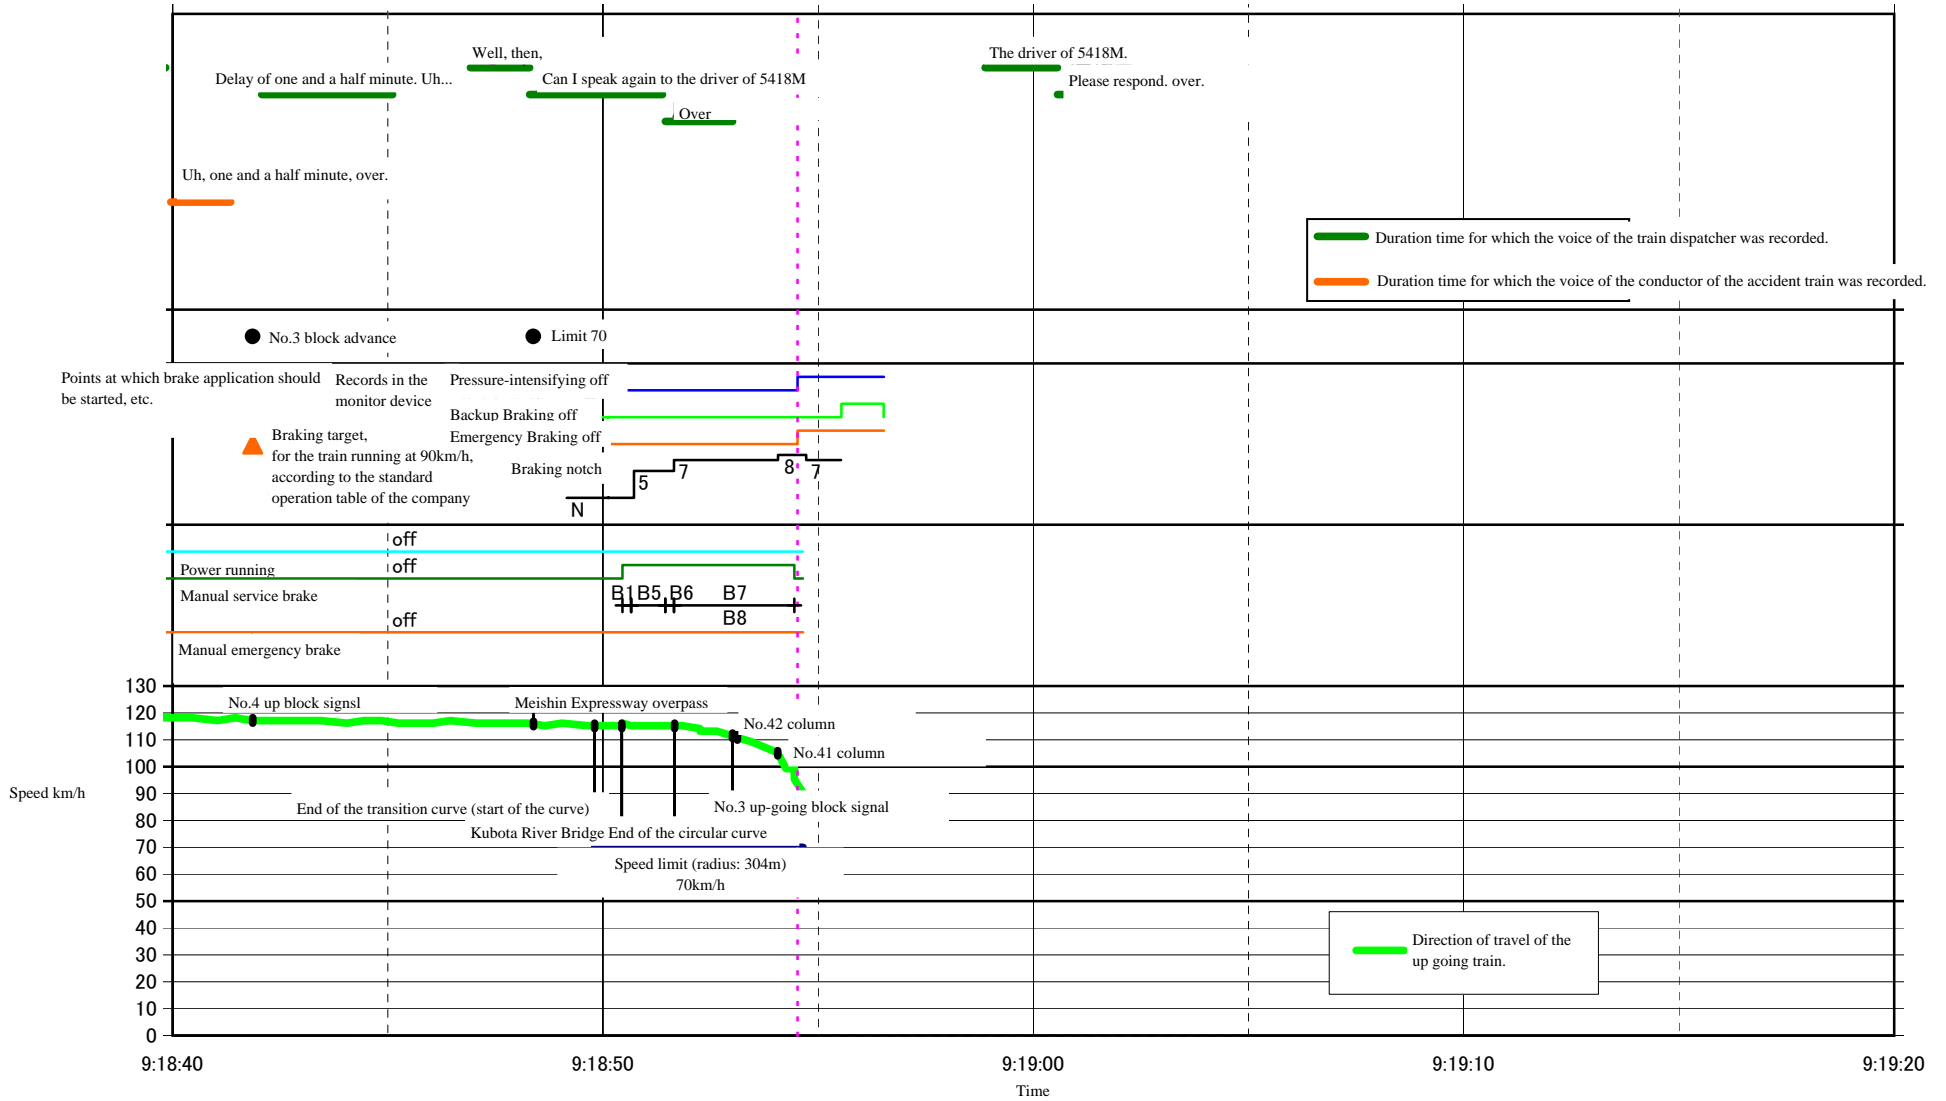
Figure 24 -(Time-based) Record of Train Operation (in the Vicinity of the Accident Site) 1/3

a false report was turned off by a negative response, based on the circumstances described in 3.8.6.1, and that he was looking for an excuse, etc. consistent with "8-m overrun" stated by the conductor of the accident train, worrying about being sent to retraining (see Figs. 24 and 25).

Furthermore, the train dispatcher A is addressing the train driver of the accident train as shown in Figs. 24 and 25, but communications by the train

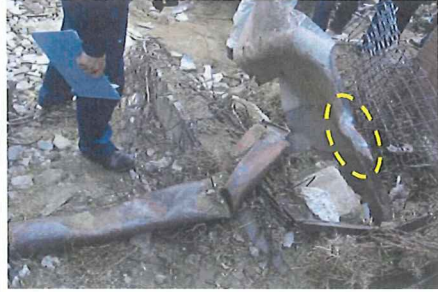
10	Materials stuck to the skirt.	Dent at left side of the skirt of the first car.	White stuck material.	Ca(OH) ₂ CaCO ₃ Quartz Feldspar Mica	Cement, frame	Concrete

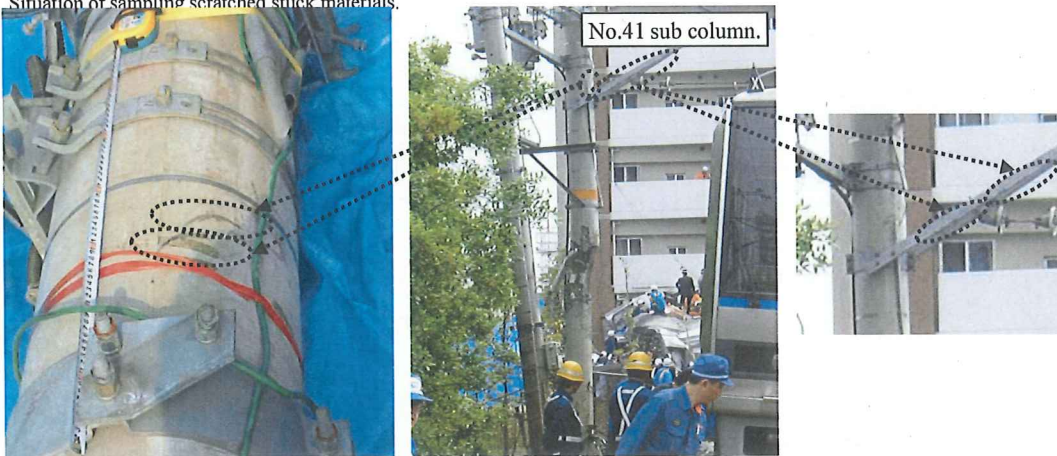
Compared element analysis between scratched side part of the No.41 sub column and the head of referred pantograph.

Situation of sampling scratched stuck materials.

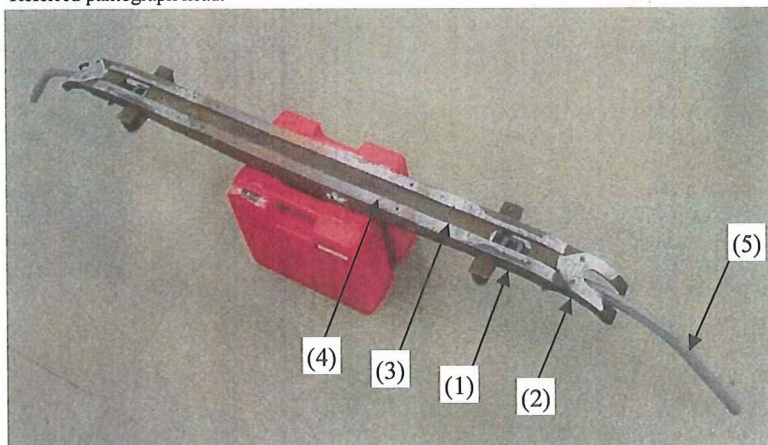
Referred pantograph head.
