**Railway Accident Investigation Report
(Excerpt)**

Train Derailment Accident between Tsukaguchi and Amagasaki Stations of the
Fukuchiyama Line of the West Japan Railway Company

June 28, 2007

Aircraft and Railway Accidents Investigation Commission

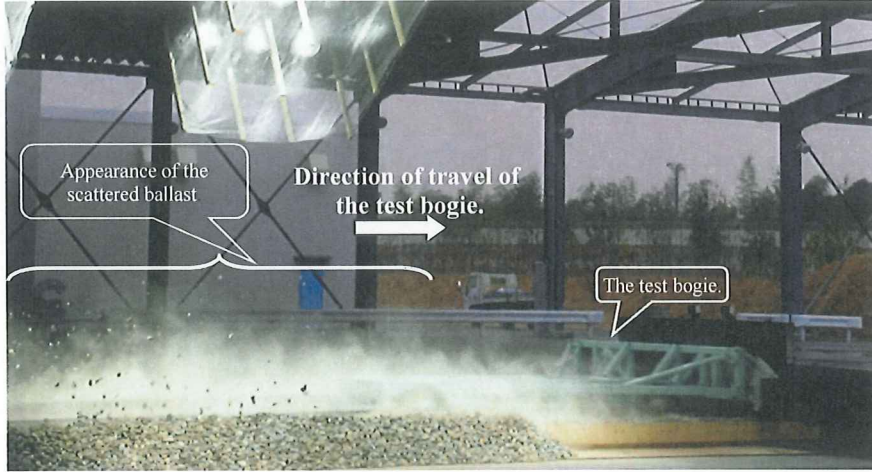
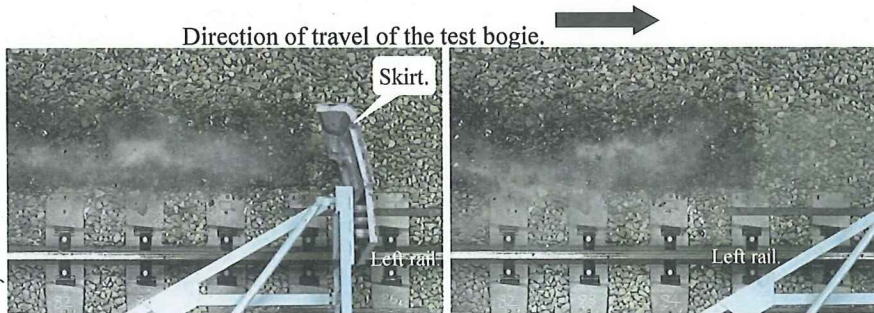
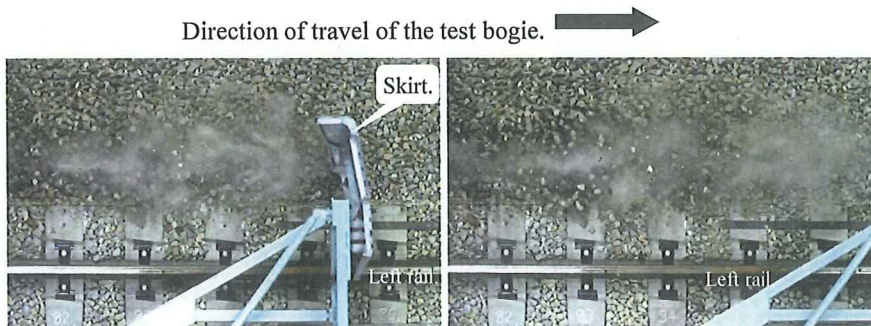
Figure 71 - Ballast Scattering Test Results etc. (2)

1. Appearance of the scattered ballast when the grouting agent for ballast was applied.

2. Appearance of the scattered ballast when the grouting agent for ballast was not applied.

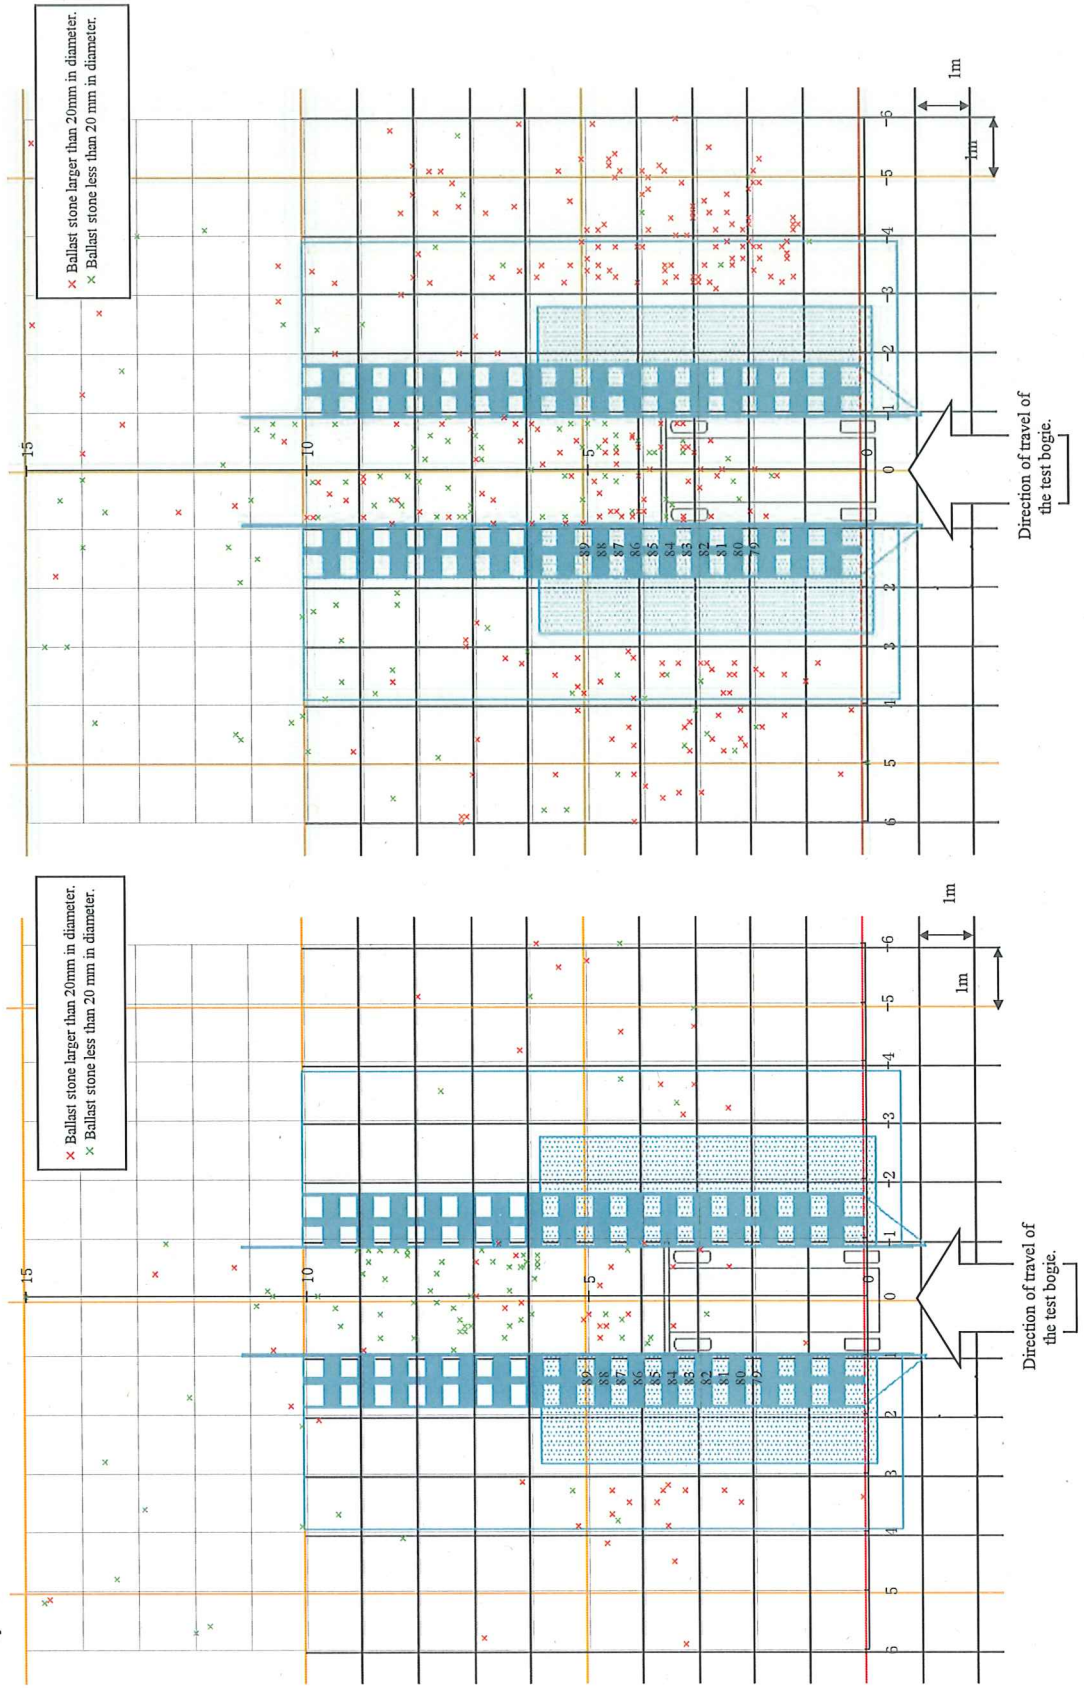
Figure 71 - Ballast Scattering Test Results etc. (3)

Ballast distribution after the grouting agent for ballast applied test at speed of 115 km/h.

- (1) Ballast distribution when the lower edge is lower than the surface of ballast by 30 mm.
- (2) Ballast distribution when the lower edge is lower than the surface of ballast by 50 mm.

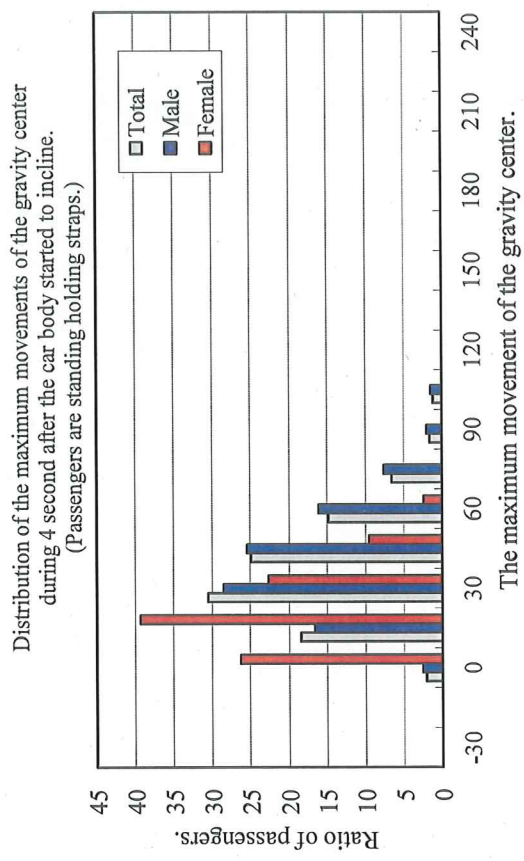
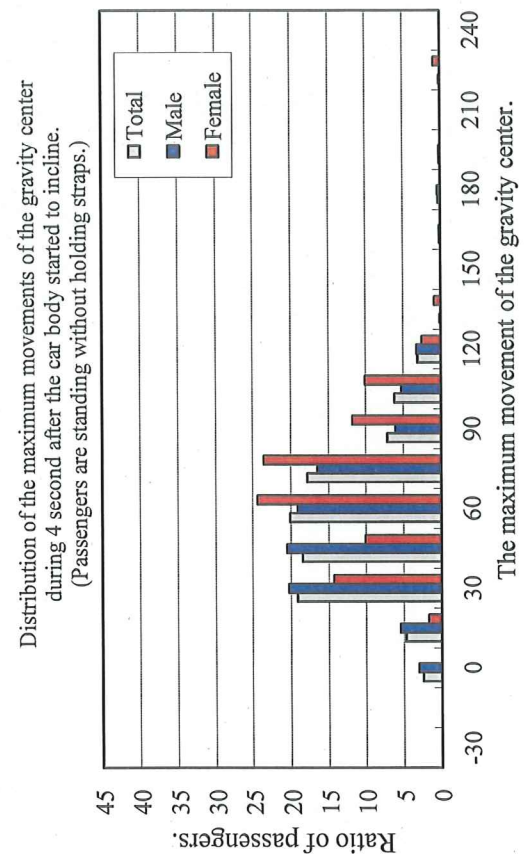
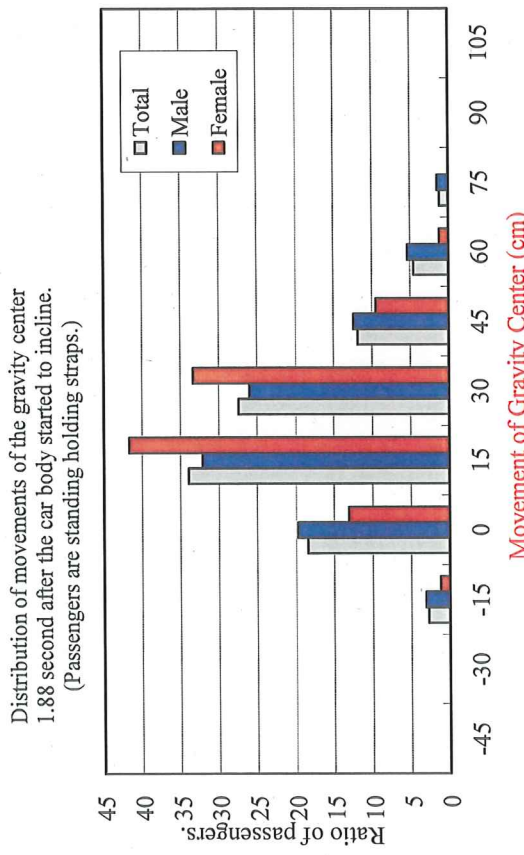
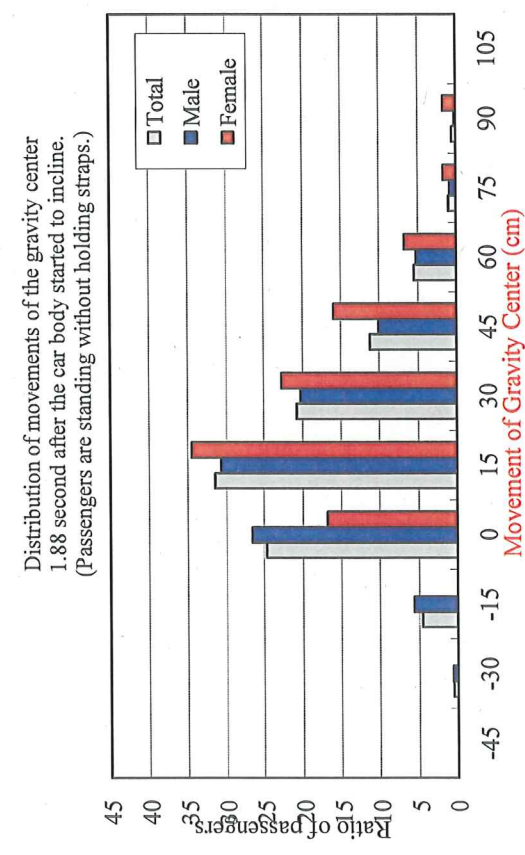
Figure 72 - Results of the Test to Reproduce and Measure the Shifts of the Centers of Gravity of the Passengers in the Individual Railway Cars.

(See Fig. 72)

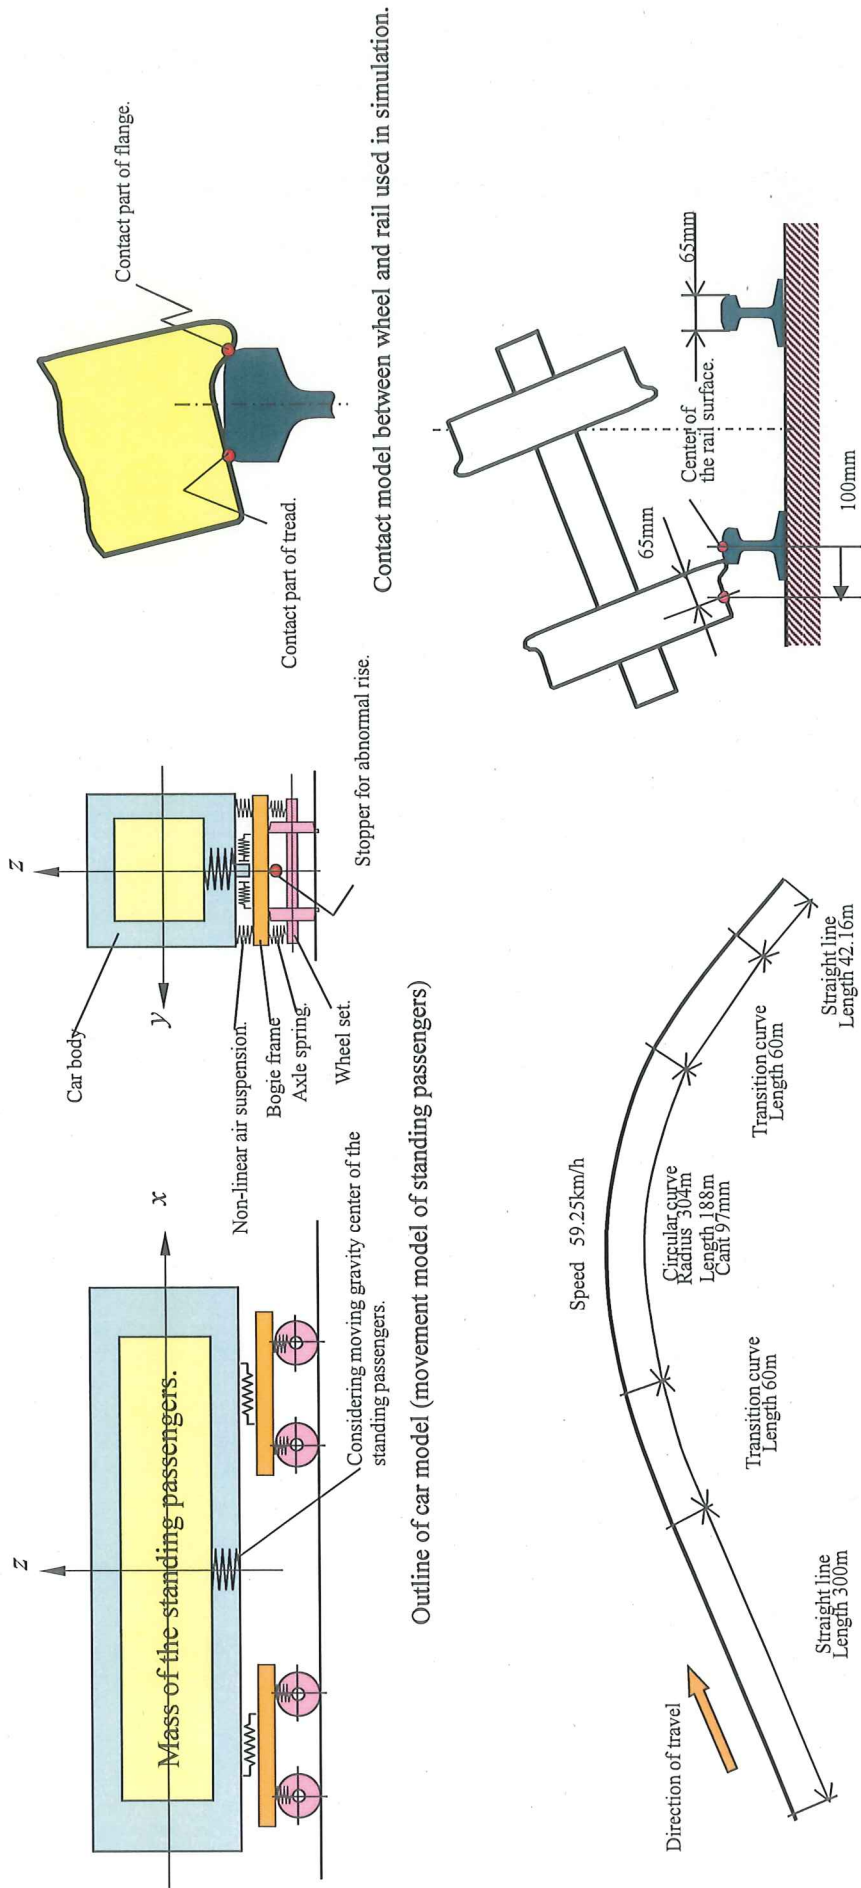
Figure 73 - Overview of the Computer-based Derailing Simulations

Outline of car model (movement model of standing passengers)

Contact model between wheel and rail used in simulation.

Judgment condition for derailment :
 Tread center of left wheel displaced more than
 100mm with respect to the center of left rail surface.

Track model used in simulation.

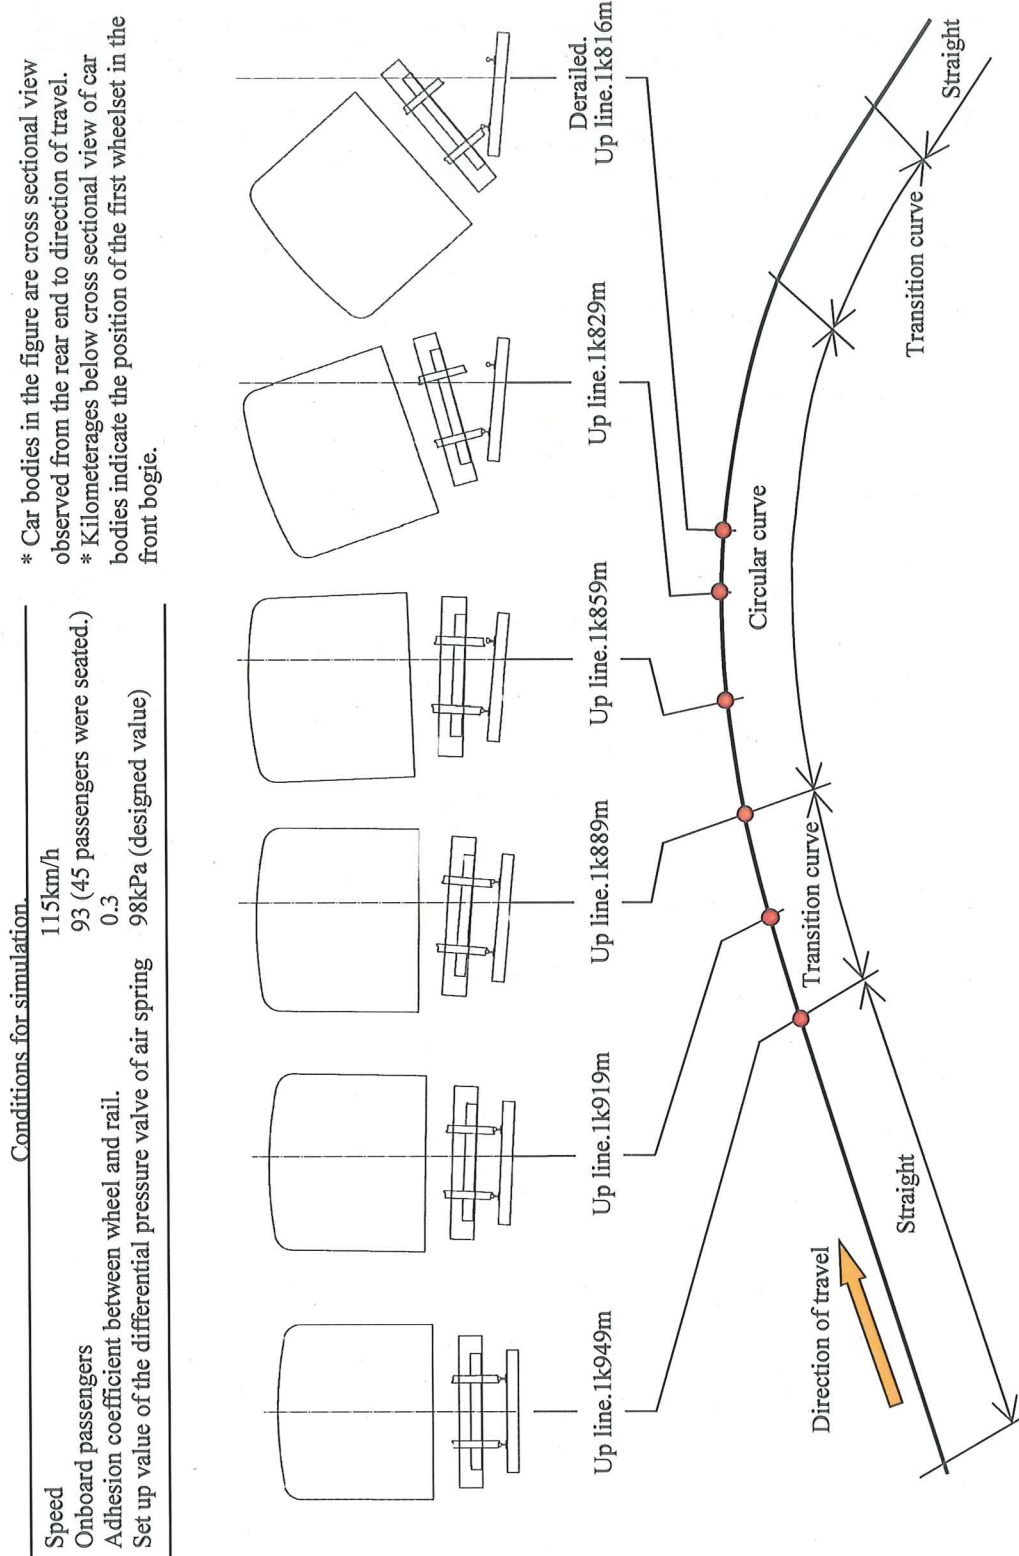
Figure 74 - Simulated Changes in the Postures of the Railway Cars in the Train up to the Moments of

(See Fig. 74)
