Marine Accident Inquiry Agency MAIA DIGEST

Marine Accidents in Naka Suido (Channel) and Nishi Suido (Channel) of the Kurushima Kaikyo (Strait)

- ◆ Traffic Rules of the Kurushima Kaikyo (Strait) 1 ~ 2
- ◆ Typical Marine Accidents in Naka Suido (Channel) and Nishi Suido (Channel) 3
- ◆ Case Studies (Collision and Grounding) 4 ~ 8

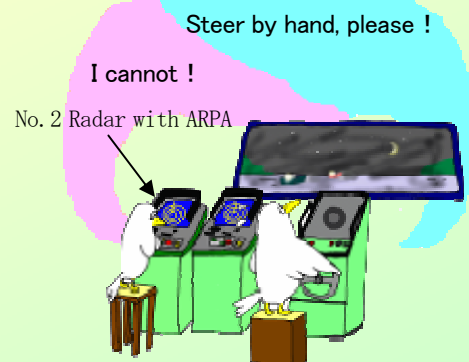
A few temporary seamen dispatched from a manning company were always on board “S” to replace those on leave.

The boatswain had been temporarily on board “S” for 2 months. But he was unable to steer by hand in the Kurushima Kaikyo and did not know where the whistle button was.

Crew must be trained and educated appropriately for specific voyages.

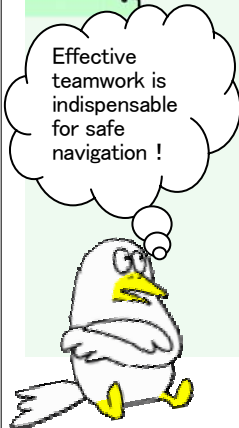
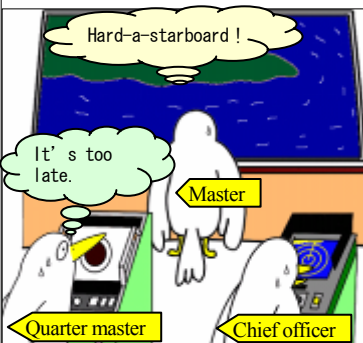
En route from Osaka Port to Naha Port, "S" intended to anchor for sheltering from a typhoon off Yashiro Shima, Yamaguchi, under the condition that typhoon No.23 was approaching the south coast of Shikoku. The vessel proceeded westward in the Seto Naikai (the Inland Sea) and reached the Kurushima Kaikyo. Receiving NNE wind on her starboard bow, "S" was proceeding with the fair current at almost full speed of 19.0 knots at the south entrance of Naka Suido, when the ship ran aground on shallows off the south-east coast of Uma Shima due to the delay of changing course.
