Marine Accident Inquiry Agency

MAIA DIGEST

Message for the Prevention of Marine Accidents in Fog

“Why Did the Ship Make a Port Turn ? ”
- clearing the mystery of accidents in fog -

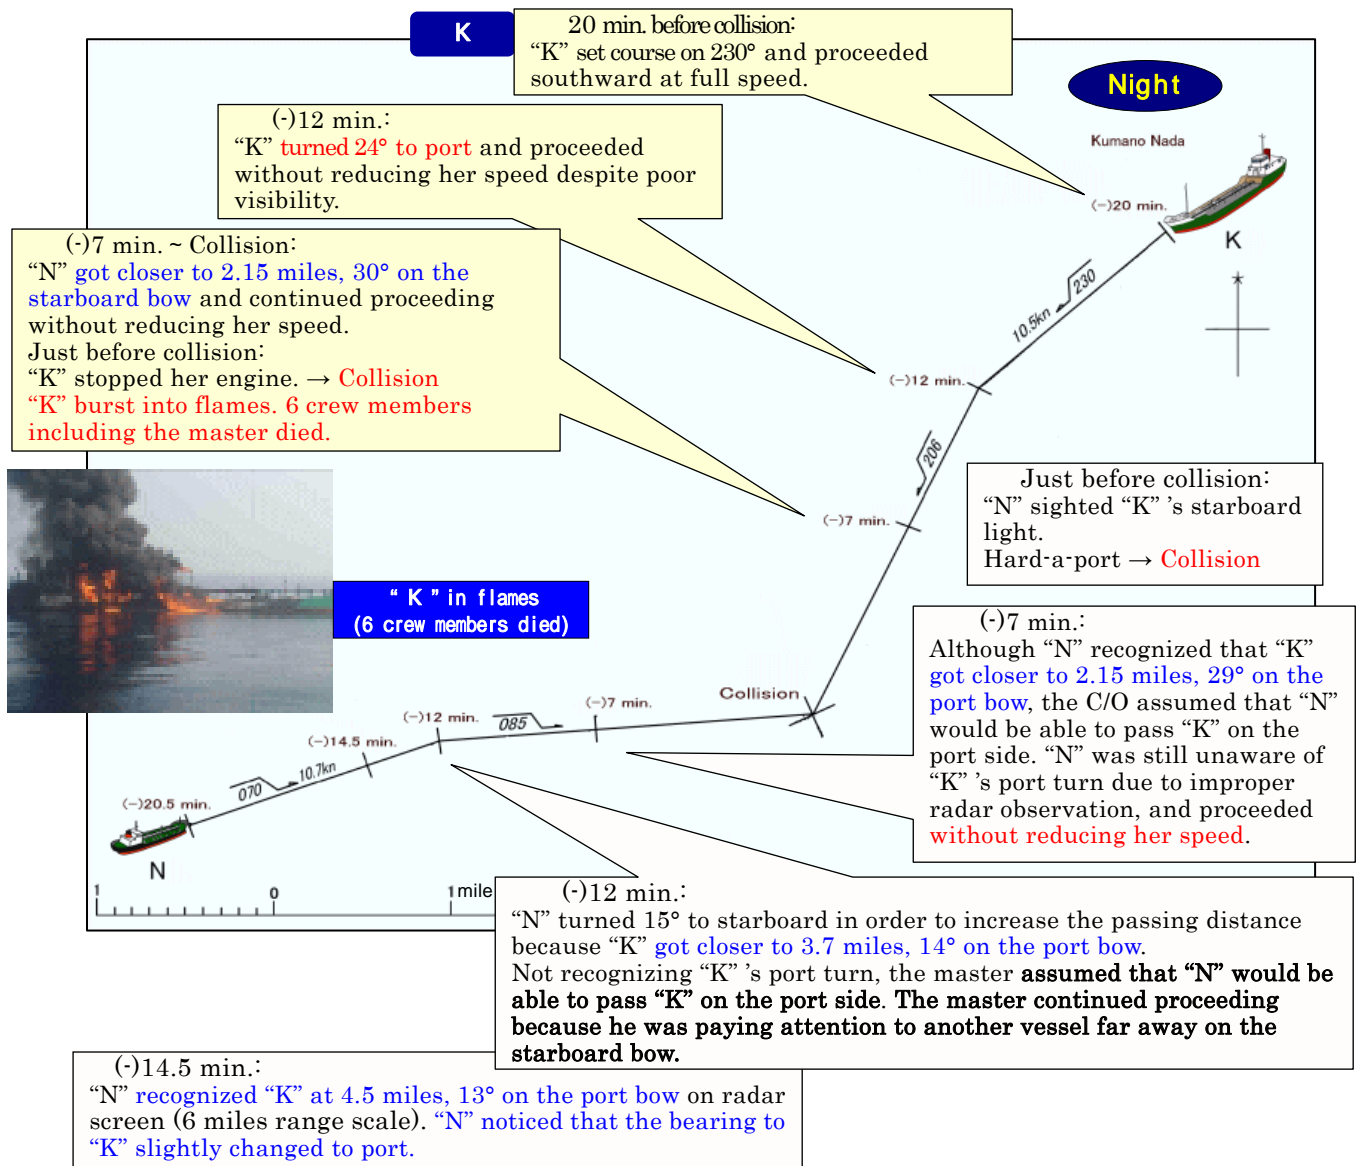
Oil tanker “K” G/T: 697 t Crew: 7 Cargo: DM Reformate (2,000kl) Yokkaichi Port → Matsuyama Port
 Master Age: 56 (OOW is not identified)
 Chemical tanker “N” G/T: 499 t Crew: 5 Cargo: Deoxidized naphthalin (203 t) and Creosote oil (805 t)
 Mizushima Port→ Chiba Port
 Master Age: 60 License: Fifth class (Deck) (36 years after acquisition) Experience at sea: 36 years
 C/O (OOW) Age: 53 License: Third class (Deck) (16 years after acquisition) Experience at sea: 38 years
 Time and date : At 04:05 JST (UTC+9h) on July 15, 2005 Place of accident: Kumano Nada
 Weather: Fog No wind Visibility: About 250m During dense-fog warning

20 minutes before collision:
 The 2/O informed the C/O, next OOW, of the course, the condition of the fog and the existence of another vessel on the opposite course on the starboard bow, and left the bridge. The visibility became less than 5 miles, but the C/O did not report it to the master.
 The vessel continued proceeding at full speed without giving sound signals nor reducing her speed.

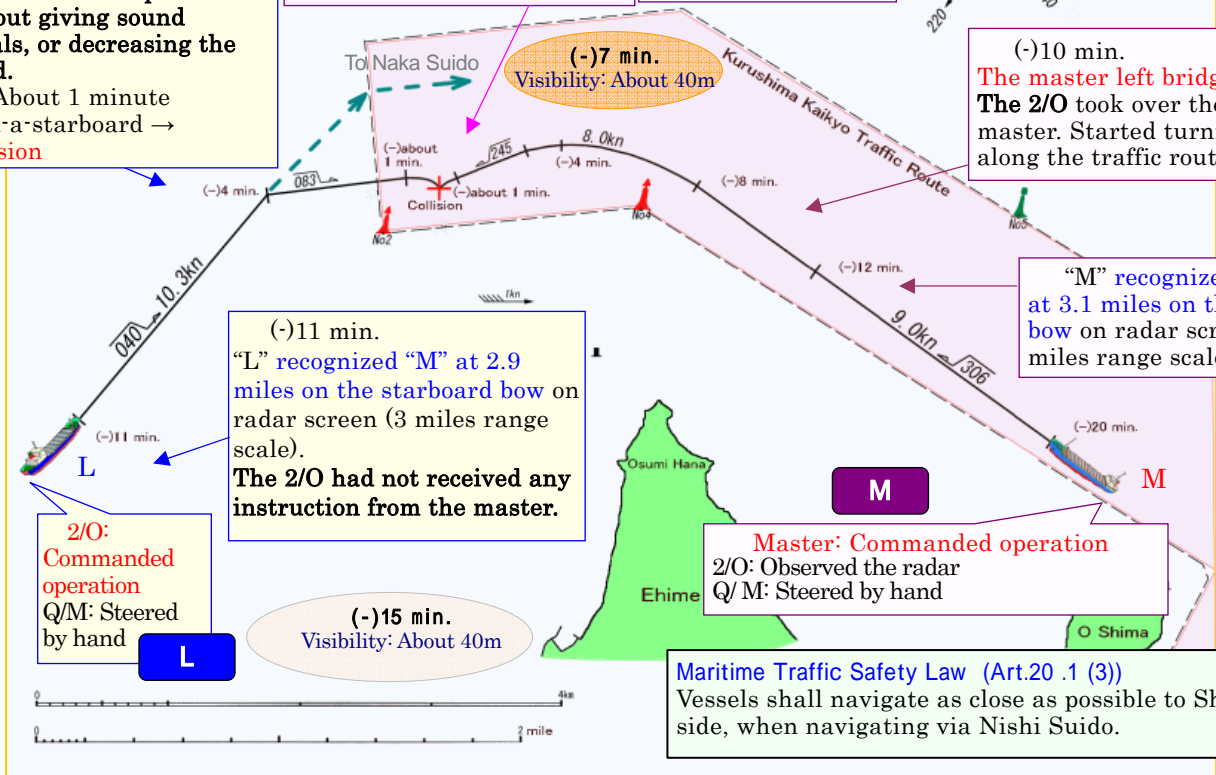
(-)4 min.
 The 2/O failed to report to the master that visibility worsened rapidly. The 2/O recognized "L" at 1.2 miles on the port bow on radar screen while "M" turned port gradually. "M" proceeded without giving sound signals, or reducing the speed.

(-)10 min.
 The master left bridge. The 2/O took over the port. Started turning port along the traffic route.

(-)11 min.
 "L" recognized "M" at 2.9 miles on the starboard bow on radar screen (3 miles range scale).
 The 2/O had not received any instruction from the master.

"M" recognized "L" at 3.1 miles on the port bow on radar screen (3 miles range scale).

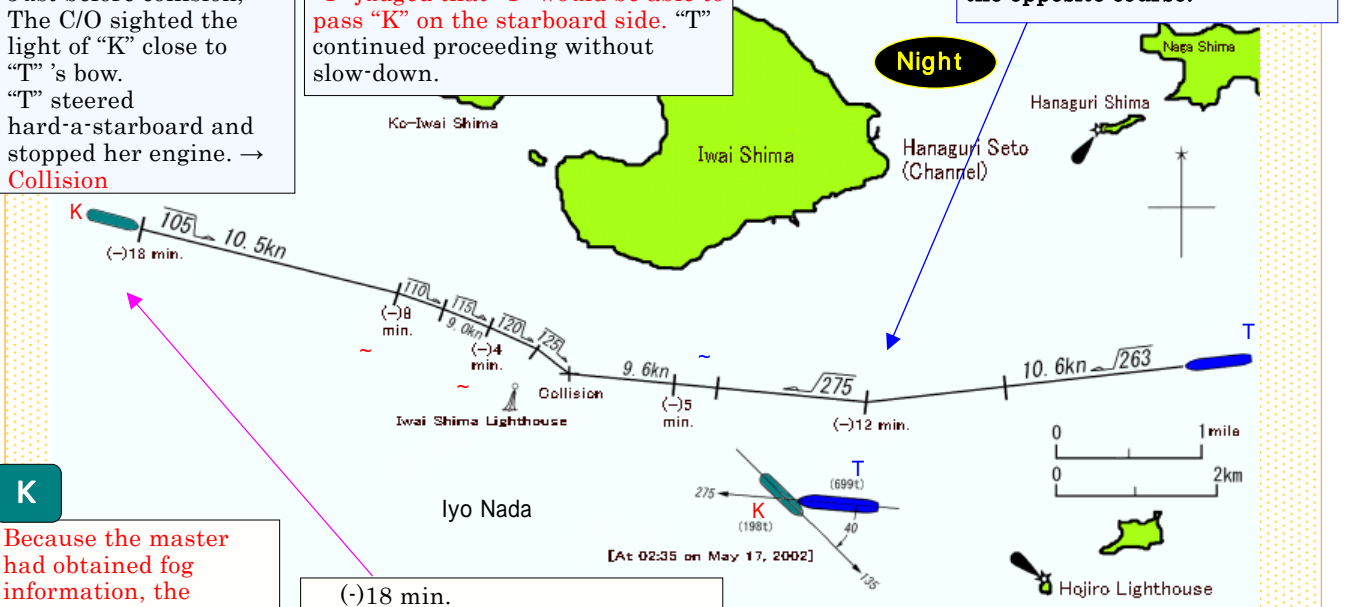
Cargo vessel "T" G/T: 699 t Crew: 5 Cargo: Cement (1,086 t) Higashi Harima Port, Hyogo → Kanda Port, Fukuoka
 Master Age: 54 License: Forth class (Deck) (29 years after acquisition) Experience at sea: 36 years
 C/O (OOV) Age: 73 License: Fifth class (Deck) (35 years after acquisition) Experience at sea: 60 years
 Cargo vessel "K" G/T: 198 t Crew: 2 Cargo: Stainless steel(364t) Kanmon Port → Kinuura Port, Aichi
 Master (OOV) Age: 42 License: Fifth class(Deck) (16 years after getting license) Experience at sea: 19 years
 Time and date : At 02:35JST (UTC+9h) on May 17, 2002 Place of accident: Iyo Nada
 Weather: Fog, no wind Visibility: About 100m

(-)10 min.
 The C/O recognized the fog emerging ahead of "T" because he could not sight the "K" 's light, 3.2 miles from "T".

The master had relied on the well-experienced C/O, and had not instructed him to report poor visibility to the master.
 (-)12 min.
 After "T" changed course to 275°, "T" recognized "K" at 4.0 mile, 8° on the starboard bow on radar screen (12 miles range scale and Off center). "T" recognized that "K" was on the opposite course.

Because the master had obtained fog information, the master had ordered the C/E (OOV) to report to the master when visibility became poor.
 (-)About 1 hour
 The C/E reported to the master that visibility became poor about 100m. The master went up to the bridge and commanded operation.

(-)18 min.
 The master recognized "T" at 6.0 miles on the right ahead on radar screen (6 miles range scale). He recognized that "T" was on the opposite course. He turned 5° to starboard in order to pass "T" on the port side, so that the echo of "T" is located on the port side of heading marker on the radar. "K" proceeded at full speed using auto-pilot without giving sound signals.

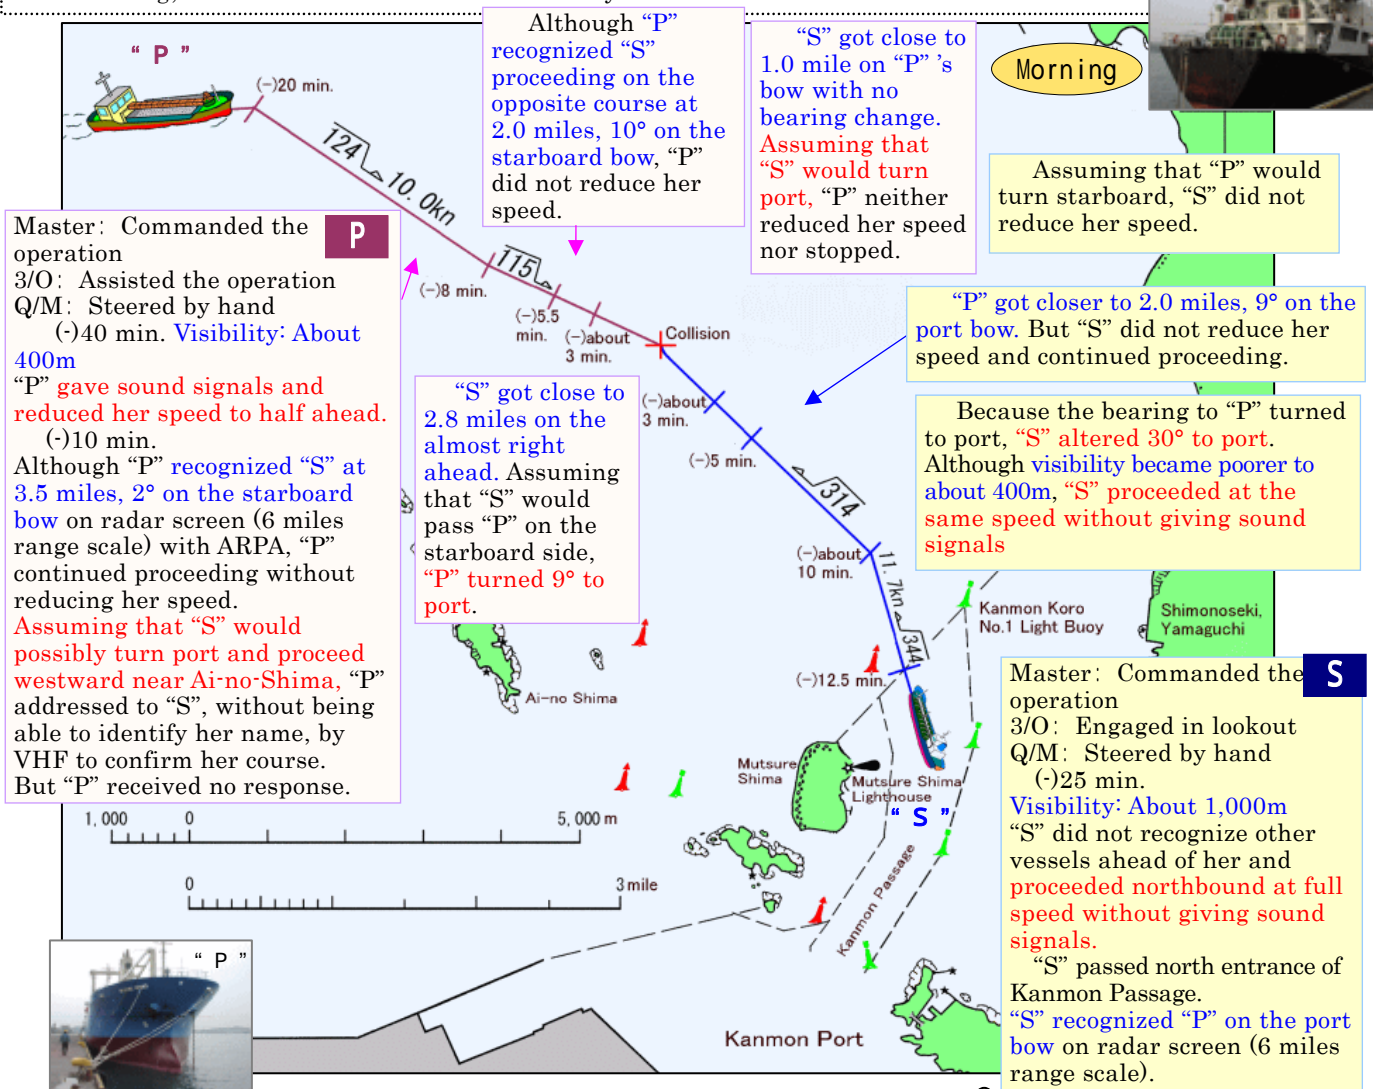
Place of accident: Off North of Mutsure Shima, Yamaguchi

Weather: Fog, WNW wind with force 3 Visibility: About 400m

Lessons for the navigation under poor visibility
Slow down to a safe speed!
Avoid a close quarters situation in ample time!
