Marine Accident Inquiry Agency

MAIA DIGEST

Message for the prevention of marine accidents due to typhoons

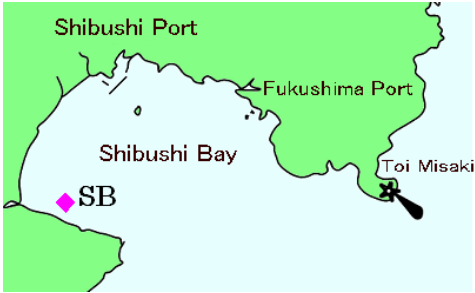
Change of wind direction & speed

Before the typhoon approached most closely to this area, the wind changed its direction, and suddenly increased its speed.

At the same time as the wind direction changed, a big swell came into the bay.

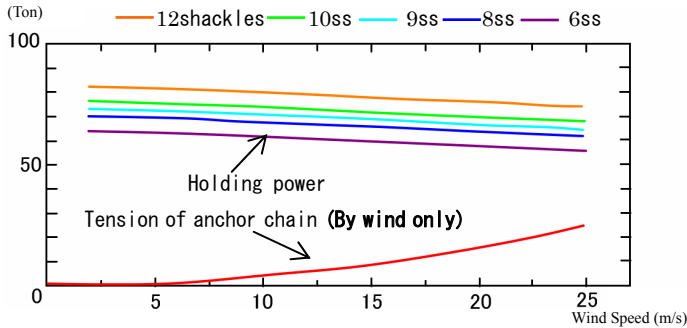
In case the ship receives only the effect of head wind

The holding power of the anchor decreases as the wind gets strong, because the contacting area to the bottom gets smaller. But the ship does not drag its anchor because holding power is always bigger than the tension.

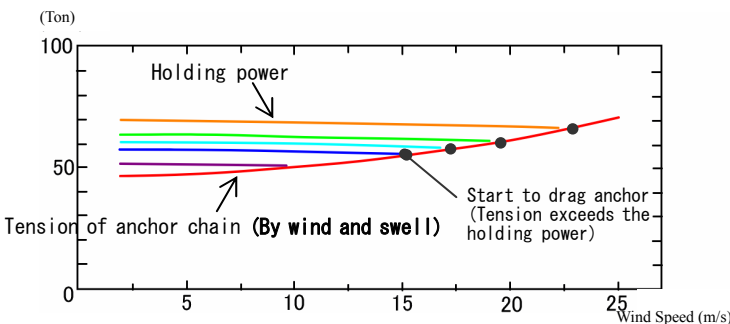
In case the ship receives the effect of both head wind and wave (Wave height: 5m, Wave length: 200m)

When wave drifting power is added to the wind, the tension of anchor chain considerably increases. It exceeds the holding power at the wind speed of 10m/s when the chain length is 6 shackles. When the speed is 15m/s, the ship drags anchor with 8 shackles. When speed is 25m/s, the ship drags anchor with 12 shackles. Waves have a great influence on dragging anchor.

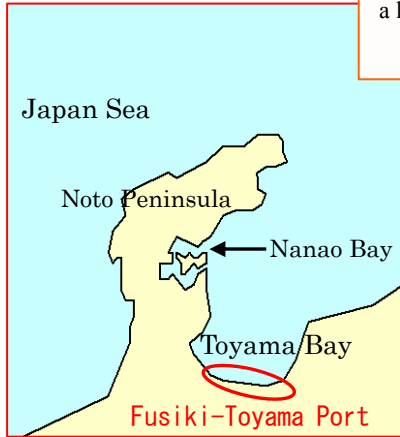
The bay is vulnerable to wave swells because its mouth is widely open from north to north east. Swells easily come into the bay especially when NE wind blows from offing for a long time.

Swells become even higher in the heart of the bay because of its shallowness.

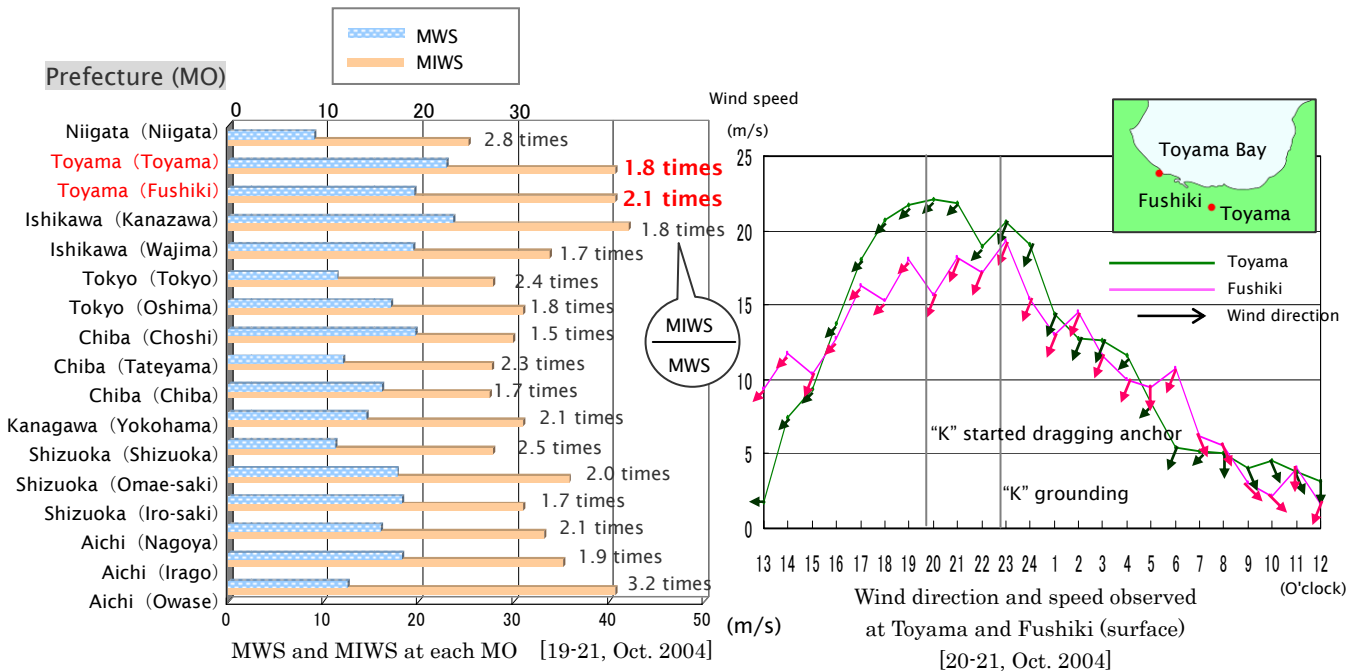
The following bar chart shows the comparison of the Maximum Wind Speed (MWS: the maximum of average wind speed in 10 minutes) and the Maximum Instantaneous Wind Speed (MIWS: the maximum of instantaneous wind speed), which were observed by meteorological observatories (MO) at the time of Typhoon No.23 in 2004.

The MIWS is twice as strong as the MWS on average. Especially, on the sea with little shield against wind, you need to anticipate that **the MIWS would be at least 1.5-2.0 times stronger than the MWS.**

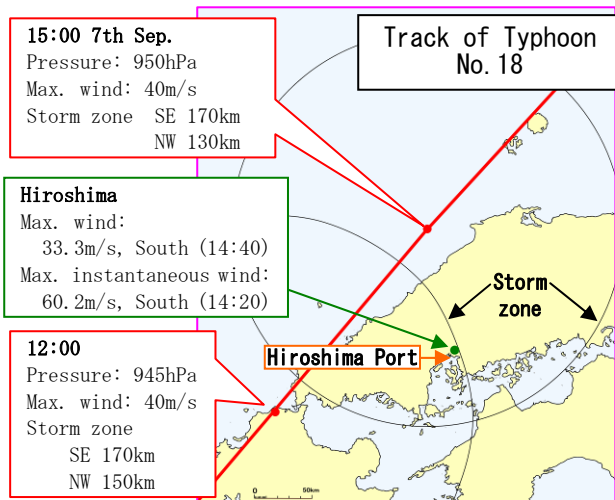
Although "B" received a recommendation from the harbor master to shelter while at berth in Hiroshima Port, she did not take any immediate action. The mooring rope was cut by strong wind and heavy waves. She collided with the berth, sustained a hole in her shell and sank.

- 21 hrs before sinking **First alert. (Preparing to shelter)**
- (-)10 hrs **Second alert. (Recommendation to shelter)**
- (-)6 hrs 15 min. **Storm, wave warning and heavy rain, flood, high water warning.** (By Hiroshima local meteorological observatory)

- (-)6 hrs **Received the recommendation through agent, but the master didn't take any action because he thought the typhoon would pass away soon and it would be safer to stay.**

- (-)1 hrs When wave height reached 2m, aft spring line was cut and stern line came out from bit. **Collided with the wharf** at port quarter and leak started in engine room. Evacuation from vessel became difficult due to oscillation.

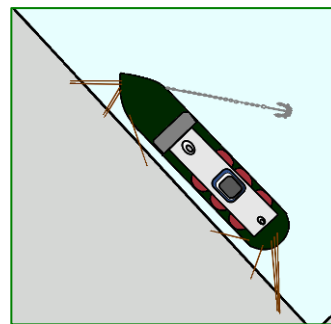
08:30 18th
On berthing
10 mooring ropes
(Dia. 80mm)

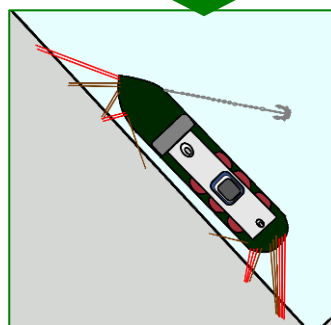
13:20 20th
Added 10 mooring ropes (Dia. 120mm)
