エアーニッポン株式会社所属ボーイング式737-700型JA16AN航空重大インシデントに係る安全勧告に基づき講じた措置について(通知)

SPECIAL AIRWORTHINESS INFORMATION BULLETIN

SUBJ: Flight Controls

SAIB: NM-15-03

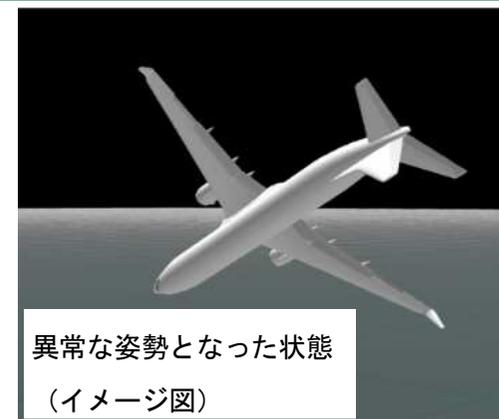
エアーニッポン株式会社所属ボーイング式737-700型JA16ANは、平成23年9月6日(火)、全日本空輸株式会社の定期140便として那覇空港から東京国際空港へ向けて飛行中、22時49分ごろ、串本の東約69nm、高度41,000ftにおいて、機長が操縦室を退室した後、機長を再入室させようとした際、副操縦士がドアロックセレクターを操作するつもりで誤ってラダートリムコントロールを操作したことにより、機体が異常な姿勢になり急降下した。
機体の損壊はなかった。

・スイッチの形状・大きさ・操作上の類似性を低減又は解消する必要性について検討すること
