JAPAN TRANSPORT SAFETY BOARD
ANNUAL REPORT 2014

Japan Transport Safety Board

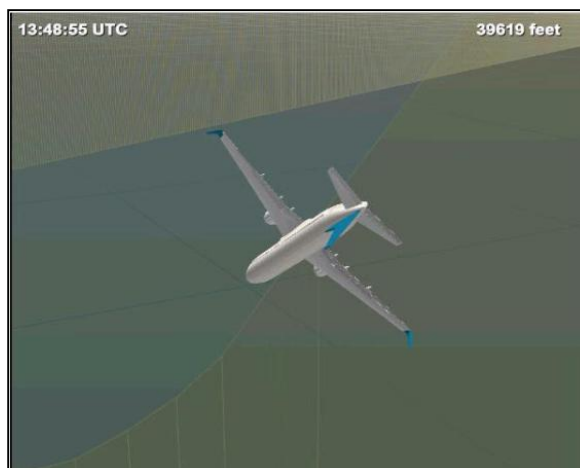
I think some of you may have seen the image on the right in a video form on TV news. The video was released to the press by JTSB regarding the incident of the aircraft sudden nosedive occurred over the Pacific on September 6, 2011.

Needless to say, the video that you saw was not prepared with the skills and intuitions of officers in charge of analysis. The video was prepared by using special software based on the data that was recorded/stored in the aircraft. The data was recorded/stored in the flight recorder (generally referred to as “black box”). Flight recorder records the attitude/altitude/speed of the aircraft, pilot operations, conversations inside of the cockpit, etc.

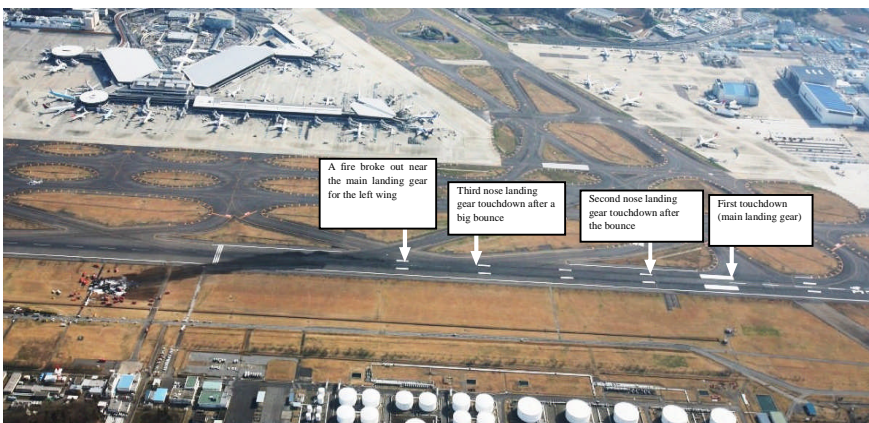
Summary of the accident: On March 23 (Monday), 2009, about 06:49 Japan Standard, a McDonnell Douglas MD-11F, operated by Federal Express Corporation as the scheduled cargo flight FDX80, bounced repeatedly during landing on Runway 34L at Narita International Airport. During the course of bouncing, its left wing was broken and separated from the fuselage attaching point and the airplane caught fire. The airplane rolled over to the left being engulfed in flames, swerved off the runway to the left and came to rest inverted in a grass area. The Pilot in Command (PIC) and the First Officer (FO) were on board the airplane, and both of them suffered fatal injuries. The airplane was destroyed and the post-crash fire consumed most parts.

There were the pilot and one F/O on board the aircraft, and both suffered fatal injuries.

It is highly probable that the aircraft bounced after the touchdown due to the facts that it received strong ground reaction force due to the sink rate (approximately 7 fps) that was greater than usual and that the lift at the time of touchdown was great enough to bounce the aircraft (vertical acceleration rate immediately before the touchdown was approximately 1.24G)

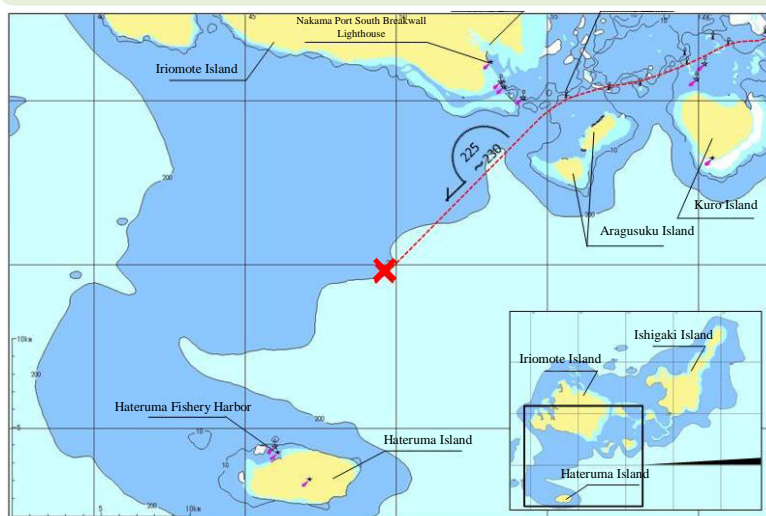
When the vessel's bow fell down between the waves, Passenger A's **body was lifted up from the seat and the impact on their posterior when falling back on the seat caused a compression fracture in her lumbar spine**

[Weather and sea conditions at the time of the accident]

Significant wave height: 1.52m, wave period: 6.5s, wave direction: south-southeast, wind direction: south wind velocity 7m/s

Probable causes: It is probable that this accident was caused by a chain of events in which the ship was sailing south-southwest at a speed of approximately 15 to 20kn in the sea south-southwest of Nakama Port when continuous waves from the south-southeast with a wave height of approximately 1.5m hit the port bow, and because Passenger A was not guided to the back cabin where the pitching is relatively low and Company A did not take measures to ensure that Passenger A properly wore their seat belt, when the vessel's bow rode the high wave crest with a wave height of approximately 2.0m and fell down between the waves, Passenger A's body was lifted up from the seat and the impact on her posterior when falling back on the seat caused a compression fracture in her lumbar spine. It is probable that Passenger A was not guided to the back cabin where the pitching is relatively low and Company A did not take measures to ensure that Passenger A properly wore their seat belt because Company A did not thoroughly ensure that its crew complied with the safe operation manual for adverse weather.
