ANNUAL REPORT 2016

JTSB Mission

Chapter 1 Summary of Recommendations and Opinions Issued in 2015

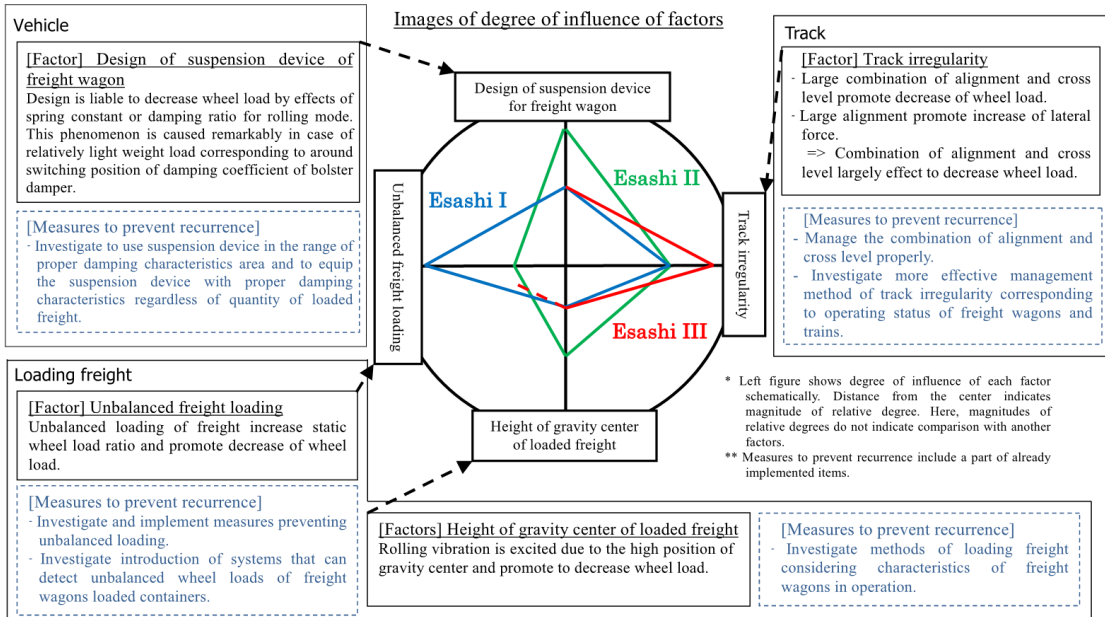
Attached diagram. Factors of the Esashi Line derailment accidents and their degrees of influence, etc.

- A series of the derailment accidents of freight trains occurred in Esashi Line have the common situation that the outer rail side wheels of the freight wagon in the freight train running in relatively sharp curve at near the limited speed, derailed by flange climbing.
- It is somewhat likely that these accidents were caused by the combination of the factors such as vehicles, track, and loading freight, etc., in the worse direction, while each factor would not cause the derailment.
- Here, degrees of influence of the factors to a series of derailment accidents differ as shown in the followings.

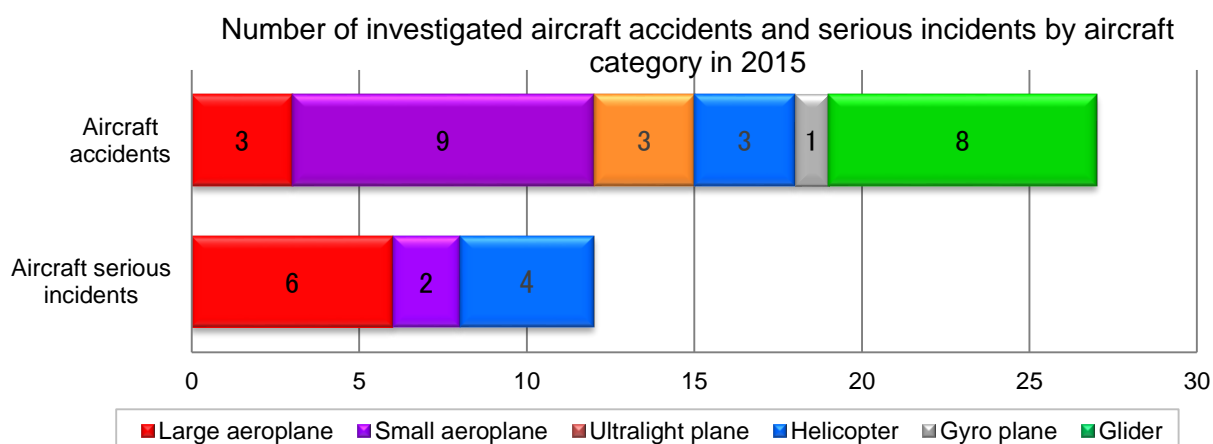
By aircraft category, three of the accidents involved large aeroplanes and nine other cases concerned small aeroplanes, while three ultralight planes, three helicopter, one gyro plane and eight gliders were involved in the remaining cases. The aircraft serious incidents included six case involving large aeroplane, two case involving small aeroplane, and four cases involving helicopters.

* Large aeroplane refers to an aircraft of a maximum take-off mass of over 5,700 kg.

* Small aeroplane refers to an aircraft of a maximum take-off mass of under 5,700 kg except for Ultralight plane.

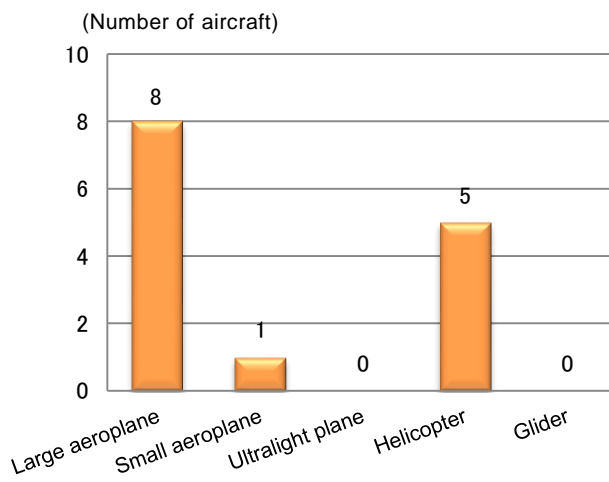
Number of published aircraft serious incident reports (11 cases) by aircraft category in 2015

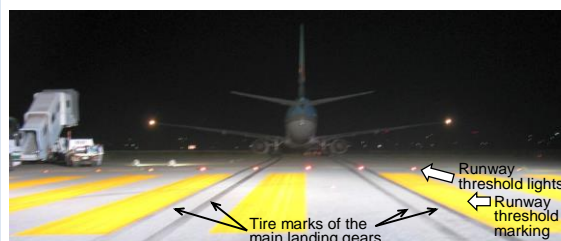
- The Captain normally judges the runway remaining length with using runway centerline lights, which varies in color according to length, though, the Captain could not notice the remaining length of the runway.
- The F/O was also saying that the Aircraft was slightly too fast to stop short of the red lights.
- The brake pressures had dropped after the disarming of the autobrakes.

Since the Captain and the F/O had already recognized that they were not allowed to vacate from the intersecting RWY 04/22, it is highly probable that they had intended to continue rolling until TWY-B1, the end of the runway, as being conscious of the sequence that passing over the side of TWY-P3 and then crossing the intersecting runway. However, the Captain had the Aircraft continuously roll in parallel with looking for the intersection with RWY 04/22 which was assumed far ahead, having trouble to figure out the position; therefore, it is somewhat likely that those circumstances contributed that the Captain did not let the Aircraft reduce enough lower speed.

Probable causes (Excerpt): It is highly probable that this serious incident occurred when the Aircraft landed on RWY 10 in Niigata Airport, the Captain did not let the Aircraft reduce enough lower speed to approach the runway threshold lights that the Captain understood as the stop bar lights for the intersecting RWY 04/22, which the Captain was holding a doubt, and when the Captain realized there was no runway beyond the red lights, the Aircraft could not stop within the runway anymore, resulting in overrunning.

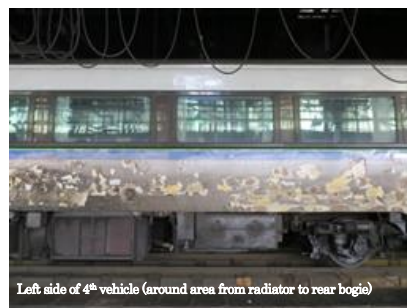
Probable causes (Excerpt): It is highly probable that the incident occurred by the following process.

- [1] As the pin press fitted into the guide arm of the sliding block, used as the speed governor for the diesel engine installed in the 4th vehicle of the express train, broke by metal fatigue at the edge of press fitted part, then the engine became uncontrollable and over speed operation caused damages of the piston and connecting rod etc., equipped inside of the engine.

It is probable that the reason why the engine was damaged by the over speed operation were related with that the control rack was designed to act to increase fuel injection rate when the pin of the sliding block was damaged, and that there was no mechanism to stop the engine operating in over speed, forcibly.

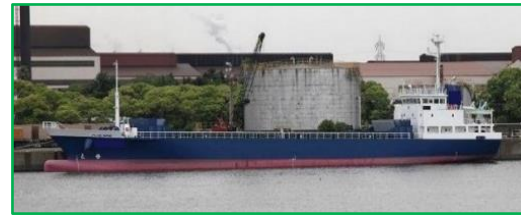
The bearing of Vessel B had been changed approximately 3° to port, but the Officer thought that he could pass in front of Ship B and did not confirm the change of bearing of Vessel B with a compass (did not notice the course alteration of Vessel B).

Officer turned to the port about 10° toward the front side of Ship B which approached about 0.9M.

At about 01:15:31

Ship B proceeded at the speed of 055° 12.1kn for the course over the ground.

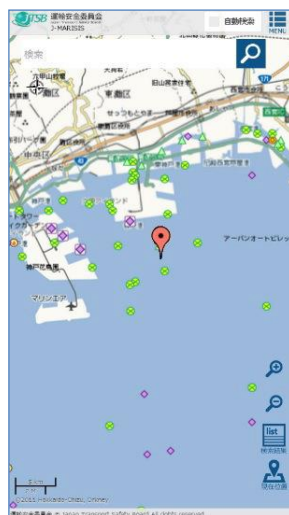
Screen displaying information near to the user's current location, using GPS functions

With touch panel support as well as revised display buttons and layouts, its ease of use has been increased and by using the GPS functions of mobile terminals, it is able to display information on areas near to the user's current location.

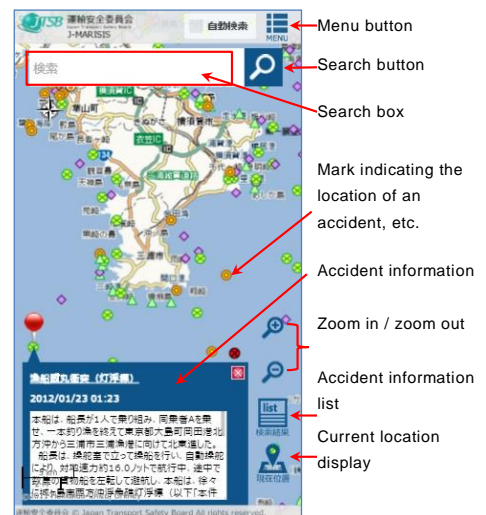
Screen displaying accident information

It is possible to view the same content, including accident information, as the conventional PC version, so users on small vessels such as pleasure boats or fishing vessels can easily use their smartphones or tablets to check information on accidents in areas of water they are intending to navigate to, and we hope that it will be useful in promoting safe ship operation.
